Comparative Study on Damage Index of RCC Frame Considering Fiber Discretization Technique

Mr Vishal M. Sapate¹, Mr Nikhil S. Jadhav²

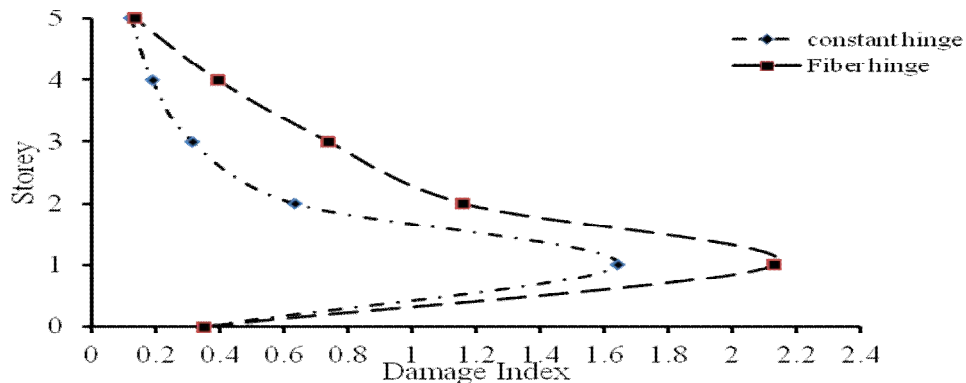
Figure 4 shows the comparison of storey damage index considering coupled and uncoupled effect of axial force and flexure moment under the El-Centro motion.

Figure.4: Comparison of Storey Index for El-Centro Ground Motion

In the above Fig 4 by comparing damage distribution of storey index, the fiber hinge shows more damage than constant hinge and is increasing gradually with bottom storey axial force up to failure occur. The maximum axial forces are inducing in bottom storey column still softening damage index does not progress to any damages.
