Comparative Study on Damage Index of RCC Frame Considering Fiber Discretization Technique

Mr Vishal M. Sapate¹, Mr Nikhil S. Jadhav²

^{1,2}Department of civil engineering, PG Student, G.H Rasoni University Amravati

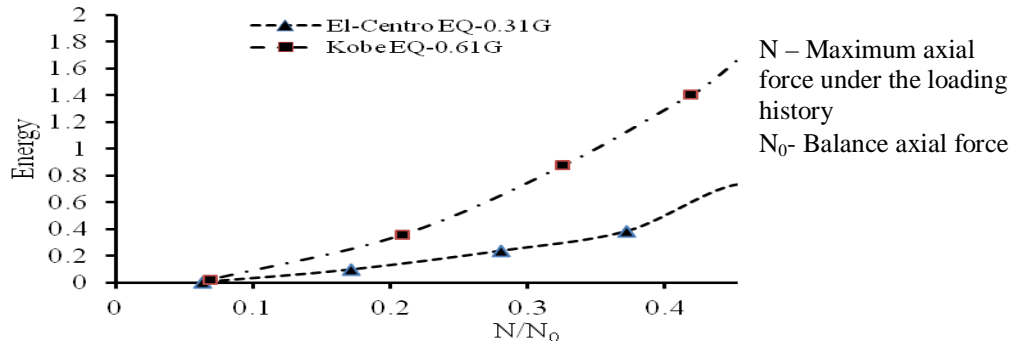
Figure.5: Influence of Axial Load on Energy Dissipation

The plot of energy dissipated in element verses ratio of axial force in element to ultimate capacity of element is as shown in Figure 4 when axial load is beyond the axial load ratio of 0.45(balanced axial load to maximum axial load capacity of section) element does not exhibit ductile behaviour. In compression control region of interaction diagram due to brittle behaviour, sudden failure is expected. In addition, the brittle failure is so immediate that the computation of damage index is not possible.
