Experimental Evaluation of Quality of TMT/QST Steel Bar by Using TM Ring Test

Mohini Dhongade¹, Rajpari Khaire², Shubham Shinde³, Amar Shelke⁴, A.N. Humnabad⁵, N. V. Khadake⁶
^{1, 2, 3, 4, 5, 6}Dept. Of Civil Engineering, JSPM Imperial College of Engineering and Research, Pune

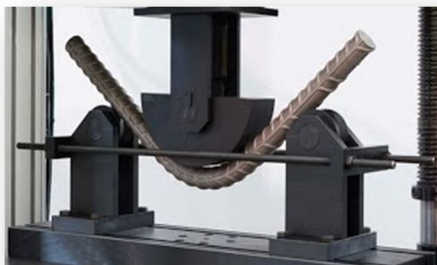
Fig 1) Re- bend test

The Re-bend test involves bending a sample of TMT Re-bar through plastic deformation by placing a force against an appropriate mandrel to a 135-degree included angle. The bend sample should be aged for 30 minutes in boiling water (100 degrees Celsius) and then let to cool. The sample should be bent back to a 157.5 degree included angle. Typically, tests are performed at room temperature. The mandrel diameters used for various grades of TMT Re-bar are listed below.

The sample used for the bend test should not be used for the re-bend test.

It is critical to ensure that the load applied to the sample bar is uniform, smooth, and vertically downwards. It is best to avoid using an impulse load.

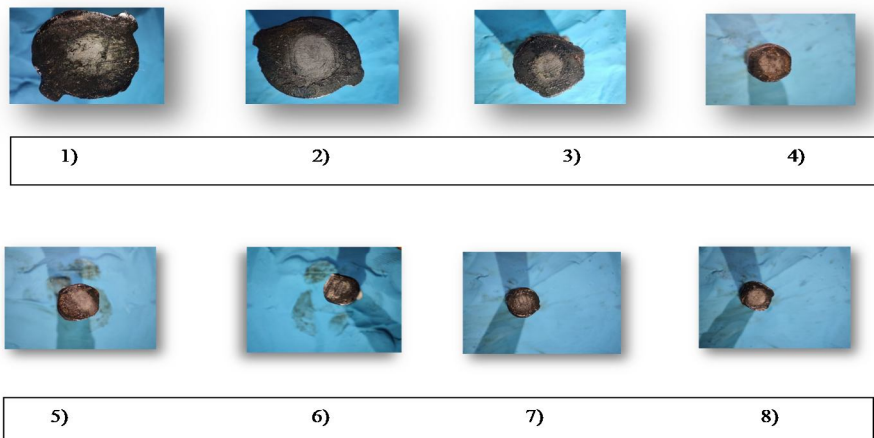
EXPERIMENTED BARS OF DIFFERENT DIAMETER

Figure depicts an ideal rebar with a continuous, concentric, and evenly thick TM-ring. It was discovered through laboratory experiments on various steel rebars acquired from the market that this type of perfect TM-rings are primarily prevalent in big diameter rebars and are absent in rebars with less than 16 mm diameter. Furthermore, such small diameter rebars are used as stirrups with a shallower cover depth than larger diameter primary reinforcement. This suggests that for smaller diameter rebars, better quality control is essential.

Case B in Figure 8 is an example of TM phase that is continuous, eccentric, and non-uniform. The ring thickness is exceedingly thin in two areas on the image's left side. This is most likely to happen if the coolant temperature or pressure is not uniform around the circle. As a result, a differential temperature gradient occurs, resulting in a TM ring with non-uniform and insufficient thickness in some areas. These flaws were most commonly detected in 12 and 16 mm sizes. On the other hand, overquenching at specific spots can result in a TM-ring with a non-uniform and more than enough thickness in some areas.

Figure depicts a non-uniform TM-phase with dispersed discontinuities. This cannot be defined as a photograph taken with a measuring scale next to a test sample.
