Experimental Evaluation of Quality of TMT/QST Steel Bar by Using TM Ring Test

Mohini Dhongade¹, Rajpari Khaire², Shubham Shinde³, Amar Shelke⁴, A.N. Humnabad⁵, N. V. Khadake⁶
^{1, 2, 3, 4, 5, 6}Dept. Of Civil Engineering, JSPM Imperial College of Engineering and Research, Pune

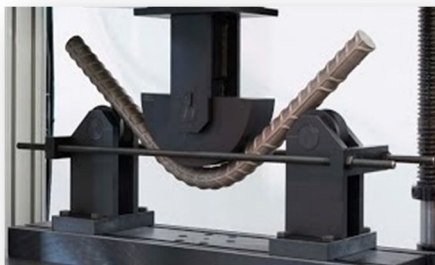
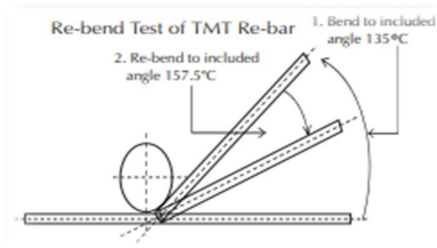
Fig 1) Re- bend test

The Re-bend test involves bending a sample of TMT Re-bar through plastic deformation by placing a force against an appropriate mandrel to a 135-degree included angle. The bend sample should be aged for 30 minutes in boiling water (100 degrees Celsius) and then let to cool. The sample should be bent back to a 157.5 degree included angle. Typically, tests are performed at room temperature. The mandrel diameters used for various grades of TMT Re-bar are listed below.

The sample used for the bend test should not be used for the re-bend test.

It is critical to ensure that the load applied to the sample bar is uniform, smooth, and vertically downwards. It is best to avoid using an impulse load.

This test is intended to assess the impact of strain ageing on steel. Strain ageing is an embrittlement effect caused by nitrogen diffusion in steel during cold deformation. Because these steels have decreasing toughness at lower temperatures, the risk of fracture on bending increases as the temperature decreases. As a result, temperature parameters should be followed exactly as specified by the code for the best results.

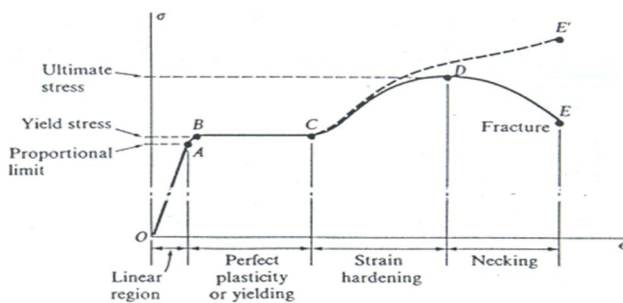
Fig 2) Yield strength of steel

Which level of stress can a material withstand? At what point will it begin to deform plastically? This information can be obtained during the Yield Stress Test/0.2% Proof Stress. The material will bend elastically until it reaches the yield point and then revert to its original shape when the applied load is removed.

Starting at 0.002 strains, the conventional technique is to project a line parallel to the initial elastic area. The 0.002 strain point is also known as the 0.2% offset strain point.

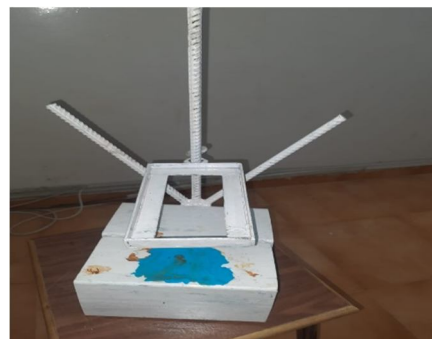
Fig 3) Model

- 1) 12 mm dia. of bar = 02 Nos, 18" length.
- 2) Square tube = 02 Nos.
- 3) Colour= half a liter.
- 4) LED Lights = 02 Nos.
- 5) Bolts = 02 Nos.
- 6) Angels = 04 Nos, 4" length.

[Note:- 90% model is made from scrap materials.]

- a) The mobile holder had to be adjustable.
- b) The color of the model had to be changed.
- c) The lighting angle had to be changed.
- d) Sample holder had to be fixed in place.

- Place the made model on a flat surface.
- After that all the STEEL BAR's were cut to 2" length and filed.
- Take ethyl alcohol 93% and 7% nitric acid in a beaker and mix well in the same manner.
- After mixing all the bars cut in the mixture, keep the mixture for at least 5 minutes.
- And to see its result, put it in the bar model and take its photo and get its result.

- 1) *Mobile holder had to be Adjustable:* In the previous model we kept the sample holder adjustable. But because of that we were not getting accurate results. Because the steel sample used to be in a state and the photo could not be taken properly due to the movement of the sample.
- 2) *The color of the Model had to be Changed:* The color of the previous model was black. But the color of the sample was black. Then 2 because the color was black, I could not understand what the result was on the sample and the photo was not coming out.
- 3) *Lighting Angle had to be Changed:* The angle of the light had to be changed for this, because the mobile holder was adjustable, the light was not focused on the sample which was kept on the plain surface.

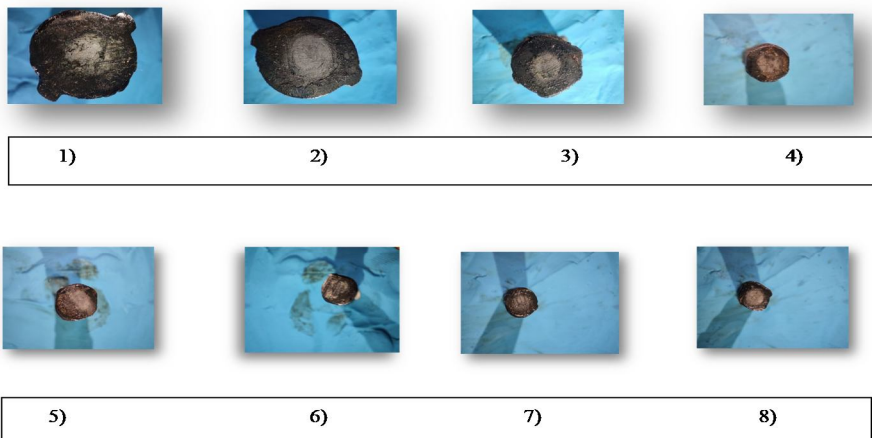
EXPERIMENTED BARS OF DIFFERENT DIAMETER

A high-quality rebar should have a continuous, concentric, and uniform TM phase, as well as a core with FP phase (as seen in Figure). on the other hand

Case B in Figure 8 is an example of TM phase that is continuous, eccentric, and non-uniform. The ring thickness is exceedingly thin in two areas on the image's left side. This is most likely to happen if the coolant temperature or pressure is not uniform around the circle. As a result, a differential temperature gradient occurs, resulting in a TM ring with non-uniform and insufficient thickness in some areas. These flaws were most commonly detected in 12 and 16 mm sizes. On the other hand, overquenching at specific spots can result in a TM-ring with a non-uniform and more than enough thickness in some areas.

The study introduces a potential quality control concern in the fabrication of TMT/QST steel rebars in the Indian market within its scope. Defects in the peripheral tempered martensite (TM) ring and ferrite-pearlite (FP) core of TMT/QST steel rebars with diameters of 8, 12, and 16 mm. The probable faults were divided into three categories: discontinuous, non-uniform TM-ring, and eccentric FP core. To analyse the cross-sectional phase distribution (CSPD) of TMT/QST steel rebars, a "TM-ring test" technique has been developed/documentated. The test protocol comprises instructions for specimen extraction, preparation, macro etching, analysis, and result documentation. The new "TM-Ring" test might be used by technicians at steel plants and building sites to assess CSPD quality. The authors gratefully thank funding from the Ministry of Human Resources Development (MHRD) via the Indian Institute of Technology Madras (ITM), Chennai. The authors would like to thank Prof. Ravindra Gettu for his encouragement and advice throughout this effort, as well as Mrs. Malarvizhi and Mr. Subramanian from the Department of Civil Engineering for their assistance with the experimental work. The authors additionally appreciate the Department of Metallurgical and Materials Engineering's laboratory help.
