Experimental Evaluation of Quality of TMT/QST Steel Bar by Using TM Ring Test

Mohini Dhongade¹, Rajpari Khaire², Shubham Shinde³, Amar Shelke⁴, A.N. Humnabad⁵, N. V. Khadake⁶
^{1, 2, 3, 4, 5, 6}Dept. Of Civil Engineering, JSPM Imperial College of Engineering and Research, Pune

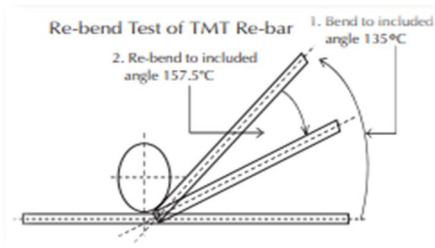
Fig 1) Re- bend test

The Re-bend test involves bending a sample of TMT Re-bar through plastic deformation by placing a force against an appropriate mandrel to a 135-degree included angle. The bend sample should be aged for 30 minutes in boiling water (100 degrees Celsius) and then let to cool. The sample should be bent back to a 157.5 degree included angle. Typically, tests are performed at room temperature. The mandrel diameters used for various grades of TMT Re-bar are listed below.

The sample used for the bend test should not be used for the re-bend test.

It is critical to ensure that the load applied to the sample bar is uniform, smooth, and vertically downwards. It is best to avoid using an impulse load.

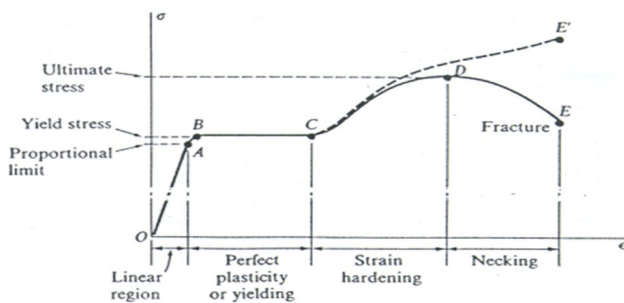
Fig 2) Yield strength of steel

Starting at 0.002 strains, the conventional technique is to project a line parallel to the initial elastic area. The 0.002 strain point is also known as the 0.2% offset strain point.

The material's behaviour can be divided into two categories: brittle and ductile. Steel and aluminium are common ductile material failures. Glass and cast iron are examples of fragile materials. The stress-strain curve can be used to distinguish between the two types. Alternating Current Components
