Feasibility Study of Pedestrian Facilities at Hebbal Ring Road Junction

Sridhara Y E¹, Praveen Kumar P²

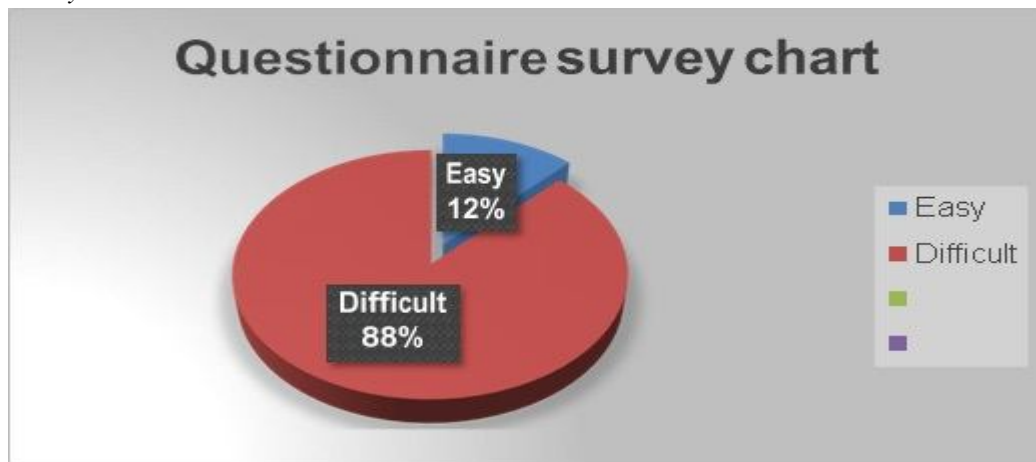
C. Questionnaire Survey Chart

The opinions of pedestrian were taken through questionnaire survey. Total 90 questionnaires were taken and the details of which are tabulated. The opinions are presented in graphical manner.

- 5) Questionnaire Survey was conducted to collect detail information of possible public needs. The survey indeed helped in bringing up public's important views. From the data collected, it was noticed that the number of people having difficulty crossing the road were more in number. The percentage of people suggesting for Underpass were 82% and people suggesting for pedestrian signals were 18%.

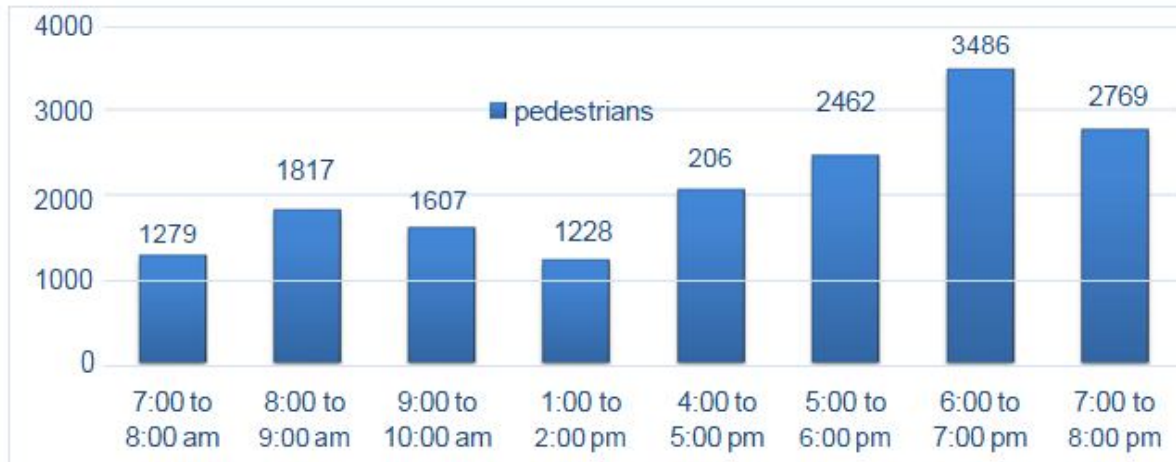
Figure 1 Flow of pedestrian per hour (K R Puram to Hebbal)

- 1) From the result obtained, the maximum morning peak hour of pedestrian flow is from Hebbal towards KR Puram at 8:00 to 9:00 am which is 4498 numbers, considering all the working and non-working days.

- 2) During noon hour, the maximum peak hour of pedestrian flow is from Hebbal towards KR Puram at 1:00 to 2:00pm which is 2460 numbers.
- 3) In evening the maximum peak hour of pedestrian flow is from Hebbal towards KR Puram at 6:00 to 7:00pm which is 3548 numbers.
