# Feasibility Study of Pedestrian Facilities at Hebbal Ring Road Junction

Sridhara Y E<sup>1</sup>, Praveen Kumar P<sup>2</sup>

<sup>1</sup>Student, Govt SKSJIT college Bangalore

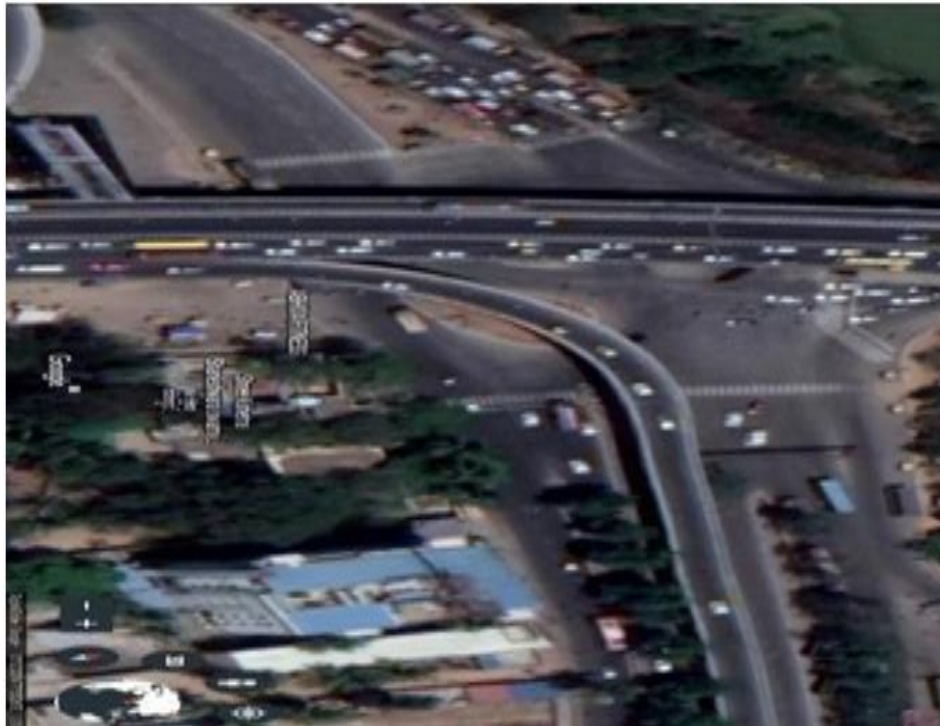
Due to the presence of heavy traffic in Hebbal ring road junction it is difficult to cross the road . There is no presence of any Underway or Cross ways in that area. I am doing the project in this study area to check whether there is an need to construct the crossways or Under ways.

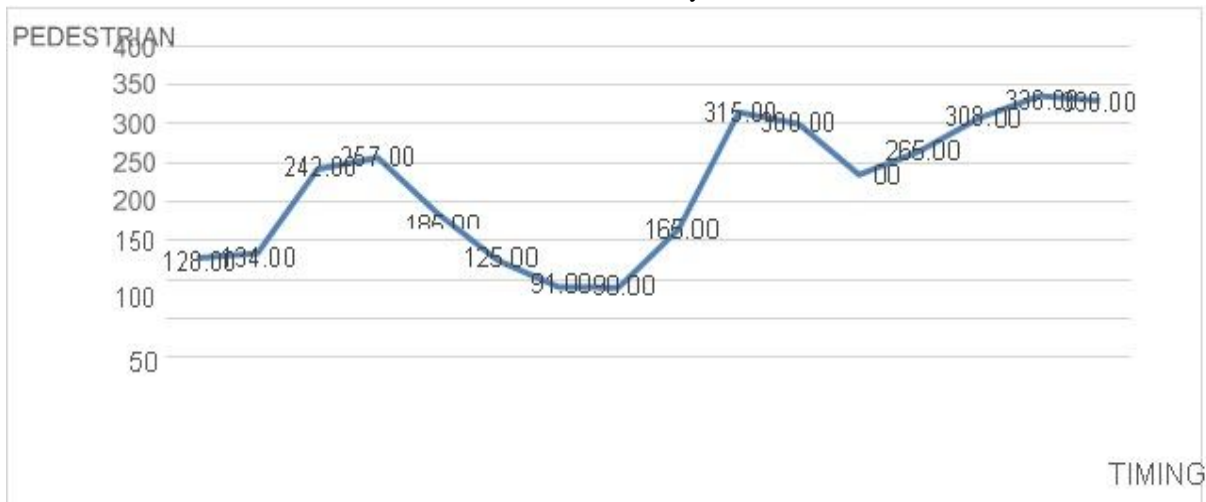
Pedestrian volume count on Thursday K R Puram towards

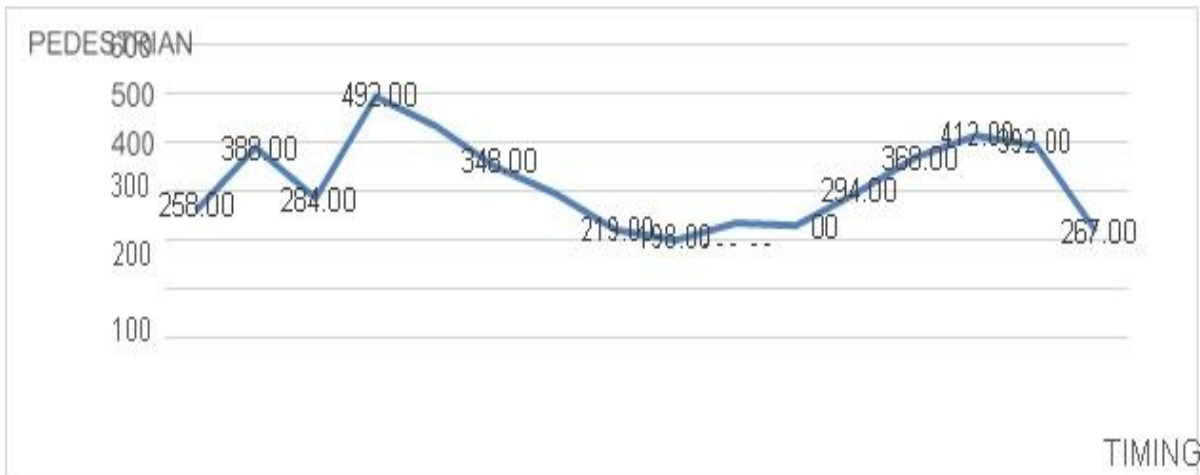
Pedestrian volume count on Friday Hebbal towards K R Puram

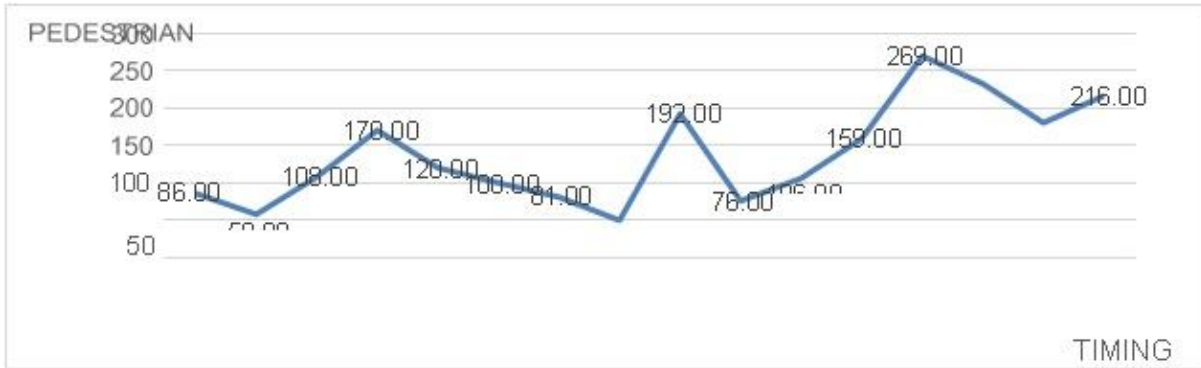
Pedestrian vol count on Tuesday(govt holiday) K R Puram towards Hebbal

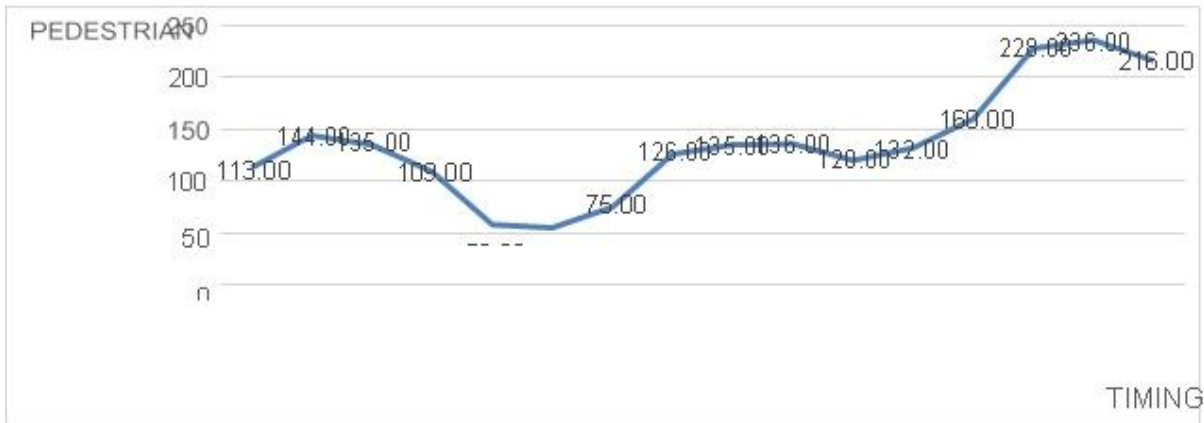
Pedestrian volume count on Sunday K R Puram towards Hebbal

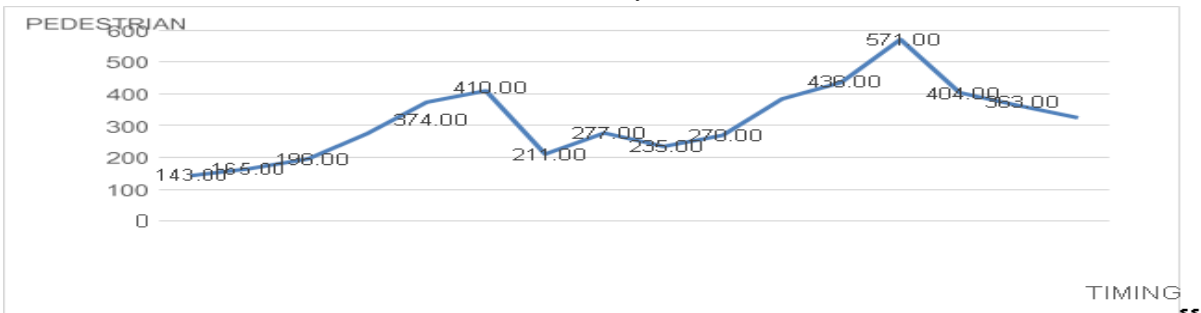
Pedestrian volume count on Sunday Hebbal towards K R Puram

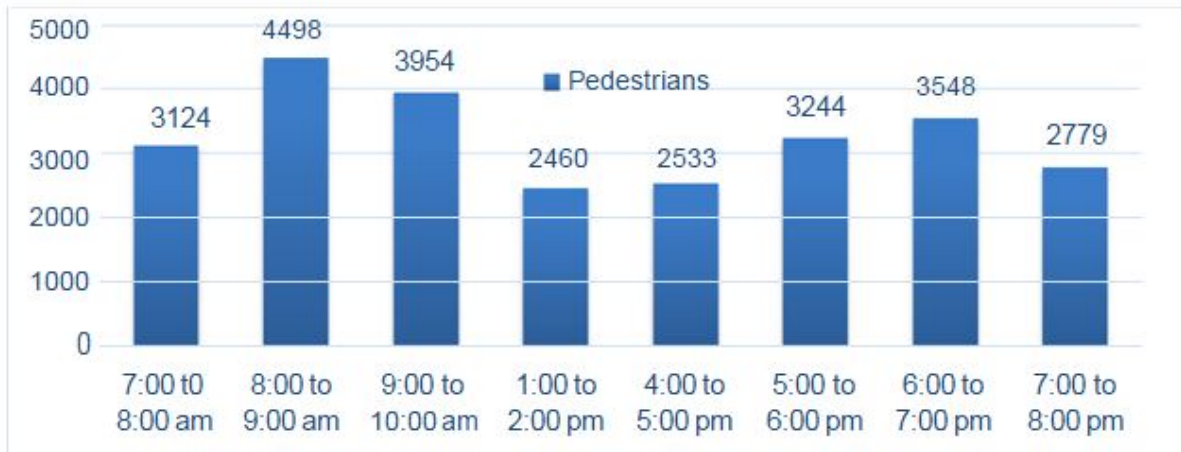
Figure 2 Flow of pedestrian per hour (Hebbal to K R Puram)

Result w.r.t Flow of Pedestrian (Hebbal To K R PURAM)

- 1) From the result obtained, the maximum morning peak hour of pedestrian flow is from Hebbal towards KR Puram at 8:00 to 9:00 am which is 4498 numbers, considering all the working and non-working days.

- 2) During noon hour, the maximum peak hour of pedestrian flow is from Hebbal towards KR Puram at 1:00 to 2:00pm which is 2460 numbers.
- 3) In evening the maximum peak hour of pedestrian flow is from Hebbal towards KR Puram at 6:00 to 7:00pm which is 3548 numbers.
