# Feasibility Study of Pedestrian Facilities at Hebbal Ring Road Junction

Sridhara Y E<sup>1</sup>, Praveen Kumar P<sup>2</sup>

<sup>1</sup>Student, Govt SKSJIT college Bangalore

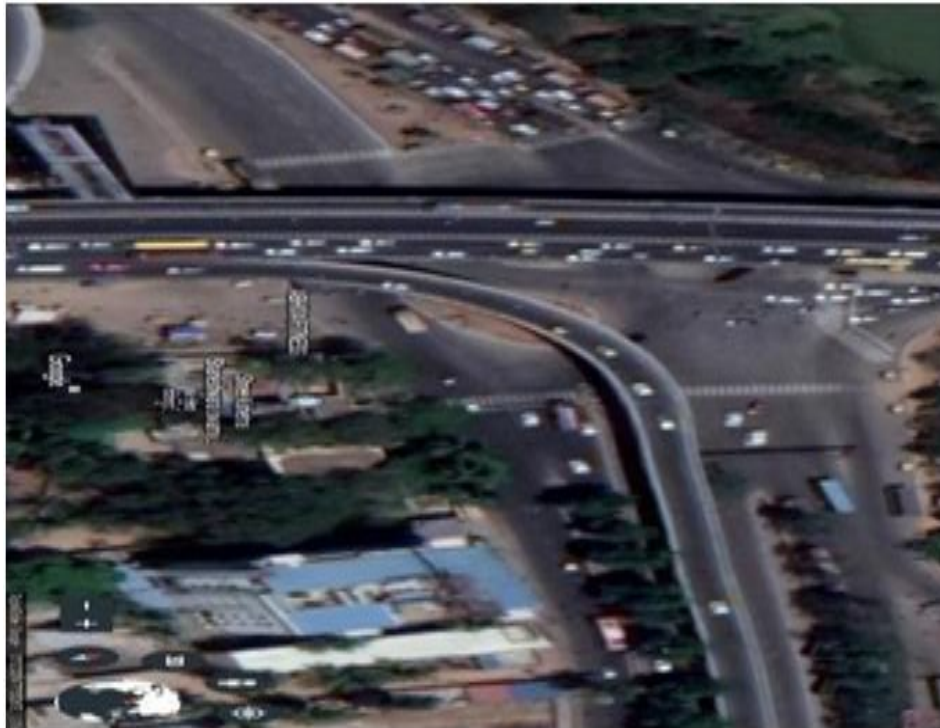
Due to the presence of heavy traffic in Hebbal ring road junction it is difficult to cross the road . There is no presence of any Underway or Cross ways in that area. I am doing the project in this study area to check whether there is an need to construct the crossways or Under ways.

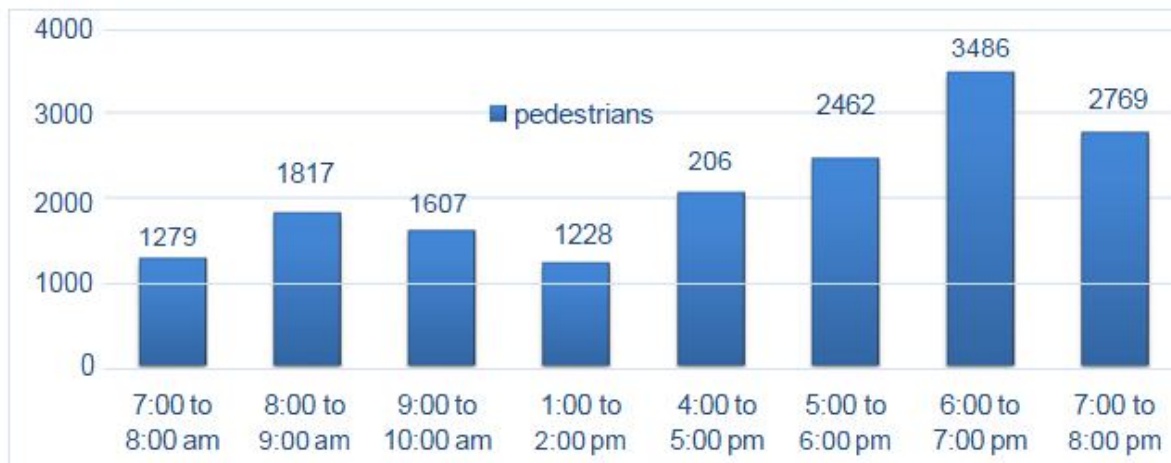
Figure 1 Flow of pedestrian per hour (K R Puram to Hebbal)

Results w.r.t Flow of Pedestrian (K R PURAM to HEBBAL)

- 1) From the result obtained, the maximum morning peak hour of pedestrian flow is from Hebbal towards KR Puram at 8:00 to 9:00 am which is 4498 numbers, considering all the working and non-working days.

- 2) During noon hour, the maximum peak hour of pedestrian flow is from Hebbal towards KR Puram at 1:00 to 2:00pm which is 2460 numbers.
- 3) In evening the maximum peak hour of pedestrian flow is from Hebbal towards KR Puram at 6:00 to 7:00pm which is 3548 numbers.

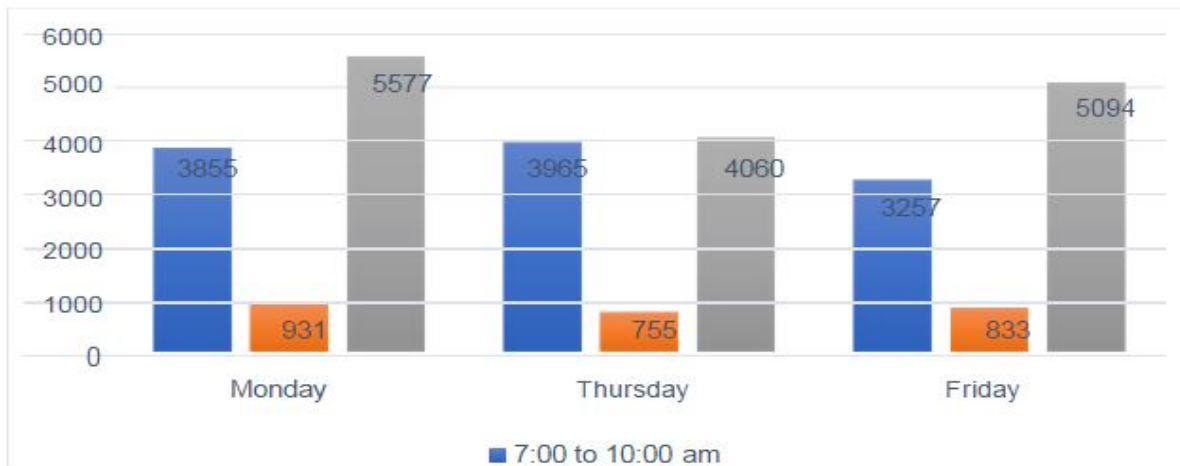
Total Pedestrians Flow on Working Days

Result Of Pedestrian Flow On Working Days

- 1) From the experiment investigation the average pedestrian observed during working days are 1057 ped/hr and on non-working days are 815 ped/hr.
- 2) The peak flow is observed during 8am to 9am in the morning hours and 6pm to 7pm in the evening hours.
- 3) The study concludes that maximum pedestrian flow from Hebbal towards KR Puram.
- 4) The study can be concluded projecting a serious need of pedestrian facilities such as underpass or pedestrian signal.
