Feasibility Study of Pedestrian Facilities at Hebbal Ring Road Junction

Sridhara Y E¹, Praveen Kumar P²

¹Student, Govt SKSJIT college Bangalore

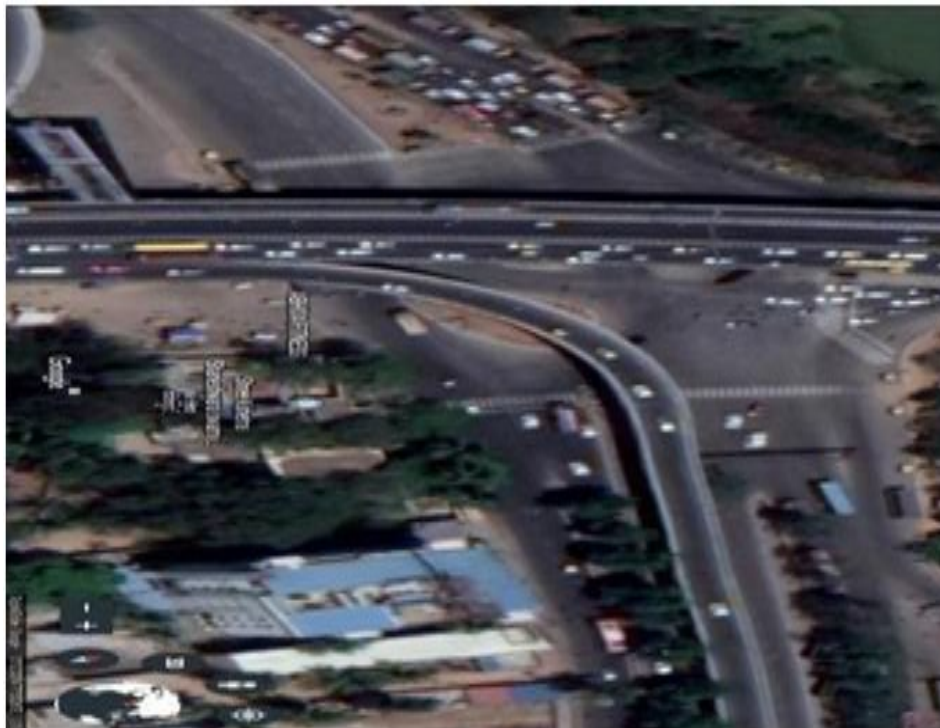
Due to the presence of heavy traffic in Hebbal ring road junction it is difficult to cross the road . There is no presence of any Underway or Cross ways in that area. I am doing the project in this study area to check whether there is an need to construct the crossways or Under ways.

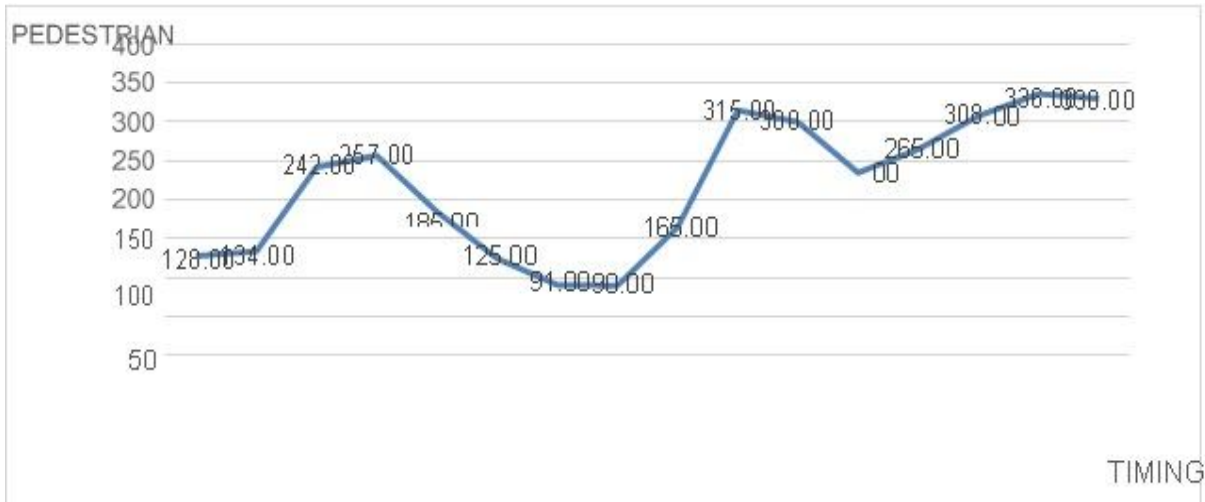
Pedestrian volume count on Thursday K R Puram towards
