Flood Plain Mapping and Identification of Warning Level Prior to Flood for Chalakudy River

Shinto M D¹, Chinnamma M A², Deepa Davis³

Abstract: Flood is one of the most dangerous disasters occur in the world. It endangers the lives of humans and other species. In India one – fifth of the global death rate is happening due to flood. From 2018 June 1 st to August 19 Kerala also experienced a high intense rainfall which results severe flooding. Five million people were affected and 433 people loss their life during this flood. Hence one way to minimize the effect of flood is proper operation of flood forecasting and flood control systems. In this paper we analysed drastic flood situations in Chalakudy river basin during the years 2018 - 2021. Mapping of flood plain of Chalakudy river basin was prepared using HEC – RAS and ARC GIS and initially drowned areas were mapped using Google Earth Engine. Also identified the flood warning level of Chalakudy river and each local bodies based on actual data and field surveys.

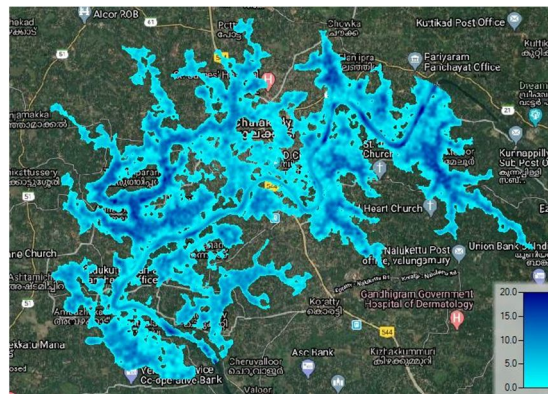
Fig. 3 Inundation depth for flood prone areas

Regarding a flood inundation study the flow depth is the most important output. The flow depth corresponding to the given conditions was obtained as output from HEC- RAS as shown in Fig.3. The inundation depth varies from 0 to 20 m. Higher depths are observed in the channel and it reduces on banks. The terrain elevation is the most important factor that determines the flood inundation. the flood inundation is maximum in the agricultural areas specifically paddy fields which have a low elevation compared to other regions.

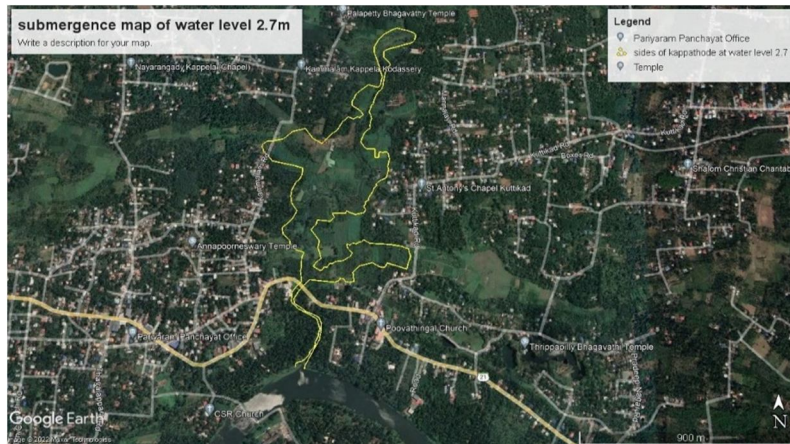
Fig.4 Flood inundation map of Pariyaram by google earth at water level 2.7m

1) *Pariyaram Panchayat*: The flood water level and spatial extent will be documented through the survey along with the duration of flood and rate of water level increase during the period. From the field observation and enquiry, the area which is affected by flood in Chalakudy river basin is very first is at Kammalam. This place is in pariaram panchayat ward. This place is flooded due to over flows Kappathode which is a tributary of Chalakudy river. This happened when the river gauge reading reached at 2.7 m and the height of inundation was 0.5 m. water level and inundation heights are shown in Table 5 and inundation map of Pariyaram panchayat at water level 2.7 m is shown in Fig.4.

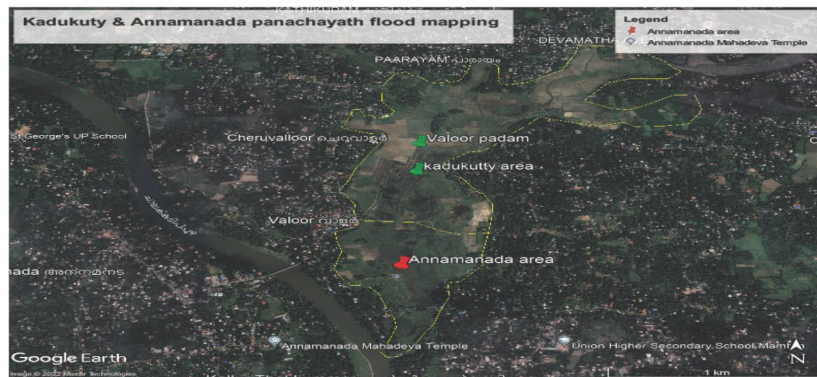
Fig.5 Flood inundation map of Kadukutty and Annamanada panchayats

4) *Annamanada Panchayat*: From the surveys and analysis, it is clear that left bank of Cheruvaloor and upstream side of Pulikakadavu bridge was the initially drowned area. Area inundated when river gauge reading reached 4.26 m at arangaly station and the corresponding inundation height was 0.1 m. Table 8 explains river gauge readings and corresponding inundation heights at vettilappara and arangaly station. Fig.5 shows inundation map of Kadukutty and Annamanada panchayats.

- 3) *Kadukutty Panchayat*: From the field enquiries and surveys, we got a clear idea about the aftereffects of flood in this panchayat. All the roads leading to the locality were washed away by the overflowing waters of Chalakudy river. Kadukutty grama panchayat is mainly depending on the water level at Arangaly station. This area is inundated when the water level reached at 3.96 m and the height of inundation was 0.6m. Table 7 shvos the river gauge readings at two different stations and corresponding height of inundation. From the analysis of data, Valoor bridge, Koratty- Annamanada road in ward 11 was initially drowned on 8th August 2018.
