Flood Plain Mapping and Identification of Warning Level Prior to Flood for Chalakudy River

Shinto M D¹, Chinnamma M A², Deepa Davis³

¹M. Tech Student, ²Professor, Department of Civil Engineering, Malabar College of Engineering and Technology Desamangalam, Thrissur

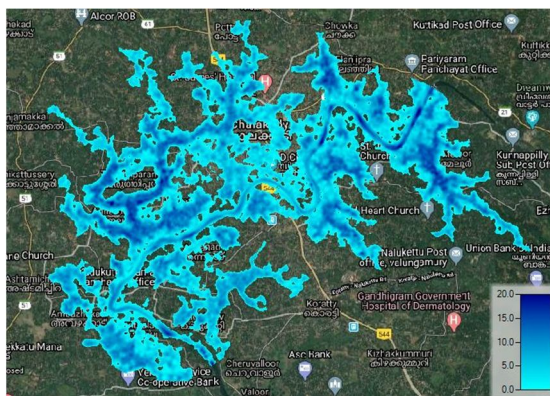
Regarding a flood inundation study the flow depth is the most important output. The flow depth corresponding to the given conditions was obtained as output from HEC- RAS as shown in Fig.3. The inundation depth varies from 0 to 20 m. Higher depths are observed in the channel and it reduces on banks. The terrain elevation is the most important factor that determines the flood inundation. the flood inundation is maximum in the agricultural areas specifically paddy fields which have a low elevation compared to other regions.

Fig. 3 Inundation depth for flood prone areas
