Flood Plain Mapping and Identification of Warning Level Prior to Flood for Chalakudy River

Shinto M D¹, Chinnamma M A², Deepa Davis³

¹M. Tech Student, ²Professor, Department of Civil Engineering, Malabar College of Engineering and Technology Desamangalam, Thrissur

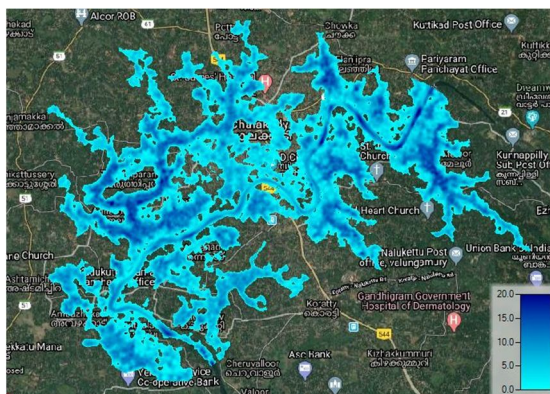
Fig. 3 Inundation depth for flood prone areas

Regarding a flood inundation study the flow depth is the most important output. The flow depth corresponding to the given conditions was obtained as output from HEC- RAS as shown in Fig.3. The inundation depth varies from 0 to 20 m. Higher depths are observed in the channel and it reduces on banks. The terrain elevation is the most important factor that determines the flood inundation. the flood inundation is maximum in the agricultural areas specifically paddy fields which have a low elevation compared to other regions.

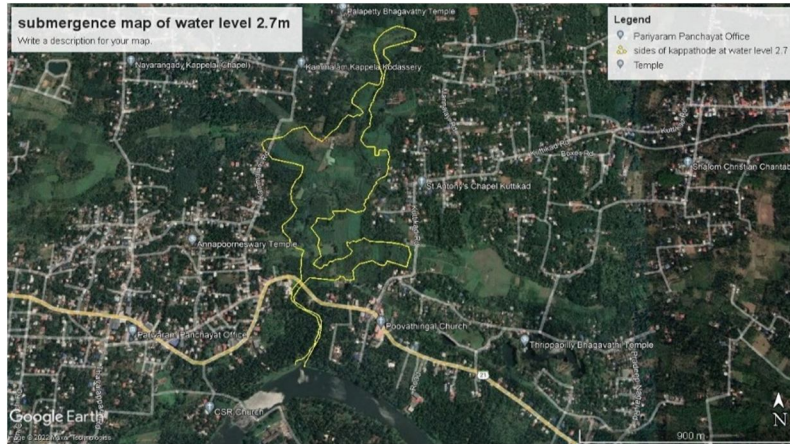
Fig.4 Flood inundation map of Pariyaram by google earth at water level 2.7m

1) *Pariyaram Panchayat*: The flood water level and spatial extent will be documented through the survey along with the duration of flood and rate of water level increase during the period. From the field observation and enquiry, the area which is affected by flood in Chalakudy river basin is very first is at Kammalam. This place is in pariaram panchayat ward. This place is flooded due to over flows Kappathode which is a tributary of Chalakudy river. This happened when the river gauge reading reached at 2.7 m and the height of inundation was 0.5 m. water level and inundation heights are shown in Table 5 and inundation map of Pariyaram panchayat at water level 2.7 m is shown in Fig.4.
