Investigation on Effects and Properties of Concrete Structure after Exposed to Fire

Prof. S. V. Dhoke¹, Akshay Chikate², Abhijit Andhare³, Anikesh Sable⁴, Ashish Gabhane⁵, Himanshu Bhabutkar⁶, Yash Gandhe⁷

*P.R.Pote (Patil) college of Engineering and Management, Amravati
Sant. Gadge baba Amravati University – India*

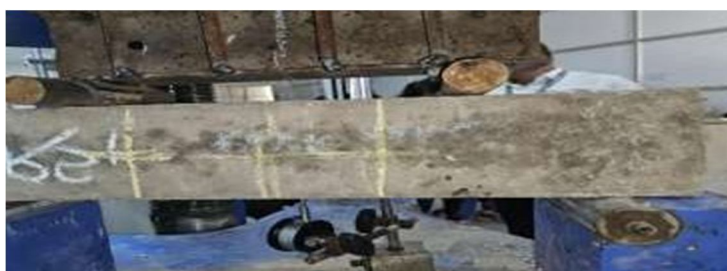
2) Apply Load On (RS1)

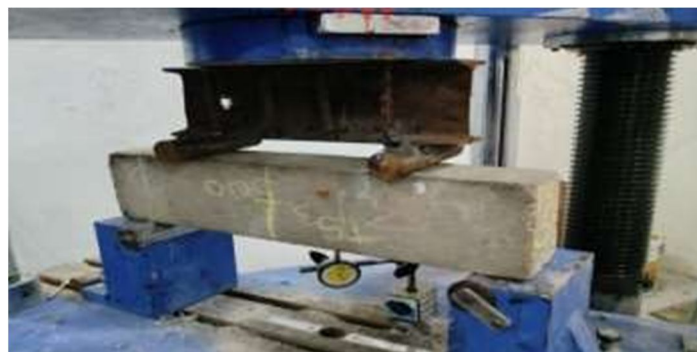
Apply Load On (RS3)

4) *Apply Load On (RS3)*

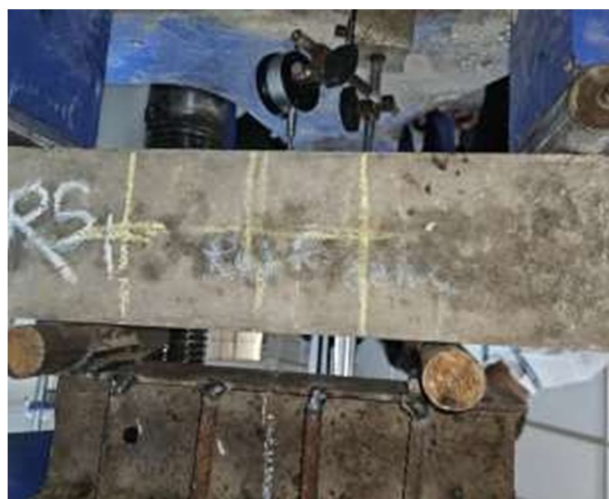
4.1.1 Reference Specimen one

Reference Specimen One (RS1)

This Reference specimen is use as reference point of view. This Reference specimen compare with the fired beam. Remaining beam are fire provided is different by using muffle Furnace after the testing of that beam all results compare RS1.
