Investigation on Effects and Properties of Concrete Structure after Exposed to Fire

Prof. S. V. Dhoke¹, Akshay Chikate², Abhijit Andhare³, Anikesh Sable⁴, Ashish Gabhane⁵, Himanshu Bhabutkar⁶, Yash Gandhe⁷

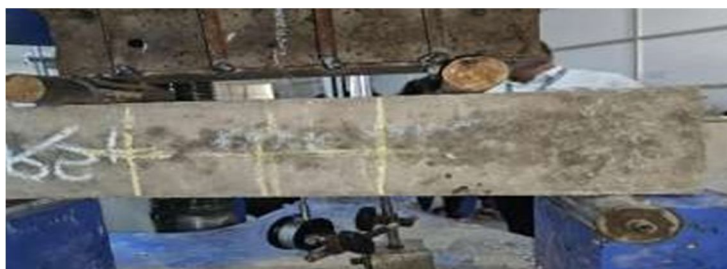
2) Apply Load On (RS1)

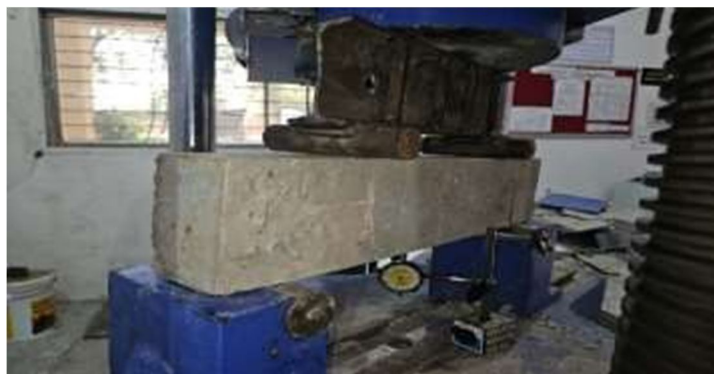
Apply Load On (RS2)

3) *Apply Load On (RS2)*

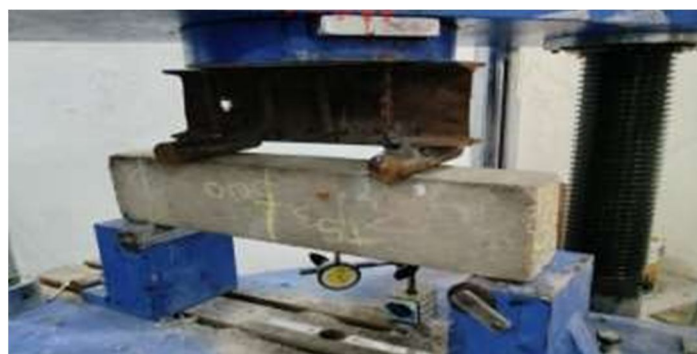
Apply Load On (RS3)

4) *Apply Load On (RS3)*

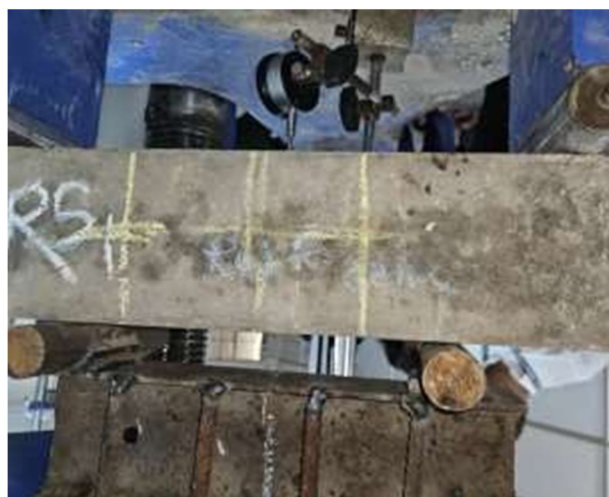
4.1.1 Reference Specimen one

Reference Specimen One (RS1)

This Reference specimen is use as reference point of view. This Reference specimen compare with the fired beam. Remaining beam are fire provided is different by using muffle Furnace after the testing of that beam all results compare RS1.

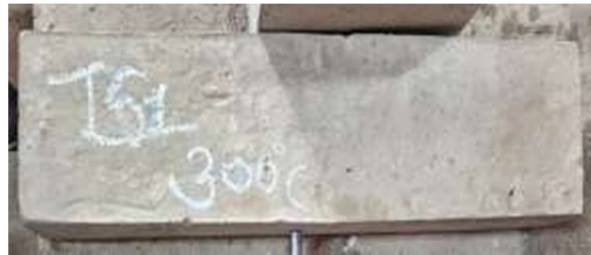
B. Temperature Specimen One (TS1 Fired At 300°C):

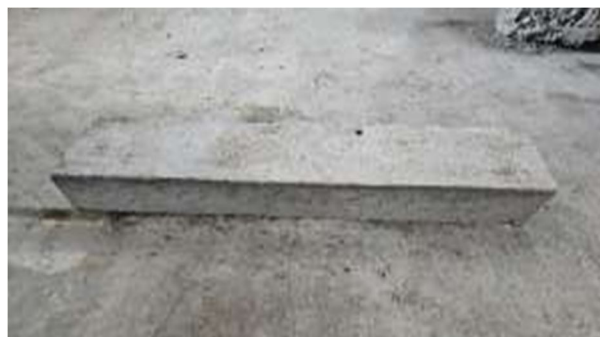
Temperature Specimen Two

1) Temperature Specimen two (TS2 Fired At 400°C)

In a muffle furnace, setting the temperature to 400 degrees Celsius means that the furnace will generate heat up to that temperature. It's important to ensure that the furnace is properly calibrated and that you follow safety protocols when operating it at such high temperatures.

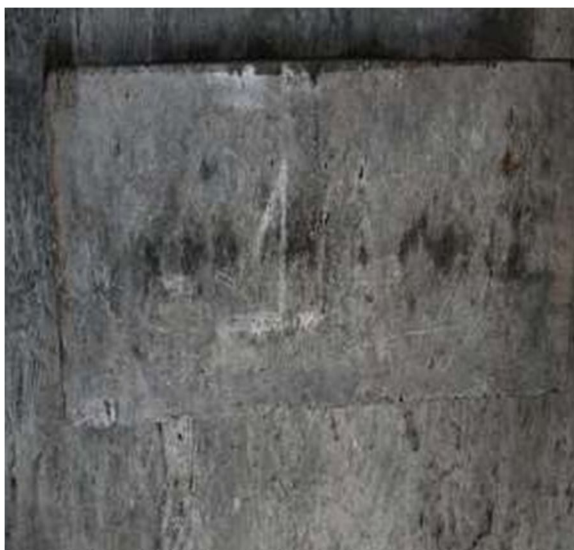
Temperature Specimen Three

2) Temperature Specimen three (TS3 Fired At 500°C)

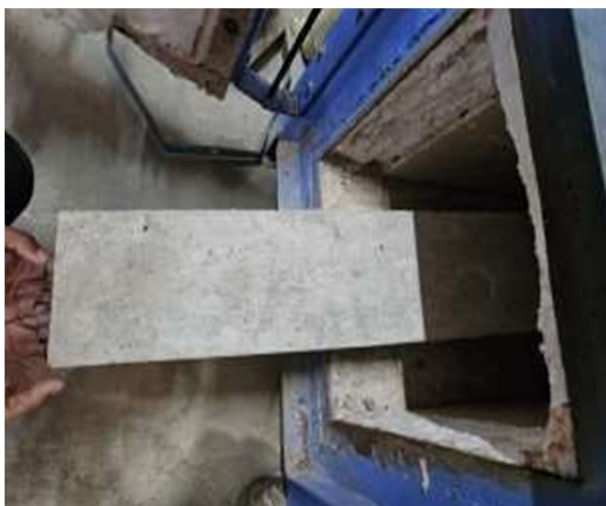
(a) Fired Process on Beam At (500°C)
