Numerical Analysis of Steel Frame Using Electro-Mechanical Impedance Technique

Laxmi Bhalla¹, Abhishek Mishra², Sachin Kumar Singh³

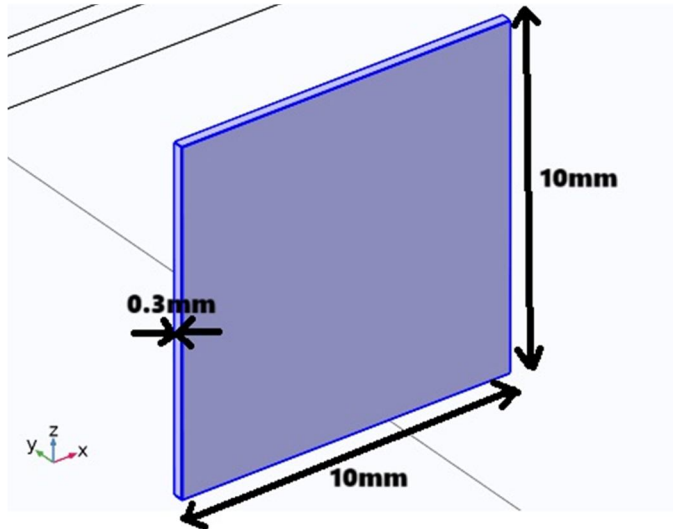
Fig.1 PZT patch

Using third equation, α and β can be easily determined for viscous damping or Rayleigh damping [15]. This paper deals with the four-storey steel frame structure, in which PZT-4 sensor was embedded as shown in fig.1. The dimension of the PZT patch was $10 \times 10 \times 0.3 \text{ mm}^3$. Multiple damages were induced in the beam which will discuss in this paper and type of finite element analysis software used was COMSOL MULTIPHYSICS 6.2.

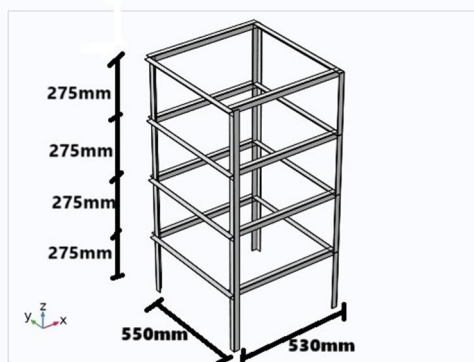
Fig.3 Isometric view

The isometric view of the four-story steel model is shown in fig.3 in which height of each floor was 275mm. The side view of the steel frame is shown in fig.4 in which left and right-side length of the beam was 550mm. The top view of the steel frame is shown in fig.5 in which the size of angle was $24.4\text{mm} \times 2\text{mm}$.

A four-story steel structure was modelled in FEA software named as COMSOL MULTIPHYSICS 6.2 and EMI technique was used to find out the signature of the beam damage in the steel model. A PZT-4 patch was embedded in the four-storey steel model. All properties of materials were assigned like modulus of elasticity, Poisson's ratio, density of material etc. The boundary conditions were applied in 4-story steel frame and tetrahedral meshing was done in steel frame model. Frequency domain analysis was done to find out the admittance value for particular frequency range that varies from 30KHz to 300KHz. All members were connected by L-shape angles, there was four number of columns in the steel model. The L-angles has size of $24.4\text{mm} \times 2\text{mm}$. The length of the column was 1100mm, the length of the front, rear beams were 530mm and the length of left, right-side beams were 550mm and the height of each floor was 275mm.

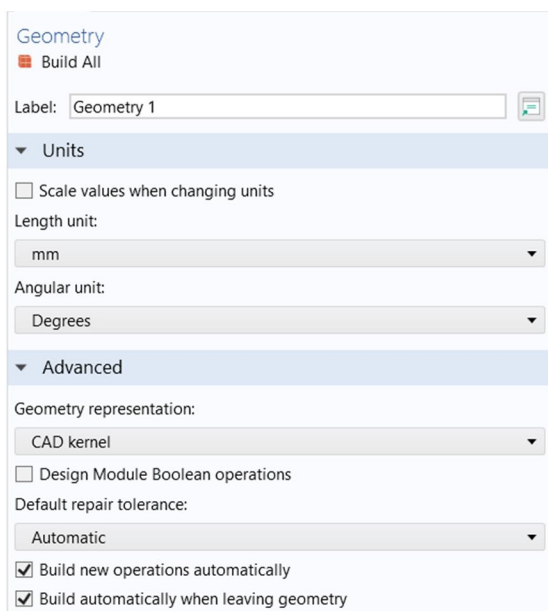
Fig.6 Units option in geometry command

In COMSOL MULTIPHYSICS a four-story steel frame model was made, the all components of the model like beams, columns etc were made by using “block” command which was available in the “geometry” tab. First of all, the dimensions were set like length in mm and angular unit in degree as shown in fig.6. Then, after that the length, width, height of the block was mentioned as shown in fig.7. There were some other parameters that involved in this like position of base, axis type, work plane, rotation angle whose values were also assigned by clicking on the build all objects option. The whole model was prepared in the same way as the single block was made. After making the all blocks of the model “form union” command was used to make the structure as a whole structure.

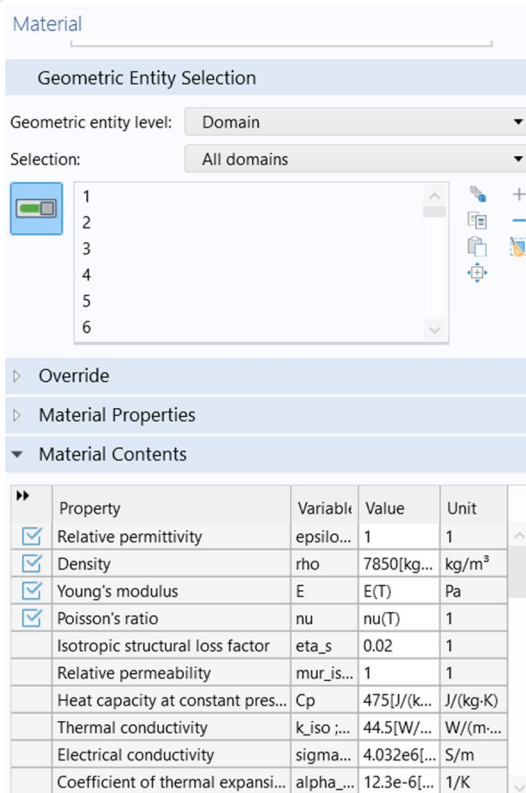
Fig.8 Material property selection shown

The material properties were defined to all the structural components like beams, columns of steel model. The properties were defined by using option “add material”. In “add material” command go to the “built-in” then “select structural steel” then after that select the all domains as shown in fig.8. and PZT selection shown in fig.9.

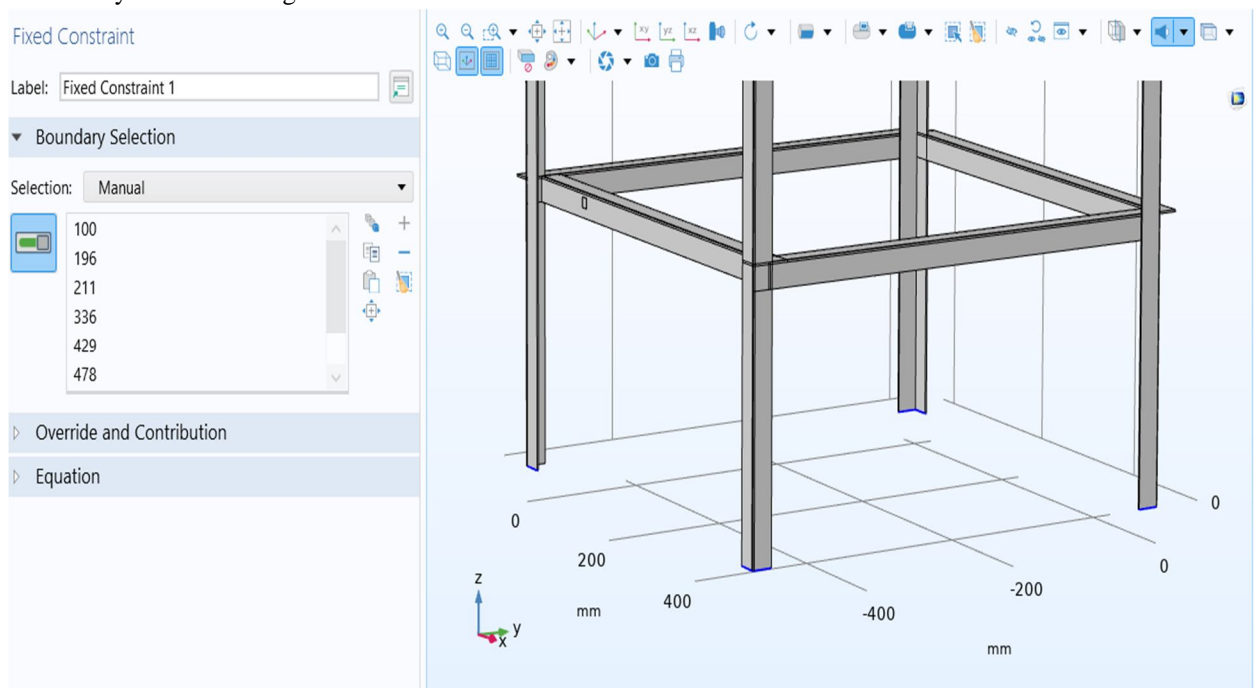
Fig.10 Fixed ends at the bottom of frame shown

The boundary conditions were assigned to make steel frame as a fixed frame from the bottom. So, the commonly used fixed type of supports were used in steel frame. For this, go to the “solid mechanics” then go to the “fixed constraints” and then do boundary selection manually as shown in fig.10.

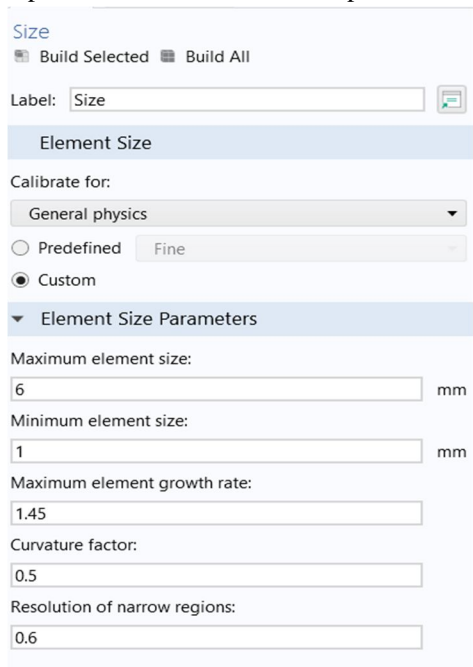
Fig.11 Meshing element size

The meshing was done in the whole steel structure by go to the “mesh” then calibrate for “general physics” and select size then choose “custom” option and define element size parameter as shown in fig.11. The select the type of mesh as “free tetrahedral”.

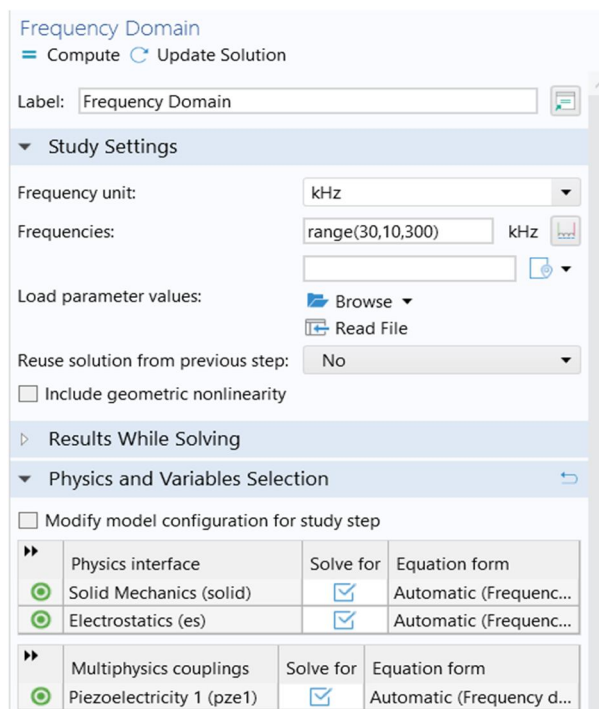
Fig.13 Computation of frequency domain

After assigning all parameters we move towards the “study” option and select the type of study as “frequency domain”. The unit of eigen frequency was selected as KHz. Then choose the range of frequency from 30 to 300KHz at interval of 10, then click on “compute” as shown in fig.13.

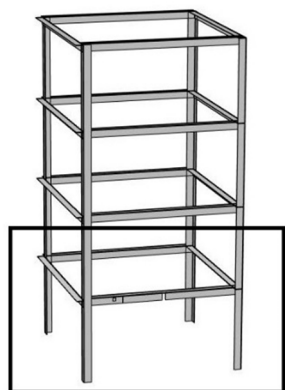
Fig.14 Steel model with multiple damages

In the four-story steel model, the damage was done on the front side of the beam whose length was 530mm at height of 275mm. In all types of damages, the length and thickness of the damage was same except the width of the damage. The length and thickness of the damage were 24.4mm and 2mm. At point “C”, there was a damage of constant width of 10mm at distance of 265mm from corner of x axis in all cases as shown in fig. 15. At point “B” there were variable width damage of 1mm, 5mm and 10mm at distance of 132.5mm from corner of x axis. The PZT patch was embedded at point “A” which was at 100mm distance from corner of x axis as shown in fig.15. The dimension of PZT patch was $10 \times 10 \times 0.3 \text{mm}^3$. The three cases of damage were-

Case 1 damage: 10mm at mid and 1 mm at one-fourth distance

Case 2 damage: 10mm at mid and 5 mm at one-fourth distance

Case 3 damage: 10mm at mid and 10 mm at one-fourth distance

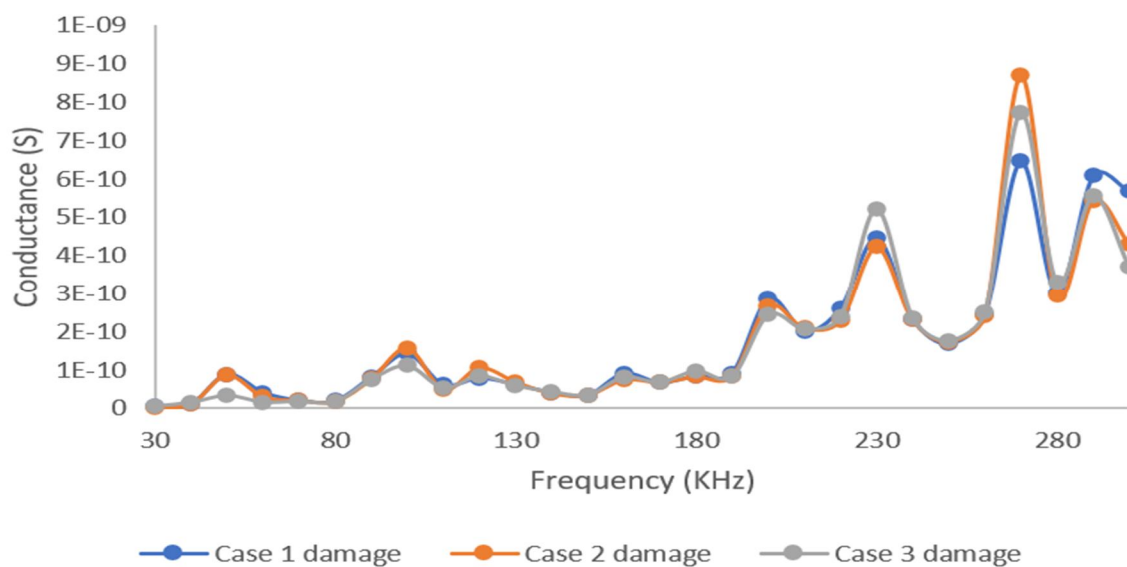
Fig.16 Conductance response obtained for frequency range of 30-300KHz

After the frequency domain analysis, the probe table of admittance and frequency was generated in the COMSOL MULTIPHYSICS 6.2 software, in which the frequency was varying from 30KHz to 300KHz. In admittance the real part denotes the conductance and an imaginary part denotes the susceptance. Here, we need only real part of the admittance which is conductance. From that we made conductance verses frequency graph which is known as signature of the damage steel frame model.

To get the quantitative measure of damage the root mean square deviation was find out for Case 1 damage it was 27.604%, for Case 2 damage it was 28.57%, for Case 3 damage it was 30.76%.
