Numerical Analysis of Steel Frame Using Electro-Mechanical Impedance Technique

Laxmi Bhalla¹, Abhishek Mishra², Sachin Kumar Singh³

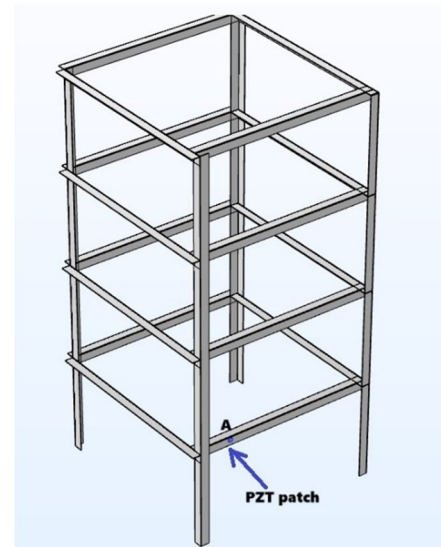
Fig.2 Steel model with embedded PZT transducer

A four-story steel structure was modelled in FEA software named as COMSOL MULTIPHYSICS 6.2 and EMI technique was used to find out the signature of the beam damage in the steel model. A PZT-4 patch was embedded in the four-storey steel model. All properties of materials were assigned like modulus of elasticity, Poisson's ratio, density of material etc. The boundary conditions were applied in 4-story steel frame and tetrahedral meshing was done in steel frame model. Frequency domain analysis was done to find out the admittance value for particular frequency range that varies from 30KHz to 300KHz. All members were connected by L-shape angles, there was four number of columns in the steel model. The L-angles has size of $24.4\text{mm} \times 2\text{mm}$. The length of the column was 1100mm, the length of the front, rear beams were 530mm and the length of left, right-side beams were 550mm and the height of each floor was 275mm.

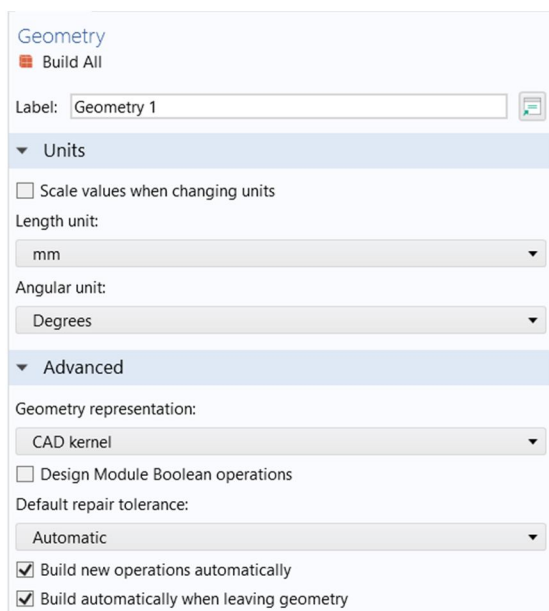
Fig.6 Units option in geometry command

In COMSOL MULTIPHYSICS a four-story steel frame model was made, the all components of the model like beams, columns etc were made by using “block” command which was available in the “geometry” tab. First of all, the dimensions were set like length in mm and angular unit in degree as shown in fig.6. Then, after that the length, width, height of the block was mentioned as shown in fig.7. There were some other parameters that involved in this like position of base, axis type, work plane, rotation angle whose values were also assigned by clicking on the build all objects option. The whole model was prepared in the same way as the single block was made. After making the all blocks of the model “form union” command was used to make the structure as a whole structure.

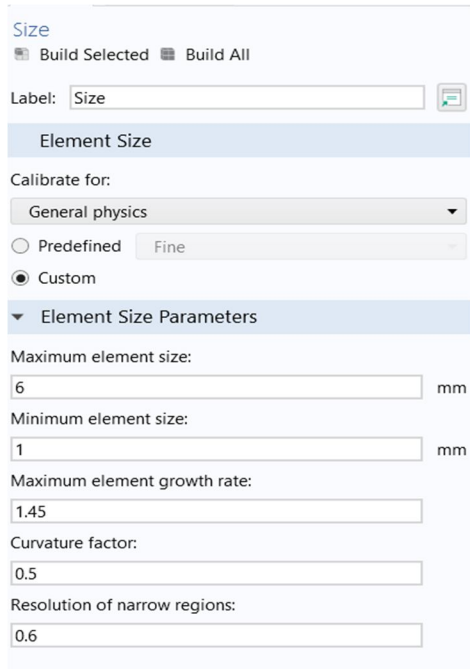
Fig.11 Meshing element size

The meshing was done in the whole steel structure by go to the “mesh” then calibrate for “general physics” and select size then choose “custom” option and define element size parameter as shown in fig.11. The select the type of mesh as “free tetrahedral”.

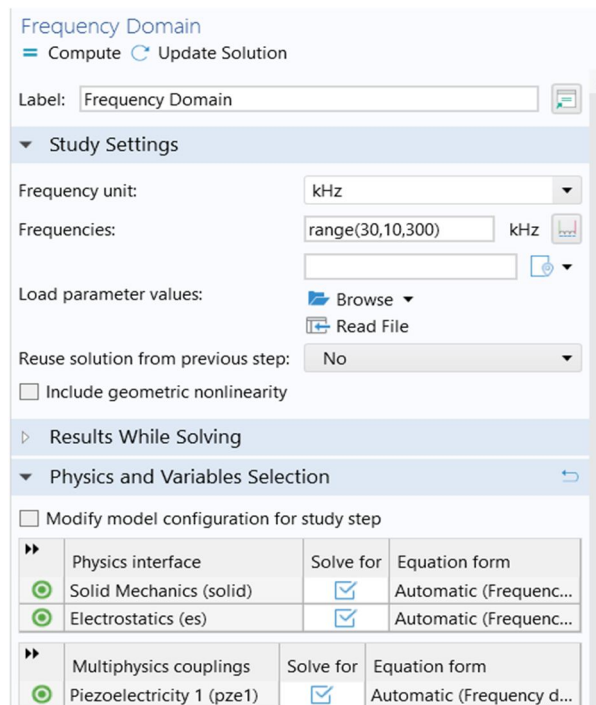
Fig.13 Computation of frequency domain

After assigning all parameters we move towards the “study” option and select the type of study as “frequency domain”. The unit of eigen frequency was selected as KHz. Then choose the range of frequency from 30 to 300KHz at interval of 10, then click on “compute” as shown in fig.13.

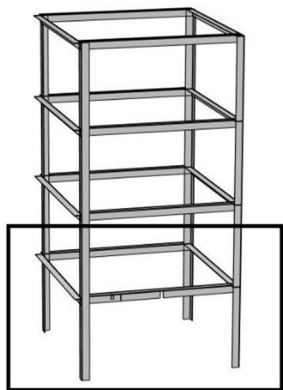
Fig.14 Steel model with multiple damages

In the four-story steel model, the damage was done on the front side of the beam whose length was 530mm at height of 275mm. In all types of damages, the length and thickness of the damage was same except the width of the damage. The length and thickness of the damage were 24.4mm and 2mm. At point “C”, there was a damage of constant width of 10mm at distance of 265mm from corner of x axis in all cases as shown in fig. 15. At point “B” there were variable width damage of 1mm, 5mm and 10mm at distance of 132.5mm from corner of x axis. The PZT patch was embedded at point “A” which was at 100mm distance from corner of x axis as shown in fig.15. The dimension of PZT patch was $10 \times 10 \times 0.3 \text{mm}^3$. The three cases of damage were-

Case 1 damage: 10mm at mid and 1 mm at one-fourth distance

Case 2 damage: 10mm at mid and 5 mm at one-fourth distance

Case 3 damage: 10mm at mid and 10 mm at one-fourth distance

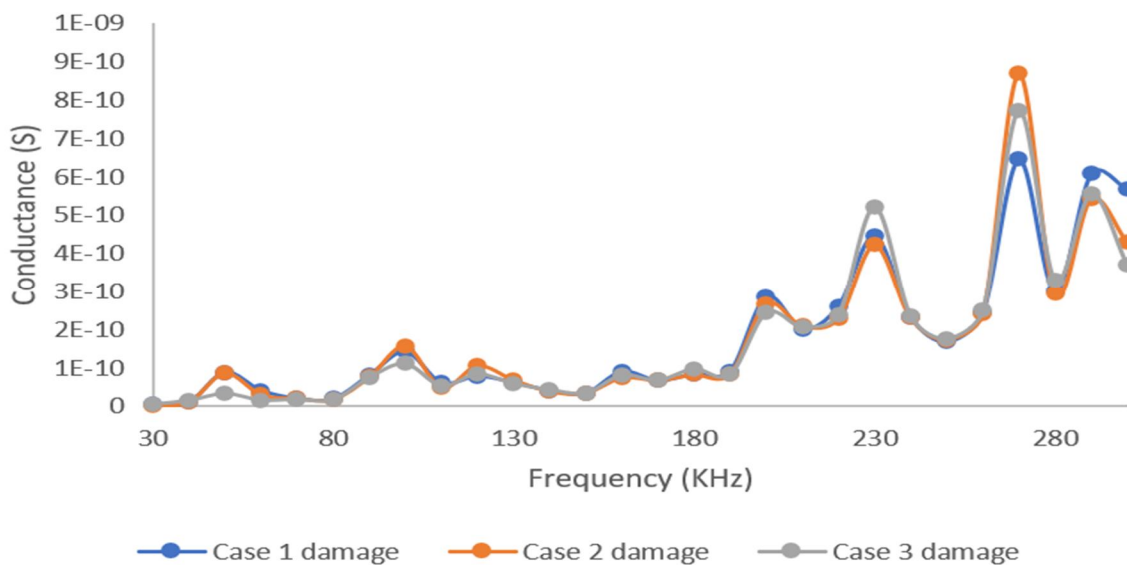
Fig.16 Conductance response obtained for frequency range of 30-300KHz

After the frequency domain analysis, the probe table of admittance and frequency was generated in the COMSOL MULTIPHYSICS 6.2 software, in which the frequency was varying from 30KHz to 300KHz. In admittance the real part denotes the conductance and an imaginary part denotes the susceptance. Here, we need only real part of the admittance which is conductance. From that we made conductance verses frequency graph which is known as signature of the damage steel frame model.

To get the quantitative measure of damage the root mean square deviation was find out for Case 1 damage it was 27.604%, for Case 2 damage it was 28.57%, for Case 3 damage it was 30.76%.
