Numerical Analysis of Steel Frame Using Electro-Mechanical Impedance Technique

Laxmi Bhalla¹, Abhishek Mishra², Sachin Kumar Singh³

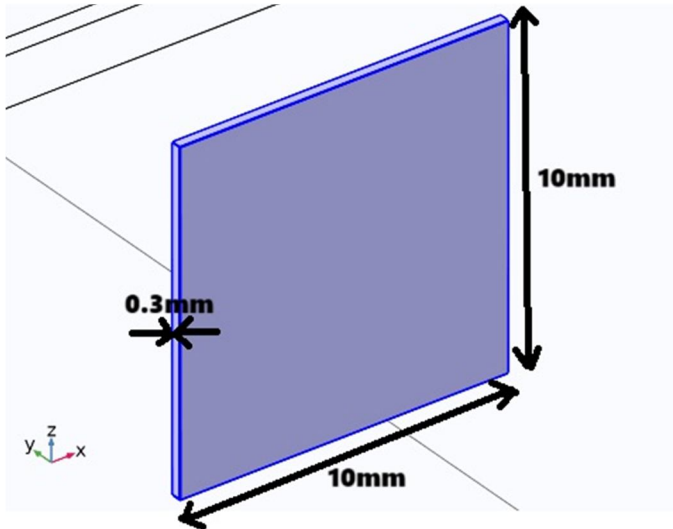
Fig.1 PZT patch

Using third equation, α and β can be easily determined for viscous damping or Rayleigh damping [15]. This paper deals with the four-storey steel frame structure, in which PZT-4 sensor was embedded as shown in fig.1. The dimension of the PZT patch was $10 \times 10 \times 0.3 \text{ mm}^3$. Multiple damages were induced in the beam which will discuss in this paper and type of finite element analysis software used was COMSOL MULTIPHYSICS 6.2.

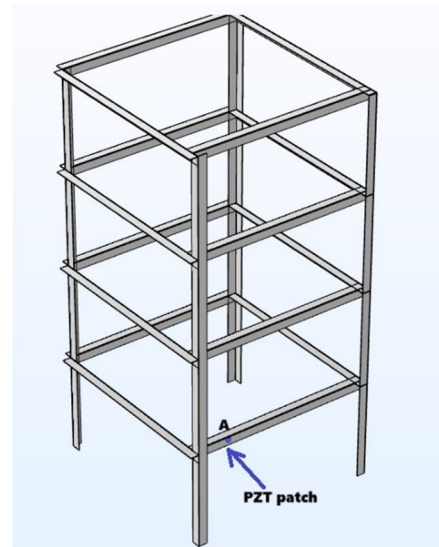
Fig.2 Steel model with embedded PZT transducer

A four-story steel structure was modelled in FEA software named as COMSOL MULTIPHYSICS 6.2 and EMI technique was used to find out the signature of the beam damage in the steel model. A PZT-4 patch was embedded in the four-storey steel model. All properties of materials were assigned like modulus of elasticity, Poisson's ratio, density of material etc. The boundary conditions were applied in 4-story steel frame and tetrahedral meshing was done in steel frame model. Frequency domain analysis was done to find out the admittance value for particular frequency range that varies from 30KHz to 300KHz. All members were connected by L-shape angles, there was four number of columns in the steel model. The L-angles has size of $24.4\text{mm} \times 2\text{mm}$. The length of the column was 1100mm, the length of the front, rear beams were 530mm and the length of left, right-side beams were 550mm and the height of each floor was 275mm.

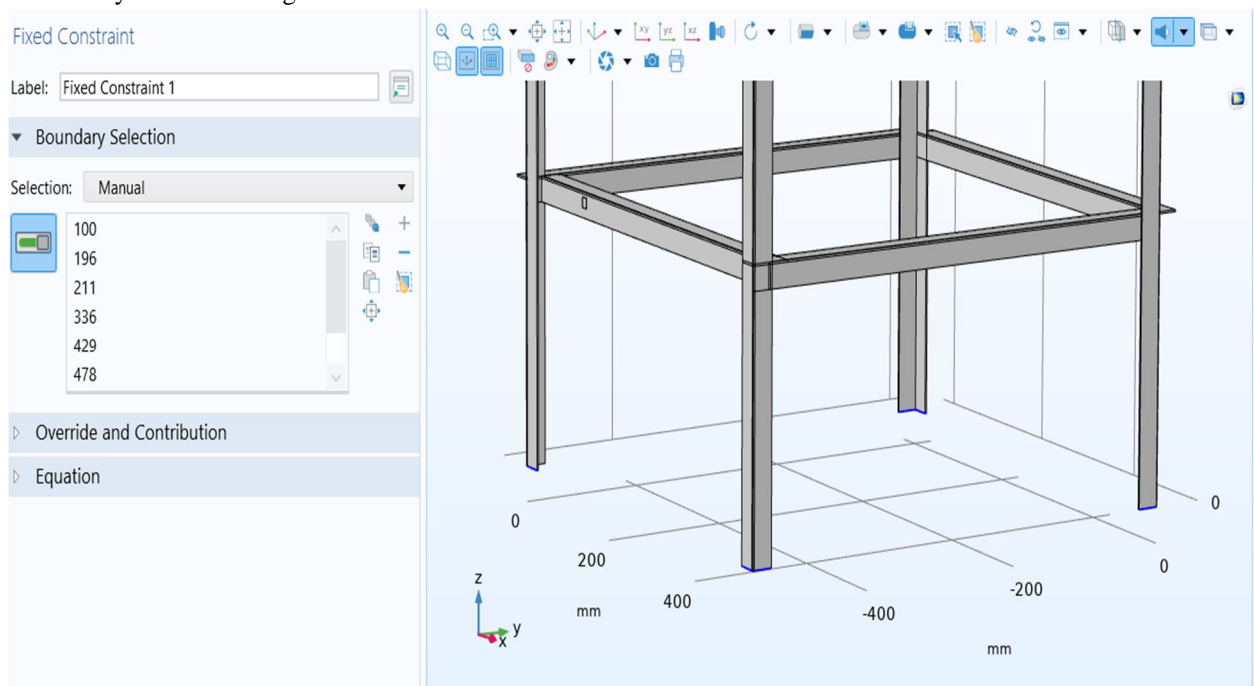
Fig.10 Fixed ends at the bottom of frame shown

The boundary conditions were assigned to make steel frame as a fixed frame from the bottom. So, the commonly used fixed type of supports were used in steel frame. For this, go to the “solid mechanics” then go to the “fixed constraints” and then do boundary selection manually as shown in fig.10.

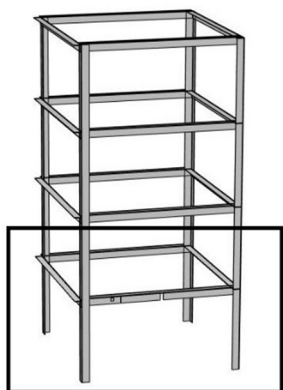
Fig.14 Steel model with multiple damages

In the four-story steel model, the damage was done on the front side of the beam whose length was 530mm at height of 275mm. In all types of damages, the length and thickness of the damage was same except the width of the damage. The length and thickness of the damage were 24.4mm and 2mm. At point “C”, there was a damage of constant width of 10mm at distance of 265mm from corner of x axis in all cases as shown in fig. 15. At point “B” there were variable width damage of 1mm, 5mm and 10mm at distance of 132.5mm from corner of x axis. The PZT patch was embedded at point “A” which was at 100mm distance from corner of x axis as shown in fig.15. The dimension of PZT patch was $10 \times 10 \times 0.3 \text{mm}^3$. The three cases of damage were-

Case 1 damage: 10mm at mid and 1 mm at one-fourth distance

Case 2 damage: 10mm at mid and 5 mm at one-fourth distance

Case 3 damage: 10mm at mid and 10 mm at one-fourth distance

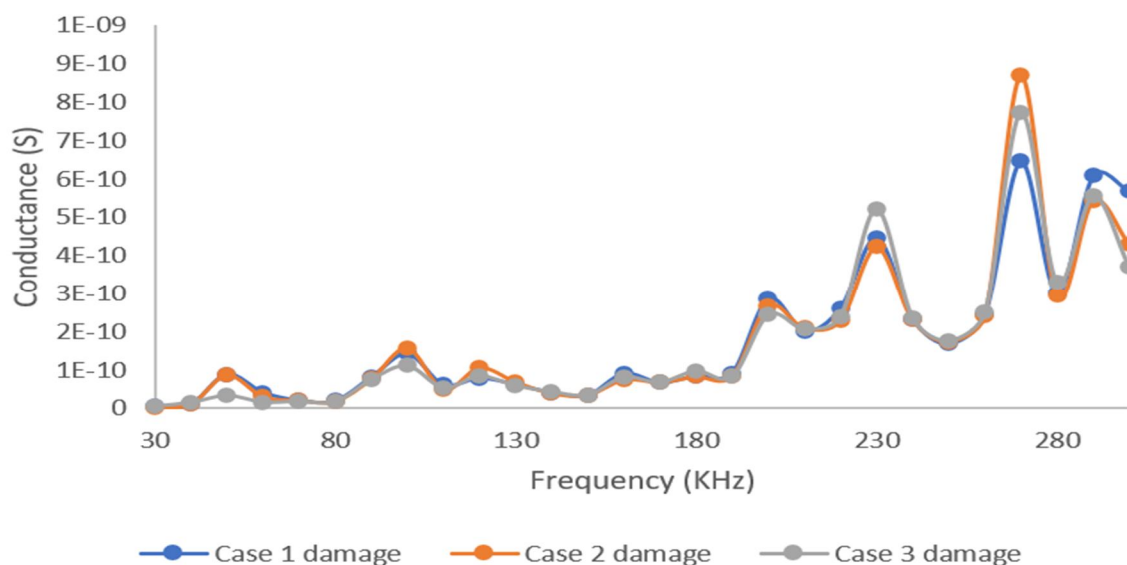
After the frequency domain analysis, the probe table of admittance and frequency was generated in the COMSOL MULTIPHYSICS 6.2 software, in which the frequency was varying from 30KHz to 300KHz. In admittance the real part denotes the conductance and an imaginary part denotes the susceptance. Here, we need only real part of the admittance which is conductance. From that we made conductance verses frequency graph which is known as signature of the damage steel frame model.

Fig.16 Conductance response obtained for frequency range of 30-300KHz

To get the quantitative measure of damage the root mean square deviation was find out for Case 1 damage it was 27.604%, for Case 2 damage it was 28.57%, for Case 3 damage it was 30.76%.

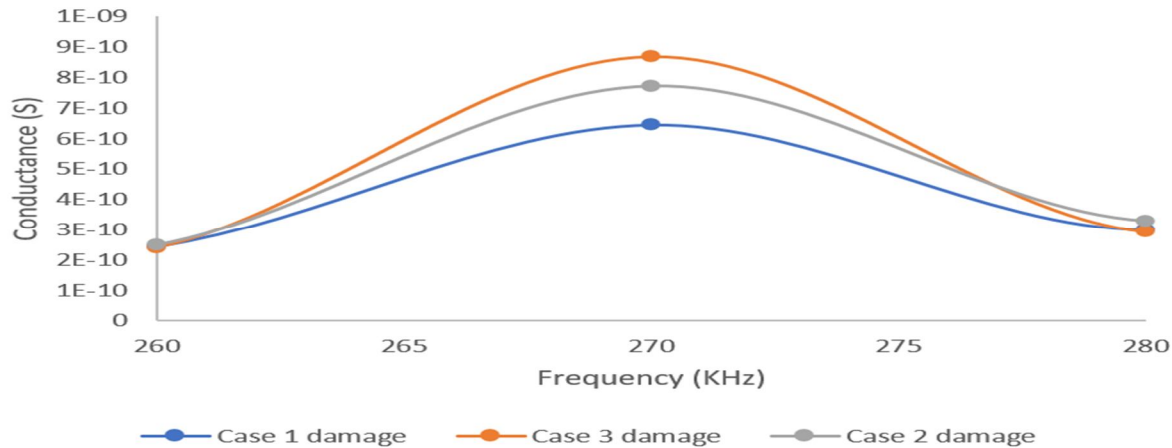
Fig.17 Conductance response obtained for frequency range of 260-280KHz
