Numerical Analysis of Steel Frame Using Electro-Mechanical Impedance Technique

Abstract: Nowadays, piezoelectric materials are most widely used in structural health monitoring (SHM) system for non-destructive evaluation. In this paper the damage study using electro-mechanical impedance (EMI) technique, which is non-destructive method of SHM. This paper presents a numerical analysis of four-story steel frame and multiple damages were induced in the steel frame by utilizing smart material like Lead Zirconate Titanate (PZT). A PZT-4 piezoelectric material was embedded in the beam of the frame. The type of damping used in steel frame model was Rayleigh damping. The numerical analysis was done in COMSOL MULTIPHYSICS 6.2 and frequency domain analysis was done, from that admittance values were find out for 30-300KHz frequency range. The real part of the admittance gives conductance values. Then, conductance verses frequency graph was created that will indicate the structural health and performance. Moreover, root mean square deviation (RMSD) index was found out for each case that provides a quantitative measure of deviation.

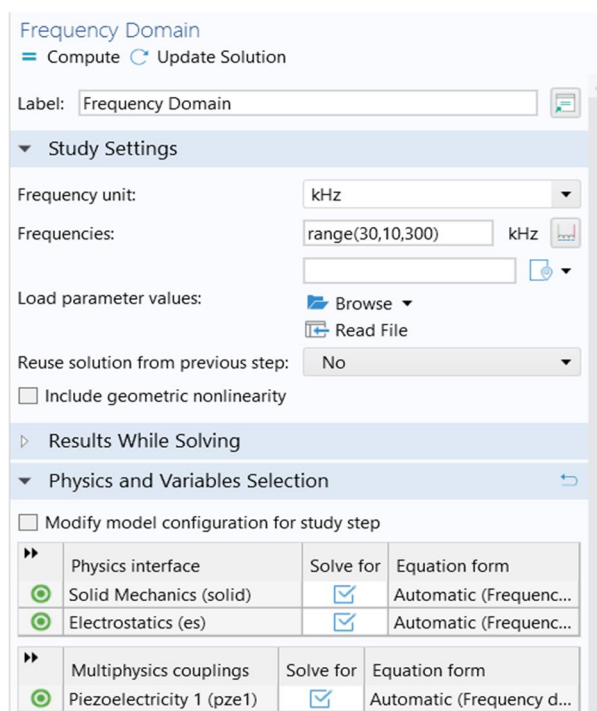
Fig.13 Computation of frequency domain

After assigning all parameters we move towards the “study” option and select the type of study as “frequency domain”. The unit of eigen frequency was selected as KHz. Then choose the range of frequency from 30 to 300KHz at interval of 10, then click on “compute” as shown in fig.13.

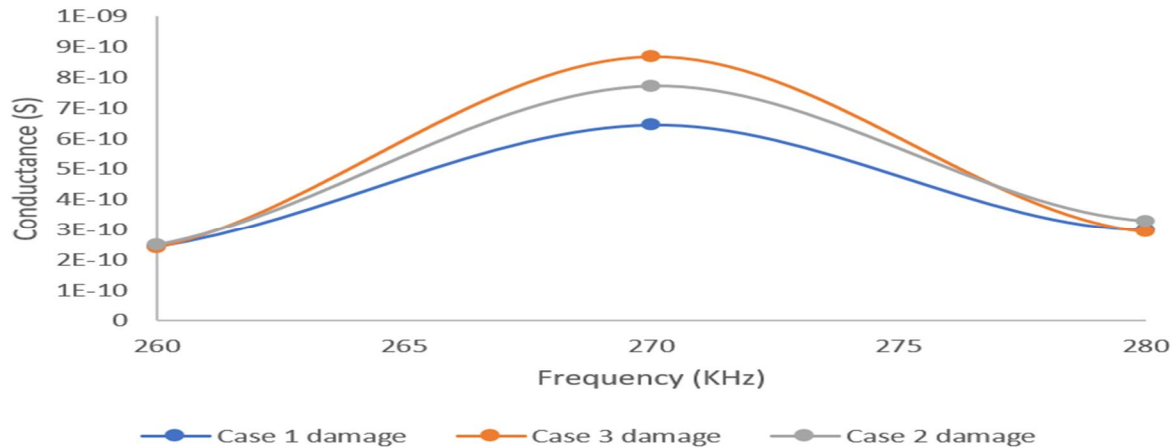
Fig.17 Conductance response obtained for frequency range of 260-280KHz

To get the quantitative measure of damage the root mean square deviation was find out for Case 1 damage it was 27.604%, for Case 2 damage it was 28.57%, for Case 3 damage it was 30.76%.
