# Quality Improvement of Oil and Fuel Leakage in Diesel Engine by using Semi Automatic Setup

Swapnil D Kurhekar<sup>1</sup>, Abhijeet B Tamse<sup>2</sup>

**Abstract:** As we know when engine goes to testing department before that we test it through semi-automatic setup which is installed on assembly line conveyor to test the oil and fuel leakage of diesel engine. Now different trials were taken on engine by using methodology which includes ATEQ D520 unit and air pressure regulator for detecting the leakage quantity. Actually ATEQ D520 UNIT is a flowmeter which measures a drop in pressure with a differential sensor. Here we supplied pressurized air into the engine through breather plug and overflow pipe. If leakage is not found, the engine will be dispatched to the testing department and if leakage is found, the problem may be solved by spraying soap water in the leakage area so that in that area bubbles come out. This work emphasizes on the analysis of the problem due to which the engine is rejected from the testing department and also time and cost saving analysis for one month. Due to this setup, there is improvement in PQCDSM, PPM and reduction in cost per unit supplied to cus

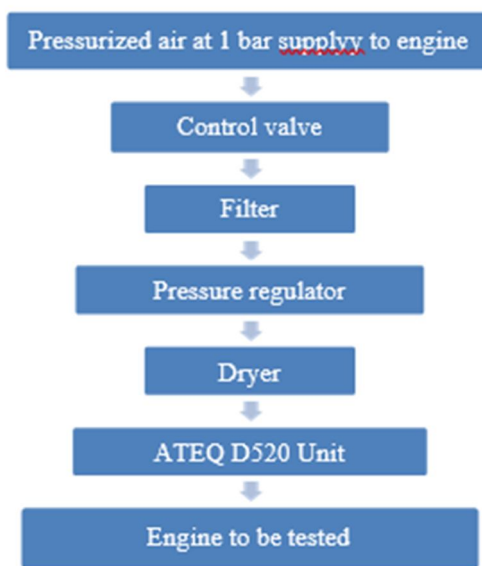
The semi-automatic set up includes ATEQ D520 unit & air pressure regulator for finding out leakage quantity. The ATEQ D520 is a flow meter which measures a drop in pressure with a differential sensor (transducer).

Flow chart of air supply

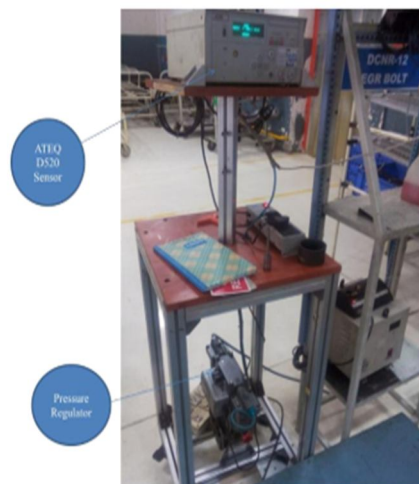
Fig. 1 Leakage Testing Setup

The setup consists of ATEQ D520 sensor, Pressure regulator, Air and Fuel line connections for oil and fuel leakage testing. Pressurized air at 1 bar is supplied into the engine through Breather plug & overflow pipe. Supply of air will be 30 seconds stabilization time. If pressure doesn't drops (within 20 seconds) engine is ok and no leak found indicated by green light. If pressure gets dropped in fuel line, engine will get rejected that means engine is not ok & ATEQ D520 indicates Red light. So engine leakage testing is done by spraying soap water on that leak portion due to which bubbles May come out which will indicate leakage at that point.

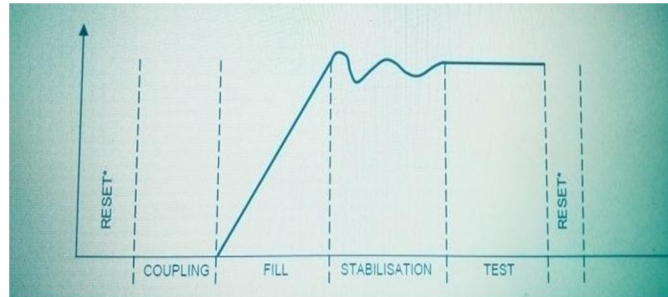
Fig. 2 Principle of cycle

The ATEQ D520 is a flow meter which measures a drop in pressure with a differential sensor (transducer) which is placed at the extremities of a calibrated flow tube. When fluid (air) moves through a calibrated flow tube (laminar flow), a drop in pressure occurs, the value of which is proportional to flow.

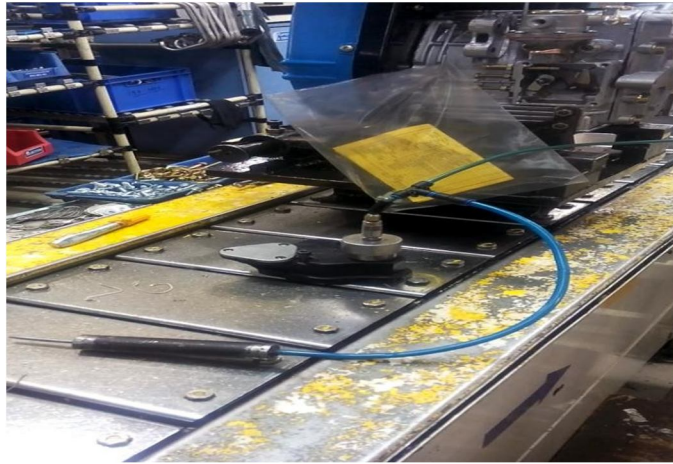
Fig. 4 Air Supply Through Rocker Cover & Overflow Pipe

- 5) Mount standard rocker cover gauge made to fill air into the engine one supply of airline is given to breather plug hole & other is given to fuel line through overflow pipe

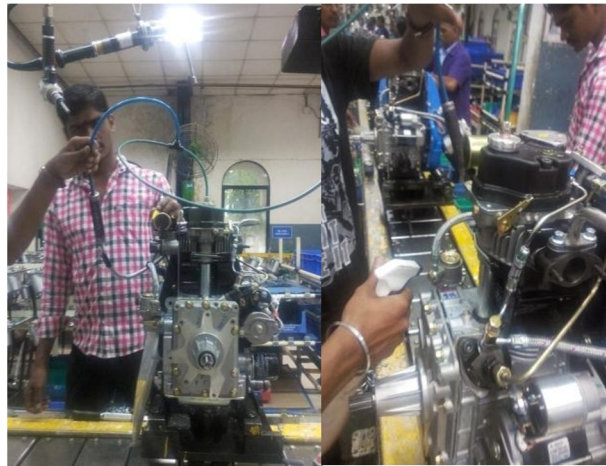
Fig. 5 Leakage Finding in the engine whether engine is ok or not

- 8) ATEQ will start Air leak testing cycle- Start, The filltime, the stabilization Time, The test time, Reset, End of Cycle.
- 9) ATEQ will give results Ok or Not Ok depending on leakage found or not & the indication of this Ok or Not Ok is presented on lamp

- 10) Green light indicates the engine is Ok i.e.no leakage found in the engine. Red light indicate engine is not ok i.e. leakage phenomenon occurred in the engine. mark Ok or Not Ok on engine

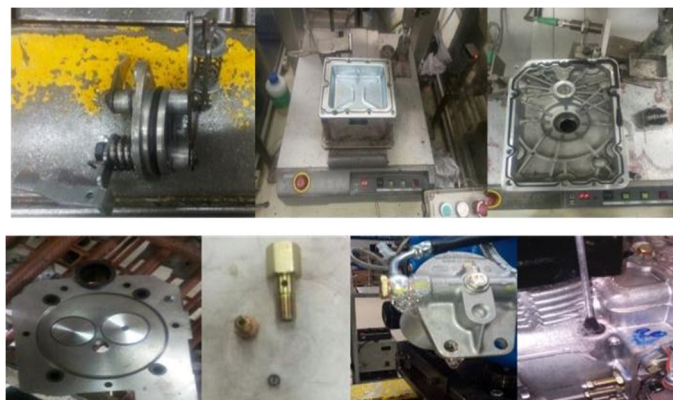
Fig. 6 Major Problem Occurring Phenomenon Analysis

Implementation on problem analysis is done to minimize cost of engine, rework time, customer complaints, and no. of engine rejection from testing. Outcomes to solve the leakage phenomenon's problems occurrence is captured and listed below for making analysis easier.

- 1) Governor support Stop lever and O-ring leakage
- 2) Oil pan oil leak due to discontinuous loctite profile
- 3) Power takes off (PTO) enlarged loctite size
- 4) 400WG Cylinder head leakage due to water seals.
- 5) Leakage from FIP (Fuel Injector Pump) NRV (Non Return Valve) Banjo bolt
- 6) Leakage from diesel filter
- 7) Leakage from deep stick

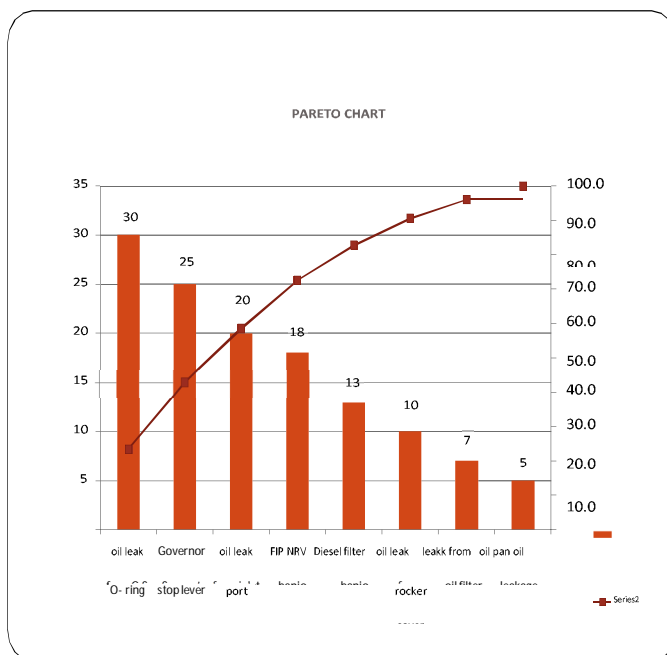
Fig. 7 Chart 1 Pareto chart for analysis of leakages

The Pareto chart shows that the no. of engines is rejected due to oil or fuel leakage & the Maximum rejection quantity is 30engines from governor support O-ring & stop lever. Governorsupport stop lever leakage is supplier problem because stop lever portion has welded joint over it when it is connected to linkage setting lever for fuel supply. Other problem is ofGovernor Support O-ring which cuts while inserting governorsupport into the assembly fitment.

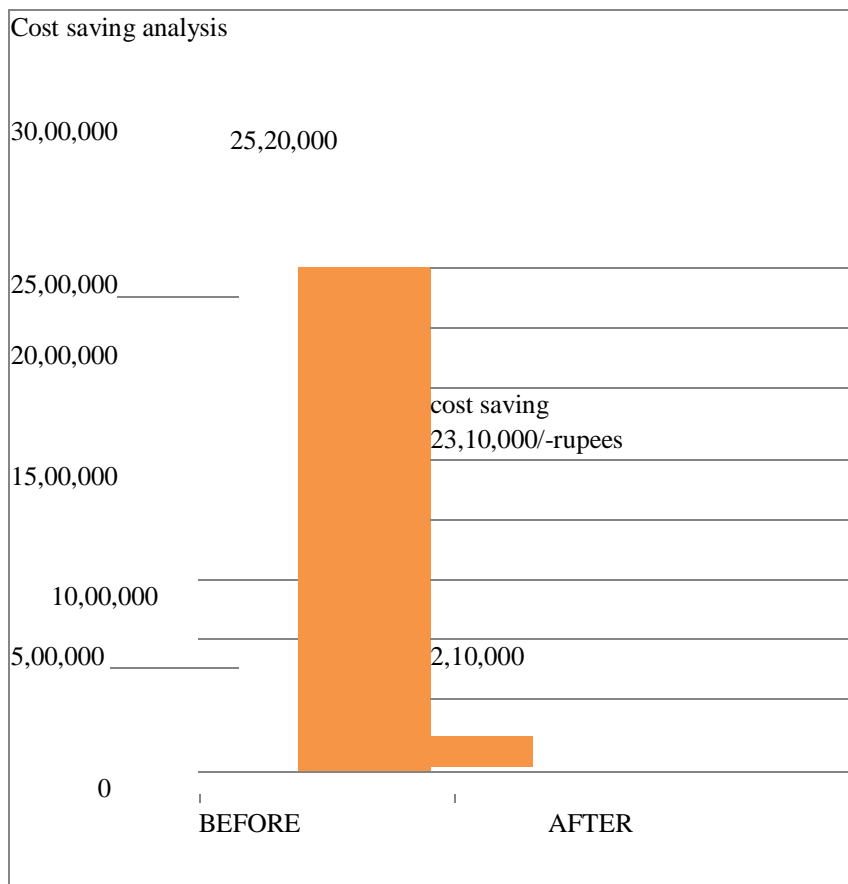
Fig. 8 Chart 3- Cost saving analysis

Cost saving of 435 series Diesel engine is 23, 10, 000/-rupees before and after the setup because earlier 120 rejections per month now this is reduced to 10. Parts per million is calculated for one month and from that respective cost saving.From below chart and table you will get the analysis.

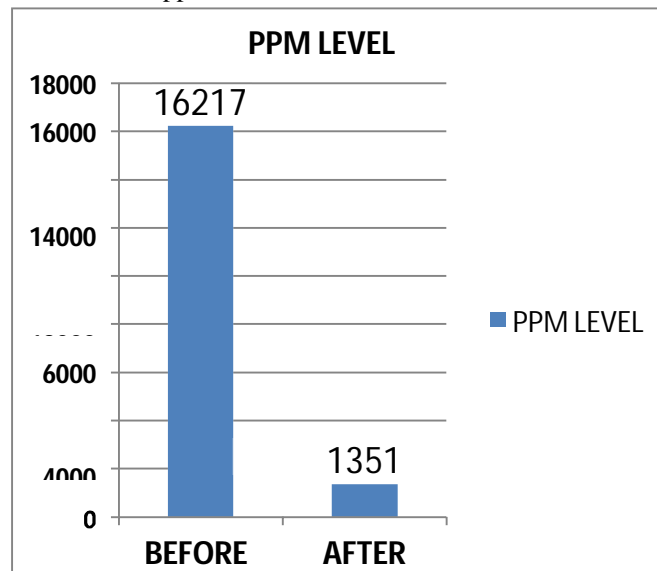
Fig. 12 Chart PPM Level

This criterion describes the main goal of this project that was to reduce the problems at PDI Line due to Engine Quality Issue and to improve the sigma level. After calculation Sigma level was found to be improved considerably and Quality improvement in PPM for Engine Quality Defect = 1351ppm from 16,217ppm in month march 2016. It is clear that the setup is more profitable.

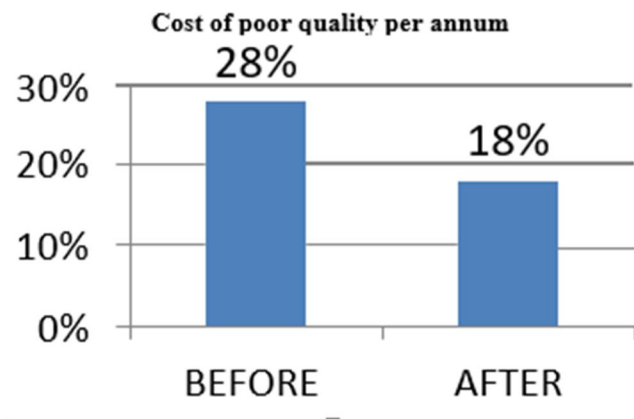
Fig. 13 Cost of Poor quality per annum

Cost of poor quality (COPQ) has been significantly reduced from 28% to 18% of sale that means if company is supplying 1000 engines to the customer and apart from that 5 engines are rejected due to leakage complaints this loss is reduced by setup which will provide 100% leakage free engines to the customers.
