Quality Improvement of Oil and Fuel Leakage in Diesel Engine by using Semi Automatic Setup

Swapnil D Kurhekar¹, Abhijeet B Tamse²

Abstract: As we know when engine goes to testing department before that we test it through semi-automatic setup which is installed on assembly line conveyor to test the oil and fuel leakage of diesel engine. Now different trials were taken on engine by using methodology which includes ATEQ D520 unit and air pressure regulator for detecting the leakage quantity. Actually ATEQ D520 UNIT is a flowmeter which measures a drop in pressure with a differential sensor. Here we supplied pressurized air into the engine through breather plug and overflow pipe. If leakage is not found, the engine will be dispatched to the testing department and if leakage is found, the problem may be solved by spraying soap water in the leakage area so that in that area bubbles come out. This work emphasizes on the analysis of the problem due to which the engine is rejected from the testing department and also time and cost saving analysis for one month. Due to this setup, there is improvement in PQCDSM, PPM and reduction in cost per unit supplied to customers from 28% to 18% of co

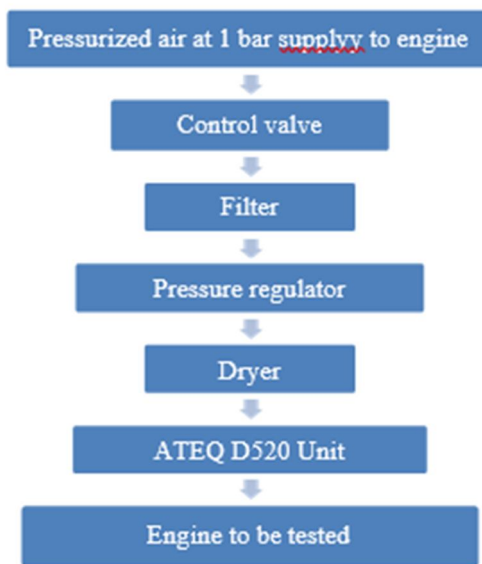
Flow chart of air supply

The semi-automatic set up includes ATEQ D520 unit & air pressure regulator for finding out leakage quantity. The ATEQ D520 is a flow meter which measures a drop in pressure with a differential sensor (transducer).

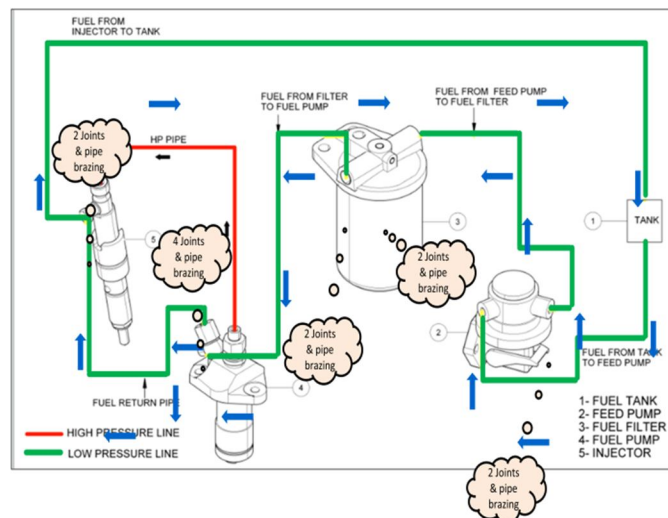
Fig. 3 Fuel Line Air Supply Circuit Diagram

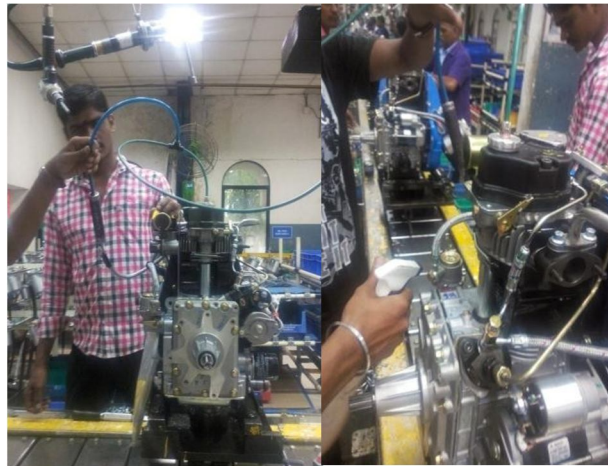
Fig. 5 Leakage Finding in the engine whether engine is ok or not

- 8) ATEQ will start Air leak testing cycle- Start, The filltime, the stabilization Time, The test time, Reset, End of Cycle.
- 9) ATEQ will give results Ok or Not Ok depending on leakage found or not & the indication of this Ok or Not Ok is presented on lamp

- 10) Green light indicates the engine is Ok i.e.no leakage found in the engine. Red light indicate engine is not ok i.e. leakage phenomenon occurred in the engine. mark Ok or Not Ok on engine

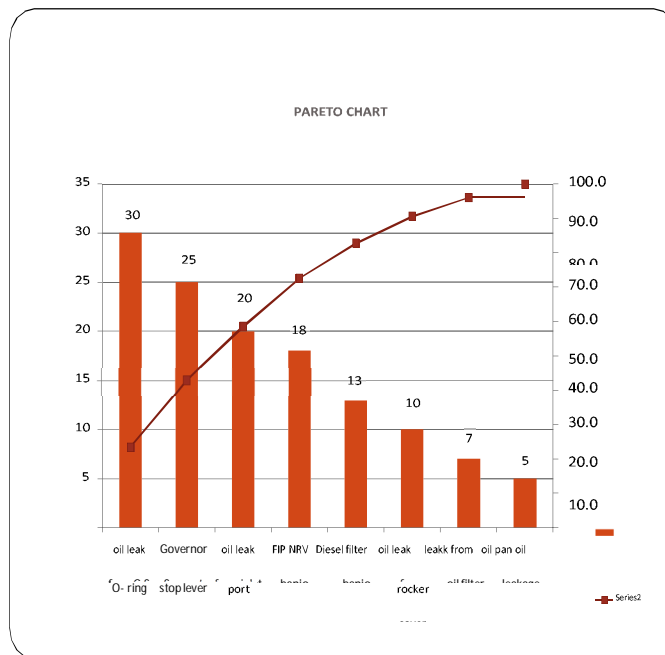
The Pareto chart shows that the no. of engines is rejected due to oil or fuel leakage & the Maximum rejection quantity is 30engines from governor support O-ring & stop lever. Governorsupport stop lever leakage is supplier problem because stop lever portion has welded joint over it when it is connected to linkage setting lever for fuel supply. Other problem is ofGovernor Support O-ring which cuts while inserting governorsupport into the assembly fitment.

Fig. 7 Chart 1 Pareto chart for analysis of leakages

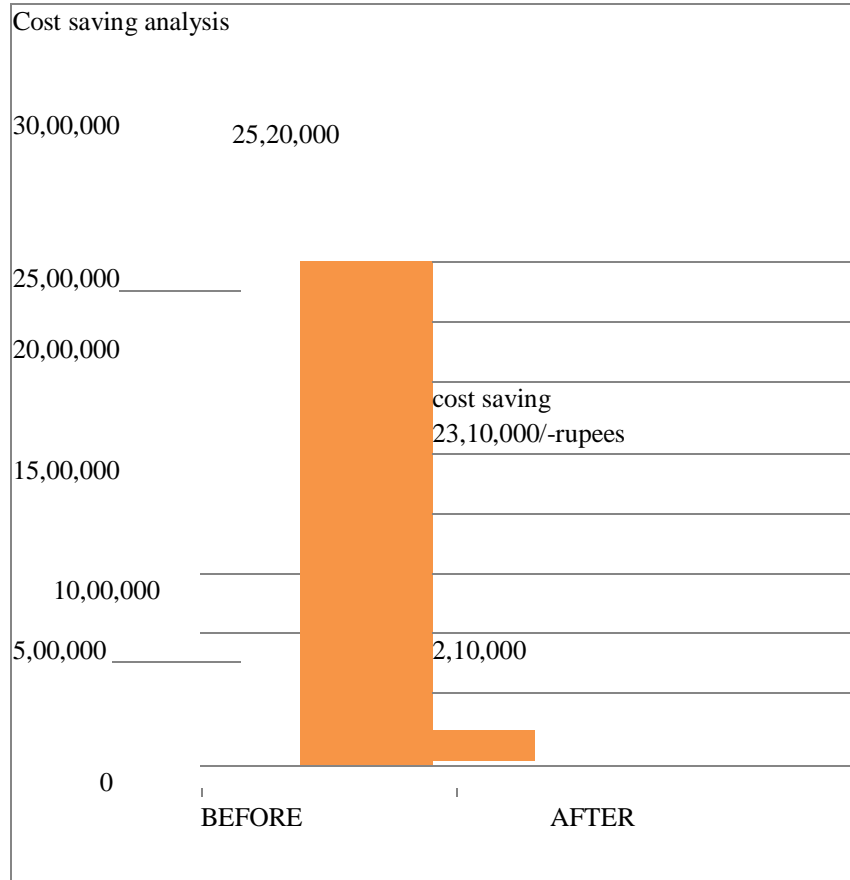
Fig. 8 Chart 3- Cost saving analysis

Cost saving of 435 series Diesel engine is 23, 10, 000/-rupees before and after the setup because earlier 120 rejections per month now this is reduced to 10. Parts per million is calculated for one month and from that respective cost saving.From below chart and table you will get the analysis.

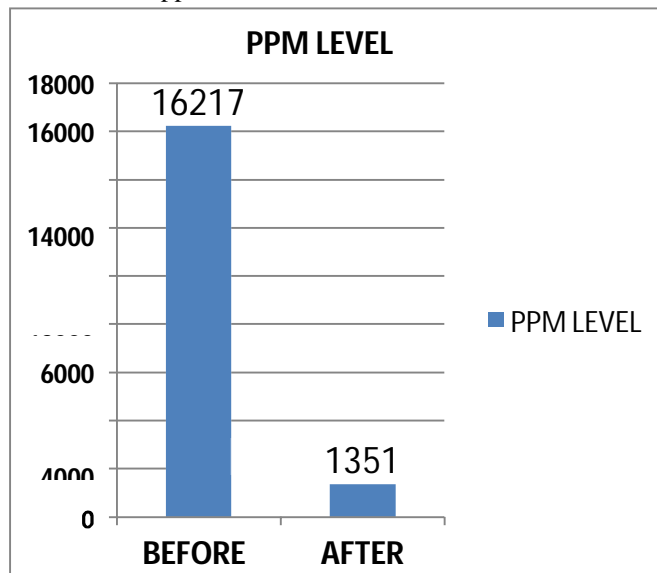
Fig. 12 Chart PPM Level

This criterion describes the main goal of this project that was to reduce the problems at PDI Line due to Engine Quality Issue and to improve the sigma level. After calculation Sigma level was found to be improved considerably and Quality improvement in PPM for Engine Quality Defect = 1351ppm from 16,217ppm in month march 2016. It is clear that the setup is more profitable.
