Quality Improvement of Oil and Fuel Leakage in Diesel Engine by using Semi Automatic Setup

Swapnil D Kurhekar¹, Abhijeet B Tamse²

Abstract: As we know when engine goes to testing department before that we test it through semi-automatic setup which is installed on assembly line conveyor to test the oil and fuel leakage of diesel engine. Now different trial were taken on engine by using methodology which includes ATEQ D520 unit and air pressure regulator for detecting the leakage quantity. Actually ATEQ D520 UNIT is a flowmeter which measure a drop in pressure with a differential sensor. Here we supplied pressurized air into the engine through breather plug and overflow pipe. If leakage not found engine will be dispatched to testing department and if leakage is found the problem may be solved by spraying soap water in leakage area so that in that area bubbles come out. This work emphasizes on the analysis of problem due to which engine is rejected from testing department and also time and cost saving analysis for one month. Due to this setup improvement in PQCDSM, PPM and reduction in cost per poor quality supplied to customers from 28% to 18% of cost per benefit, better customer s

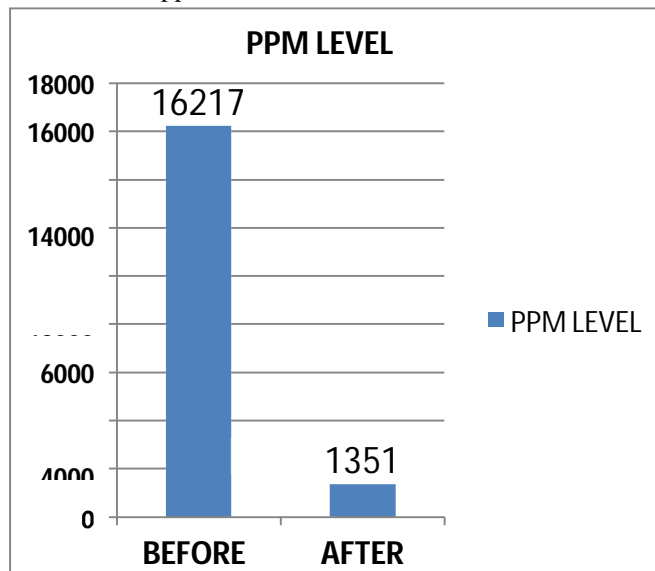
Fig. 12 Chart PPM Level

This criterion describes the main goal of this project that was to reduce the problems at PDI Line due to Engine Quality Issue and to improve the sigma level. After calculation Sigma level was found to be improved considerably and Quality improvement in PPM for Engine Quality Defect = 1351ppm from 16,217ppm in month march 2016. It is clear that the setup is more profitable.
