# To Study Rehabilitation of Old Elevated Water Tank and to Generate Non-Conventional Energy

Priya K Figueredo<sup>1</sup>, Mr. Nitish A. Mohite<sup>2</sup>, Miss Pooja A. Bhokare<sup>3</sup>, Chavan. Revati. P<sup>4</sup>, Patil. Ashwini. R<sup>5</sup>, Farakate. Snehal. S<sup>6</sup>, Patil. Mrunal. M<sup>7</sup>, Nalawade. Nikita. R<sup>8</sup>

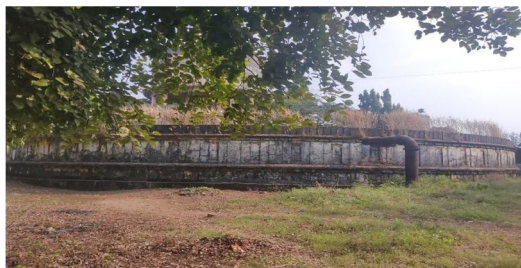
The storage tank on which rehabilitation is to perform is situated, in heart of the Kolhapur city near mangalwar peth, which is known as “PANYACHA KHAJINA”. This tank stands on the ground, the total height of the tank is 3.4 m and the diameter of the water tank is 31.70m. Construction of the tank began in 1875 and was completed in 1877, with a water tank capacity of 170,000 liters. Water tanks are also built in the minority of Chhatrapati Shahu Maharaj. Below are the steps taken in a water tank to find defects in the water tank.

FIG 1. Water Tank (Panyacha Khajina)

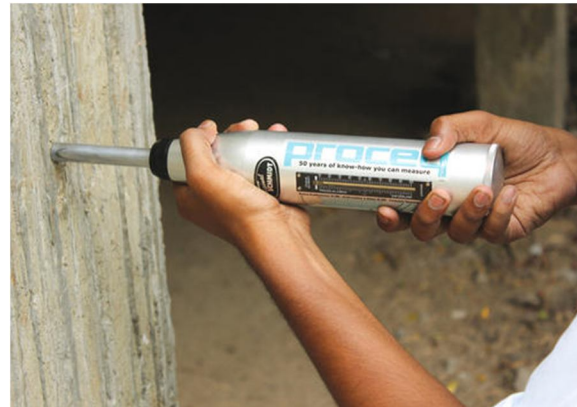
FIG 3 Rebound Hammer
