Volume: 10 **Issue:** VII **Month of publication:** July 2022

To Study Rehabilitation of Old Elevated Water Tank and to Generate Non-Conventional Energy

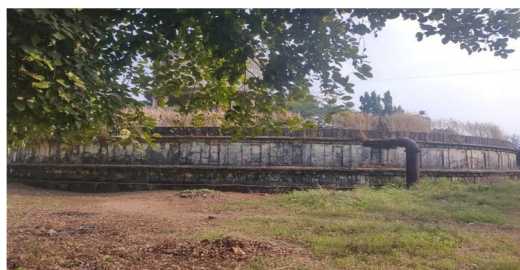
FIG 1. Water Tank (Panyacha Khajina)

The storage tank on which rehabilitation is to perform is situated, in heart of the Kolhapur city near mangalwar peth, which is known as “PANYACHA KHAJINA”. This tank stands on the ground, the total height of the tank is 3.4 m and the diameter of the water tank is 31.70m. Construction of the tank began in 1875 and was completed in 1877, with a water tank capacity of 170,000 liters. Water tanks are also built in the minority of Chhatrapati Shahu Maharaj. Below are the steps taken in a water tank to find defects in the water tank.

As explained in the methodology, the tank should first be visually inspected for efflorescence, minor leaks, or uneven adjustments, but the tank is in good condition. After conducting various tests on the aquarium, repairs and refurbishment work will be required. If the structure cracks or corrodes, proper treatment is required to restore the strength of the aquarium. Studies on non-conventional energy production show opportunities for renewable energy sources. It does not use the upper area of the water tank. After installing the solar panel in the upper area of the water tank, you can save that area. For most people who know non-renewable energy sources, solar energy is becoming more and more popular because of its economic benefits by battery backup. Solar energy can even supply electricity 24 hours a day, 365 days a year. There are more advantages compared to other forms of energy such as fossil fuels and petroleum deposits.
