# Repair of Cracks in Nicol Blocks of a Reinforced Earth Wall

**Abstract:** Bangladesh's first access-controlled expressway is the Dhaka-Khulna (N-8) Expressway. The project consists of 8 lane road of 55 km length, 54 culverts, 20 underpasses, 2 interchanges, 4 major bridges, 25 minor bridges, and 5 flyovers. Teghoria Interchange of this project is structured with 19 Reinforced Earth Wall, out of which a crack appeared in a wall that has 146 meters length and 7 meters height. Detailed inspection and analysis were followed by repair and rectification work. The aim of this paper was to find out the likely causes of this crack, discuss detailed retrofitting methodology and bring forth some recommendation. This crack may form due to weak workmanship during compaction and installation of tendons of reinforced earth, environmental load, heavy-loaded vehicle travel above the RE wall etc. The specialist team of the consultants of the project and experts from development partner inspected the problem and worked out how to repair the cracked area. The development partner developed repair methodology and executed the crack repair work as well as the treatment plan under strict supervision of

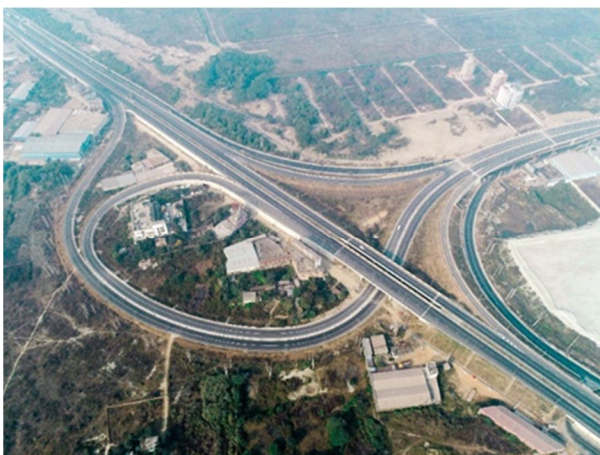
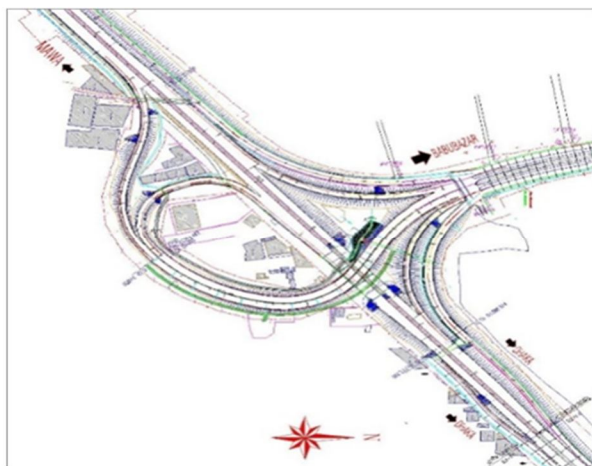
This interchange connects Jatrabari to Mawa Express Highway and Babu Bazar Link Road together. This a Trumpet type of Interchange. The trumpet interchange allows for interchange of secondary two-way streets to a multi-lane roadway with minimal traffic mix. It takes the place of a T-intersection which is often used when a roadway ends at the intersection of another roadway.

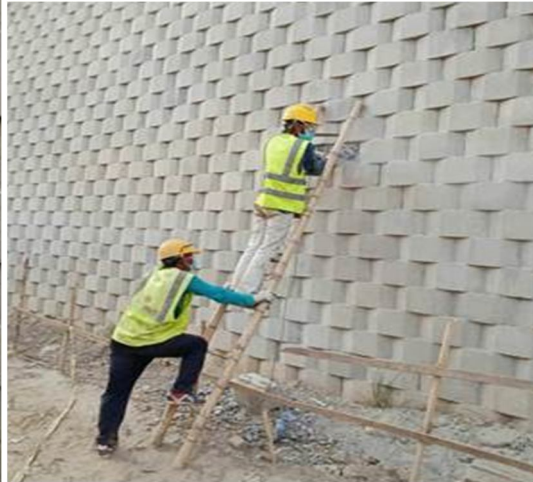
Longitudinal Cracks were found on the surface of some modular blocks of reinforcement earth wall at Tegoria Interchange Bridge abutment-3.

Crack repairing work was done base on the approved methodology, which was constantly monitored by CSC Consultant and Client Representative Team.
