Retrofitting of Confined Brick Masonry with FRP

Salman Hameed¹, Samiullah Qazi² Muhammad Asif³, Sardar Ali⁴

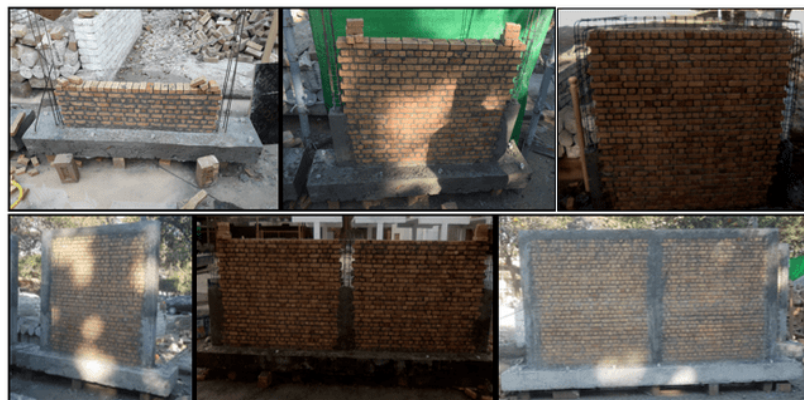
Figure 2. Models construction phases

A typical confined brick masonry walls of single bay and two bays was fabricated which replicated the walls of room of a typical building in Pakistan. The walls' dimensions were 1/3rd scale down due to limitations of the working space available in the research laboratory i.e. (UET) Peshawar. Dimensions of the Single Bay and two bay confined masonry walls was 46"x47" and 89"x47" respectively. These walls were constructed over 6" reinforced concrete pad with pre holes provided for securing it to the floor of testing frame. The walls were built using brick masonry in an English bond pattern with a thickness of 3" (76.2mm) and a 1:6 cement-sand mortar, as is typical in the area. In order to eliminate any vertical joint in the masonry each layer of the bricks is laid in a staggered pattern 0.75" toothing was provided in every course of masonry. Walls was confined by tie column having a size of 3"x3". 4 #1 longitudinal bars and #1 stirrups @ 6" c/c were used to for column reinforcing. Stirrups were made by combining three wires of 1mm diameter of binding wire. Tie beams were casted over the walls having a size of 3"x3" and reinforced with 4 #1 bars tied by #1 stirrups @ 6" c/c.

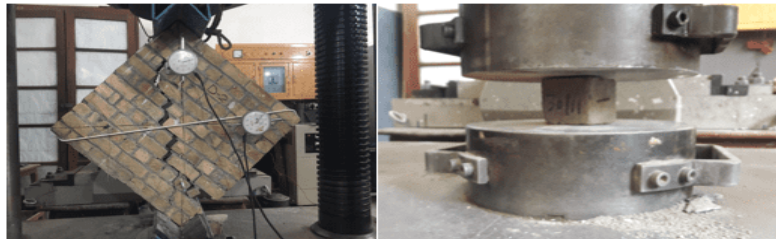
Figure 3. Diagonal Compression and Mortar Compressive Test

1/3rd scale brick of first class was selected after performing different types of tests from a local vendor. The Scale down brick replicated actual bricks qualitatively and quantitatively. After collecting all the essentials materials for the construction of walls, the second stage of experimental study was the testing of constituent materials to determine the different material properties. Compressive strength of masonry unit was calculated according to ASTM C-67 specification. Compressive strength of masonry unit was calculated according to ASTM C-67 specification. In order to measure the initial rate of absorption of brick units, Section 10 of the ASTM C-67 test specification was used. In compliance with the ASTM C-109 specification, the compressive strength of mortar used in brick masonry walls was determined using 2-inch mould. For the preparation of concrete, a standard ratio of 1:2:4 (1-part cement, 2 parts sand and 4 parts coarse aggregate) with a water-cement ratio of 0.6 was used. ASTM C39 parameters were used to measure the compressive strength of the concrete cylinder sample. The masonry tensile strength f_t was obtained by testing three masonry square prism of dimension 16”x16” under diagonal compression load as specified by ASTM 519 (ASTM C1391). All the results are shown in table 1.

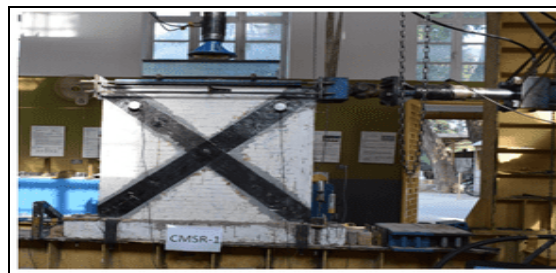
Figure 4. Load setup and instrumentation details

All the models were investigated in Structural Engineering laboratory. The bottom of specimen was fixed with stiff steel girder through bolts. Top of the specimens were kept free to allow free translation and rotation. This setup is used to simulate cantilever type setup. One actuator of 50-ton capacity was used to subject constant vertical compression load. Another actuator of same capacity was used to subject horizontal load. Vertical load was subjected on steel girder placed on 1.5” steel roller. The steel roller was rolled on 1.5” inch thick steel plate placed on the top beam, which in turn distributed vertical load uniformly as shown in figure. Three LVDTs were connected to record horizontal displacement. LVDTs along the diagonals were also connected. Location of various LVDTs are shown in Figure 3.25. As illustrated in the figure, strain gauges were also utilized to record strain in the FRP strip at various points. As indicated in the diagram, all of these instruments were linked to a data logger machine (UCAM 70). All the LVDTs were calibrated in the UTM machine before test. Also, the load cells and data cable were checked and calibrated.

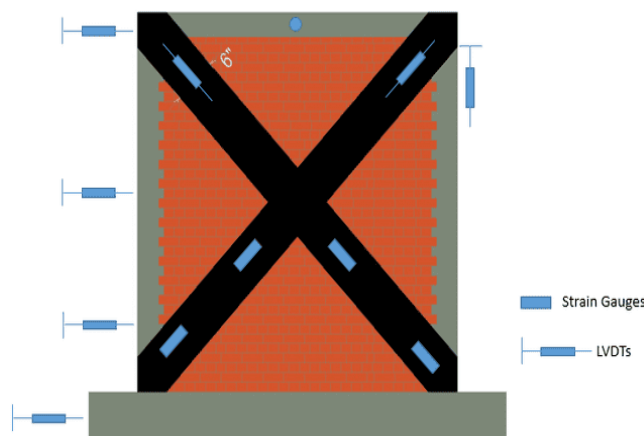
Figure 5. Instrumentation details

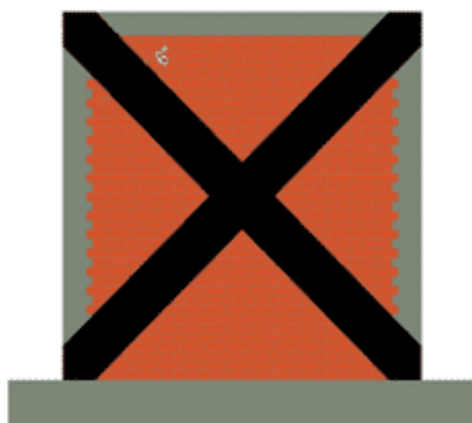
Figure 6. FRP Retrofitting configuration

FRP strips were bonded to both surfaces of damaged walls as part of the retrofitting process. Before joining the FRP strips, the cracks were cleaned with a brush and a blower but not sealed. A typical hand-held grinding machine was used to polish the surfaces of the walls. In order to achieve uniform and proper bonding between FRP and wall, surface along the diagonal strips were levelled with chemical mortar (Ultra Fairing Coat) as shown in figure. Diagonal configuration of FRP retrofitting was considered. Diagonal strips of width 6” were bonded in each direction on both sides of the wall as shown in figure. First, one coat of epoxy was applied to wall surface, then strip of FRP was bonded to pre-coated surface. Another coat of epoxy was applied over FRP strips with help of blade. In order to avoid detachment of FRP strips and to enhance the bond performance between the FRP and masonry substrate anchors were provided. Holes were driven at specific locations and then cleaned with pressurized air. Epoxy was injected in the hole through 100 ml syringe. Anchors made from FRP fiber were inserted in the holes and then fan out on FRP strips as shown in Figure 6.

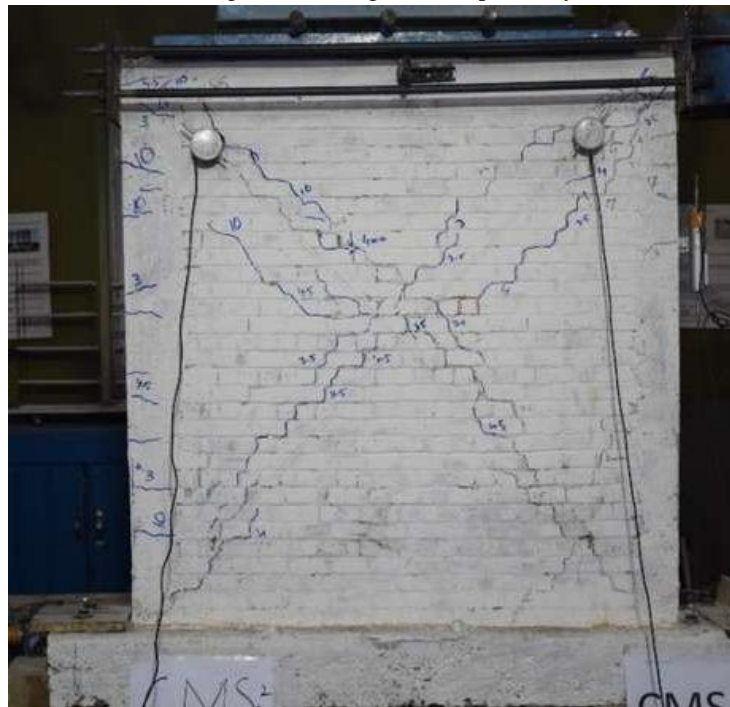
Figure 7: Damage pattern before retrofitting

A quasi-static load was performed in the specimen. The damage pattern of the specimen is shown in Figure 7. The dominant failure pattern was step crack passing through mortar joints. First crack was noticed at 2mm displacement cycle at bottom left corner. Major crack along the diagonal was started at 2.5mm displacement cycle. The cracks were mostly concentrated along the both diagonals. Cracks in the tie column was observed after 3mm displacement cycle. Some minor cracks originating from top corners were also noticed. The test was stopped at the maximum displacement of 10mm at which damages were of moderate. Hysteresis Curves and Bilinear Curve is shown in Figure 8 and Figure 9 respectively.

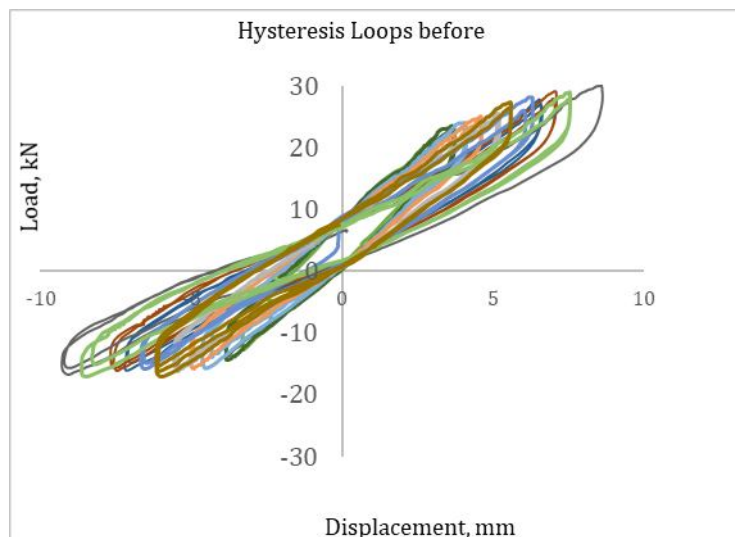
Figure 8: Hysteresis Curves before Retrofitting

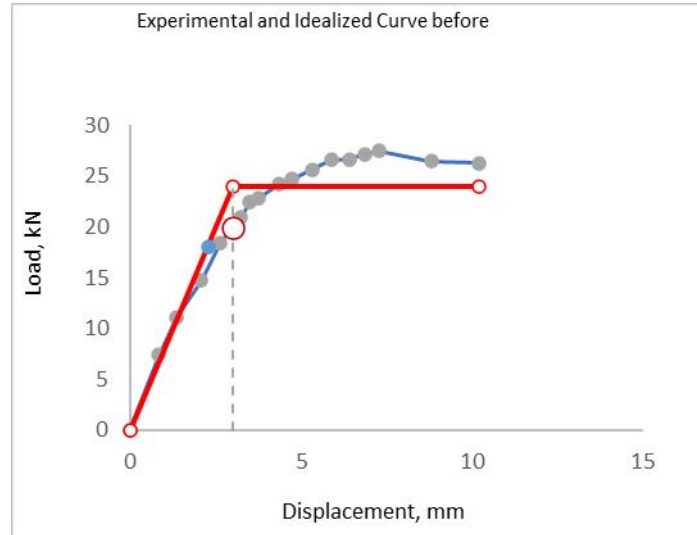
Figure 9: Bilinear Curve Before Retrofitting

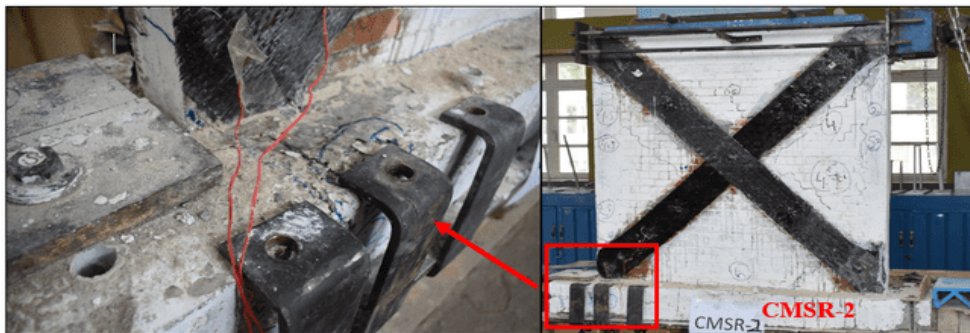
Figure 10. Crack pattern and failure mode after Retrofitting

The damage specimen and cracks pattern are shown in Figure 10. Formation of first crack occurred when the specimen was subjected to 2.5mm displacement. At 5mm displacement a horizontal crack at the interface of masonry and footing was observed which extend toward the tie columns in both directions. A diagonal shear crack appeared in the tie column which was wide enough to be visually seen during testing. Foundation pad become cracked at the top near the bottom of left tie column. This crack becomes wide and extended toward the bottom due to increase in lateral displacement. The test was then stopped. Hysteresis Curves and Bilinear Curve is shown in Figure 11 and Figure 12 respectively.

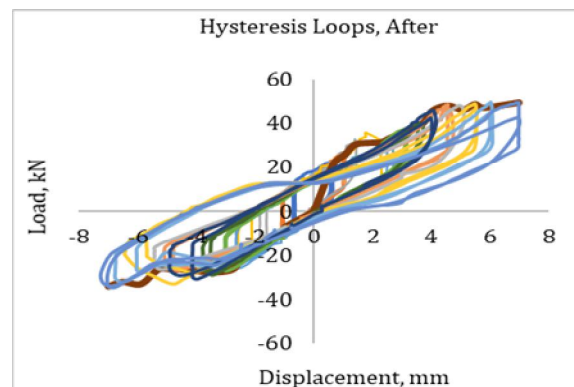
Figure 11. Hysteresis Curves after Retrofitting

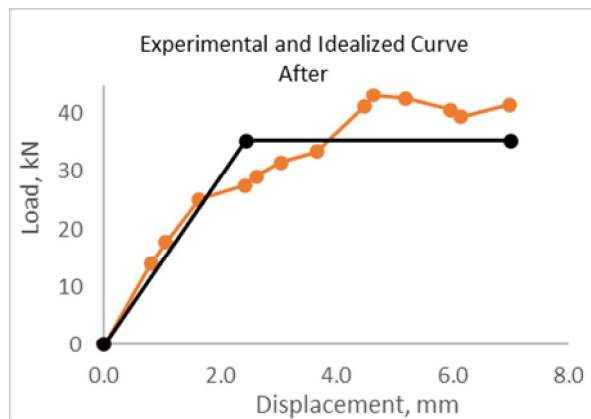
Figure 12: Bilinear Curve After Retrofitting
