Retrofitting of Confined Brick Masonry with FRP

Salman Hameed¹, Samiullah Qazi² Muhammad Asif³, Sardar Ali⁴

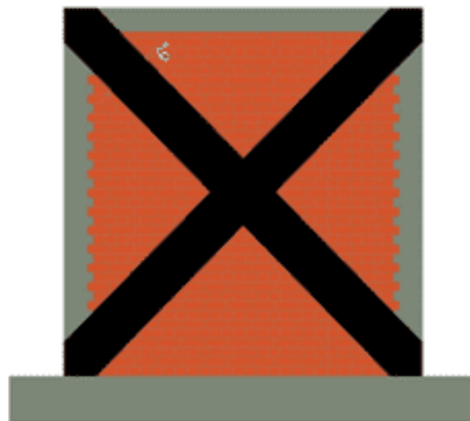
Figure 6. FRP Retrofitting configuration

FRP strips were bonded to both surfaces of damaged walls as part of the retrofitting process. Before joining the FRP strips, the cracks were cleaned with a brush and a blower but not sealed. A typical hand-held grinding machine was used to polish the surfaces of the walls. In order to achieve uniform and proper bonding between FRP and wall, surface along the diagonal strips were levelled with chemical mortar (Ultra Fairing Coat) as shown in figure. Diagonal configuration of FRP retrofitting was considered. Diagonal strips of width 6” were bonded in each direction on both sides of the wall as shown in figure. First, one coat of epoxy was applied to wall surface, then strip of FRP was bonded to pre-coated surface. Another coat of epoxy was applied over FRP strips with help of blade. In order to avoid detachment of FRP strips and to enhance the bond performance between the FRP and masonry substrate anchors were provided. Holes were driven at specific locations and then cleaned with pressurized air. Epoxy was injected in the hole through 100 ml syringe. Anchors made from FRP fiber were inserted in the holes and then fan out on FRP strips as shown in Figure 6.

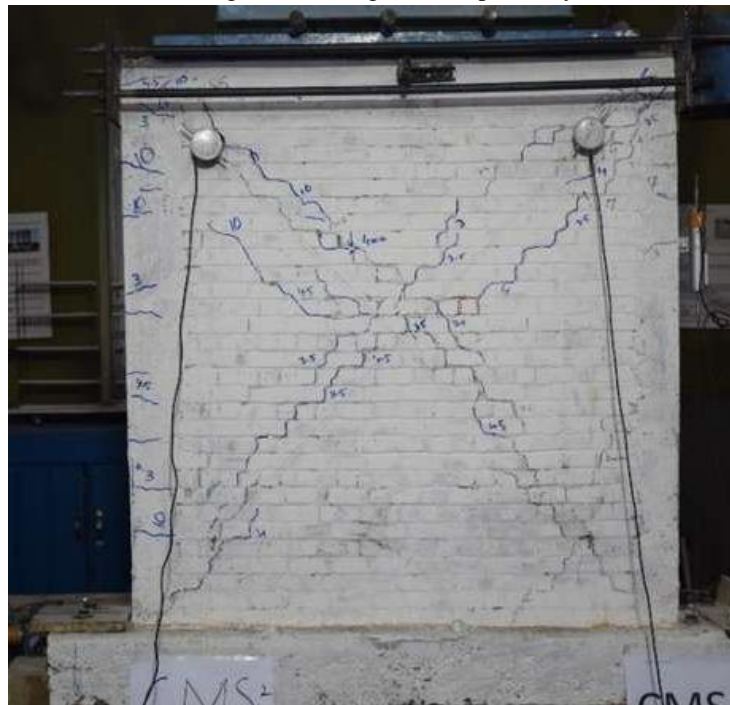
Figure 7: Damage pattern before retrofitting

A quasi-static load was performed in the specimen. The damage pattern of the specimen is shown in Figure 7. The dominant failure pattern was step crack passing through mortar joints. First crack was noticed at 2mm displacement cycle at bottom left corner. Major crack along the diagonal was started at 2.5mm displacement cycle. The cracks were mostly concentrated along the both diagonals. Cracks in the tie column was observed after 3mm displacement cycle. Some minor cracks originating from top corners were also noticed. The test was stopped at the maximum displacement of 10mm at which damages were of moderate. Hysteresis Curves and Bilinear Curve is shown in Figure 8 and Figure 9 respectively.
