Retrofitting of Damaged Crumb Rubber Concrete Frame Using Fiber Reinforced Polymers

Abstract: The research work is focused on the retrofitting of damaged crumb rubber concrete frame. The retrofitting of these frames was carried out using Carbon Fiber Reinforced Polymers (CFRP) wrapping technique accompanied with beam weakening technique, carried out at certain locations to achieve the desired failure mechanism. Two previously tested 1/3rd reduced scale models Crumb rubber concrete (CRC) and Normal concrete (NC) were CFRP retrofitted along with beam weakening and then tested dynamically. From the as-built testing strong-beam weak-column effect was observed, for that purpose beams weakening through cores removal away from the face of the column equal to two times depth of the beam, so as to shift the damage from the brittle failure mechanism of column and joint damage to more ductile damage in the beam. In addition to beam weakening the damaged beam column joints were CFRP retrofitted. A comparative study between the retrofitted and as-built models was done. The results obtained from testing has recovered the ductility up to 82% and response modification factor up to 90% for normal

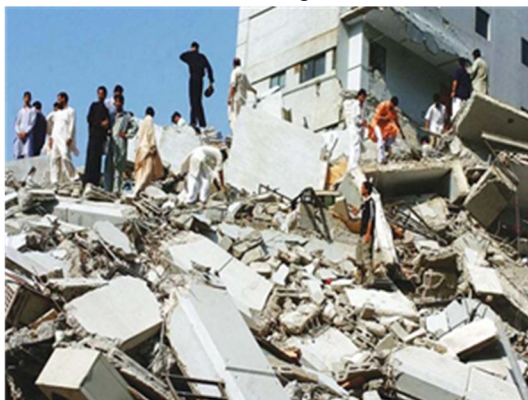
Figure 1.1: Collapse of Reinforced Concrete Structure in past earthquakes

Earthquakes are among the most lethal natural disasters, causing widespread destruction and loss of life. Earthquakes cause an annual average of 10,000 deaths and yearly economic damages in the billions of dollars, which may amount to a significant portion of the total production of the country [Javed et al., 2008] shown in Figure 1.1 to 1.3.

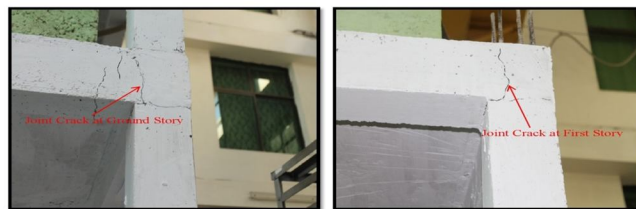
Damages observed at Ground and First Story at 140% NR

Beam-Column Joint Crack at Ground Story

Beam-Column Joint Crack at First Story

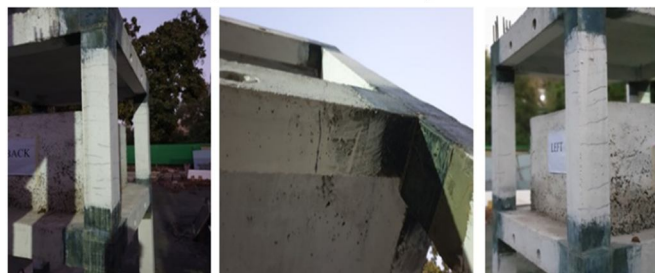
With an increase in loading up-to 80%, further opening of existing and newer shear and flexure cracks in the beam and column were observed (Figure 4.6). At the application of 200% of loading, further opening of the existing cracks and a concentration of shear cracking in the columns ends was observed

In case of both NC and CRC as-built model there were fewer cracks in the beams and nearly all of the joints observed cracking and most of the cracking concentrated in the form of flexural cracking in the column ends. In case of the both retrofitted frames most of the cracking pattern was similar with the joints hidden in FRP layers but no large size additional cracking in the joints was observed. An improved damage behavior as intended due to the retrofitting was observed in the form of relatively more distributed flexure cracking along the height of the columns especially in the case of NC model, with shear cracking concentration at the column ends in case of CRC model.
