Retrofitting of Damaged Crumb Rubber Concrete Frame Using Fiber Reinforced Polymers

Abstract: The research work is focused on the retrofitting of damaged crumb rubber concrete frame. The retrofitting of these frames was carried out using Carbon Fiber Reinforced Polymers (CFRP) wrapping technique accompanied with beam weakening technique, carried out at certain locations to achieve the desired failure mechanism. Two previously tested 1/3rd reduced scale models Crumb rubber concrete (CRC) and Normal concrete (NC) were CFRP retrofitted along with beam weakening and then tested dynamically. From the as-built testing strong-beam weak-column effect was observed, for that purpose beams weakening through cores removal away from the face of the column equal to two times depth of the beam, so as to shift the damage from the brittle failure mechanism of column and joint damage to more ductile damage in the beam. In addition to beam weakening the damaged beam column joints were CFRP retrofitted. A comparative study between the retrofitted and as-built models was done. The results obtained from testing has recovered the ductility up to 82% and response modification factor up to 90% for normal

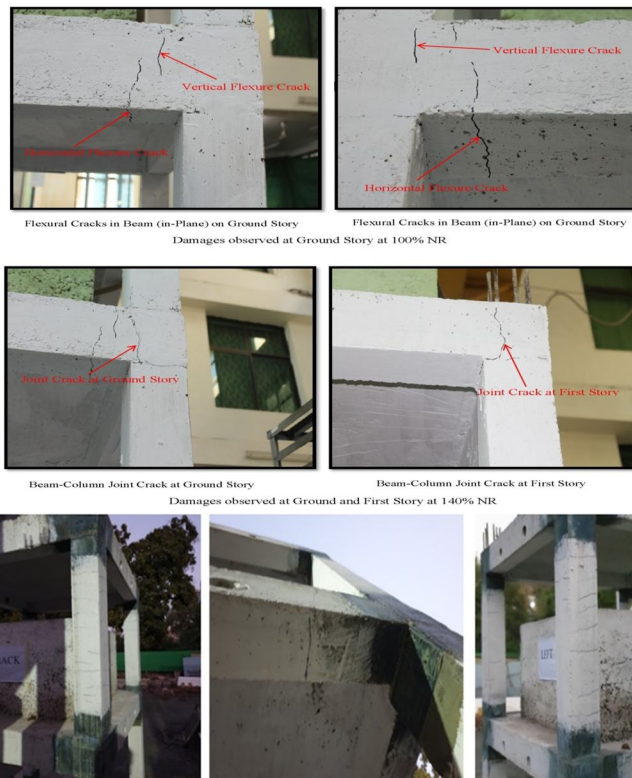
During the application of initial loading up-to 50%, no new cracks were observed just the opening of the existing cracks that were just whitewashed was observed

In case of both NC and CRC as-built model there were fewer cracks in the beams and nearly all of the joints observed cracking and most of the cracking concentrated in the form of flexural cracking in the column ends. In case of the both retrofitted frames most of the cracking pattern was similar with the joints hidden in FRP layers but no large size additional cracking in the joints was observed. An improved damage behavior as intended due to the retrofitting was observed in the form of relatively more distributed flexure cracking along the height of the columns especially in the case of NC model, with shear cracking concentration at the column ends in case of CRC model.
