Seismic Analysis of Re-Entrant Corner Plan Irregular Buildings with Roof Openings Using STAAD Pro: A Case Study for Zone III Earthquake Intensity

Abstract: This research investigates the possibility of including roof openings in the re-entrant corner plan irregular buildings at different positions for the response to seismic loads. Five different models with different types and levels of diaphragm discontinuity were analyzed using the STAAD Pro software. Variables such as node displacement, storey shear X and Z directions, stress, and maximum bending moment were investigated to measure the efficiency of the structure. The findings reveal that models featuring heightened diaphragm discontinuity tend to exhibit amplified node displacements, storey shear, and stress levels. Particularly, Model M3, showcasing a 17% diaphragm discontinuity, consistently demonstrates superior performance by showcasing reduced displacements and stress values compared to its counterparts. However, it's imperative to note that the ultimate selection of the model should be contingent upon specific project requisites and design considerations. In essence, the study underscores the importance of considering t

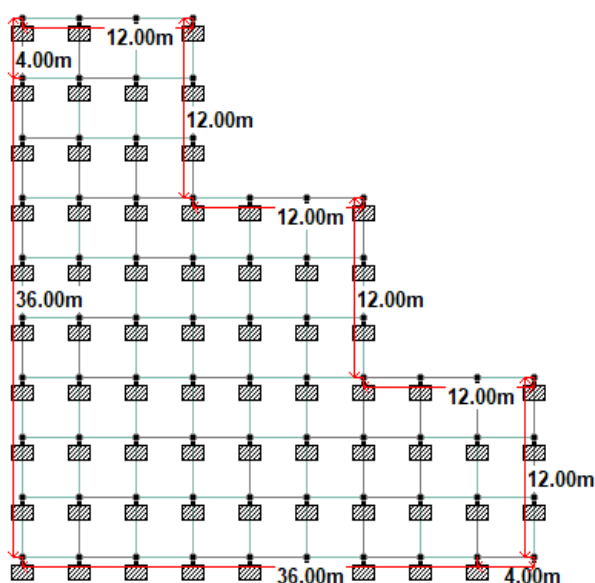
Fig. 1 Plan of G+6 structural model M1 with 0% Diaphragm Discontinuity

S.no	Model ID	Model Description
1	M1	Re-entrant Plan Irregular building with 0% Diaphragm Discontinuity
2	M2	Re-entrant Plan Irregular Building with 15% Diaphragm Discontinuity
3	M3	Re-entrant Plan Irregular Building with 17% Diaphragm Discontinuity
4	M4	Re-entrant Plan Irregular Building with 30% Diaphragm Discontinuity
5	M5	Re-entrant Plan Irregular Building with 32% Diaphragm Discontinuity

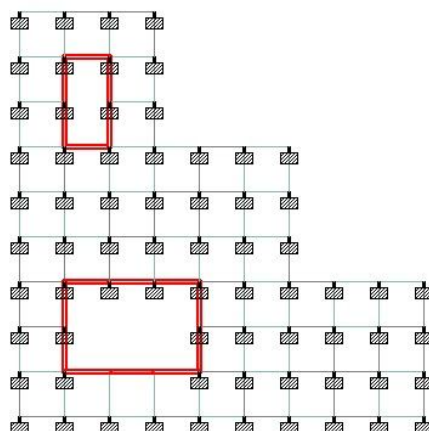
Fig. 2 Plan of G+6 Irregular Structural Model M2 with 15% Diaphragm Discontinuity in Centre and Side Corners

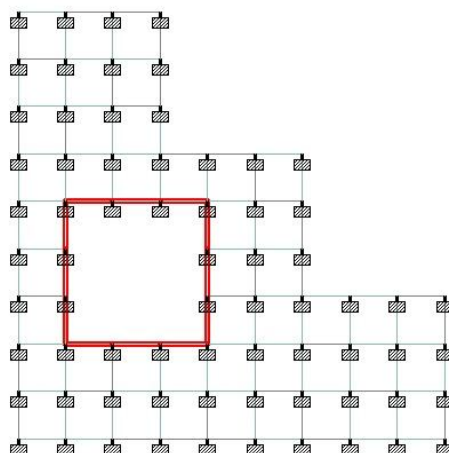
Fig. 3 Plan of G+6 Irregular Structural Model M3 with 17% Diaphragm Discontinuity in Centre

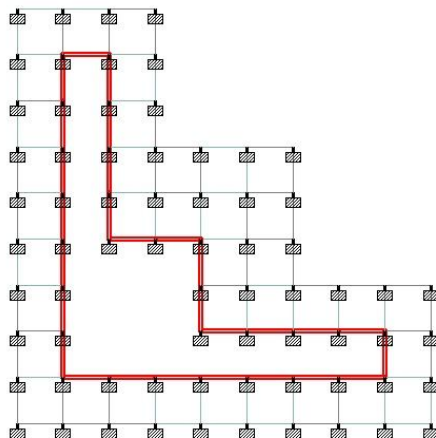
Fig.4 Plan of G+6 Irregular Structural Model M4 with 30% Diaphragm Discontinuity in L- Shape in Centre

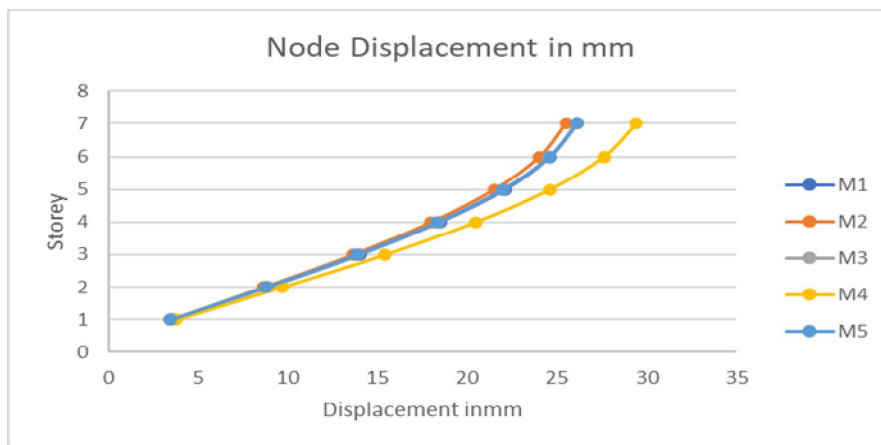
Graph No.1 Node Displacement For All Model

- 1) Models M2 and M4 generally exhibited higher node displacements across all storeys, suggesting decreased lateral stability as the percentage of diaphragm discontinuity increased.
- 2) Model M3 consistently showed lower node displacements, indicating better overall lateral stiffness and stability.

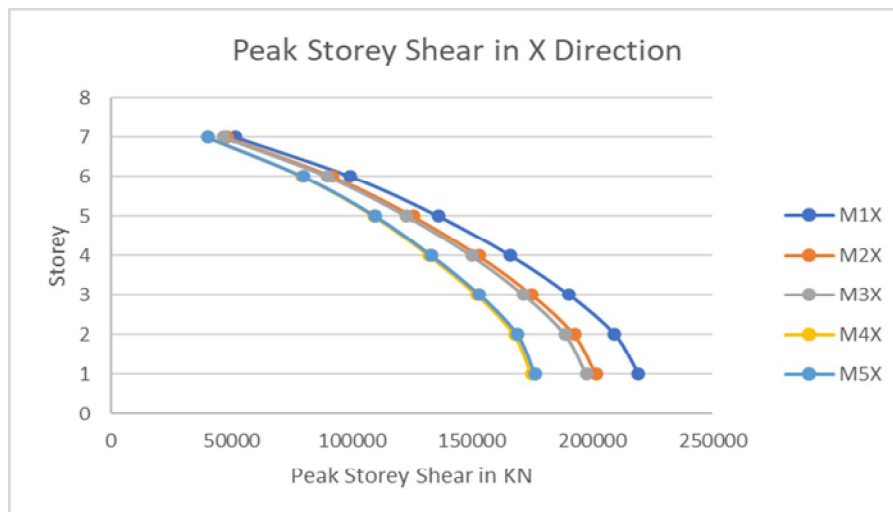
Graph No.2 Peak Storey Shear for all Model In X Direction

- 1) Model M2 consistently demonstrated the highest storey shear values, both in the X and Z directions, indicating that it experiences the highest lateral shear forces among the models.
- 2) Model M3 often followed M2 in terms of storey shear values, although the values were generally slightly lower.
- 3) Models M1, M4, and M5 exhibited lower storey shear values, with M1 frequently having the lowest shear values among them.

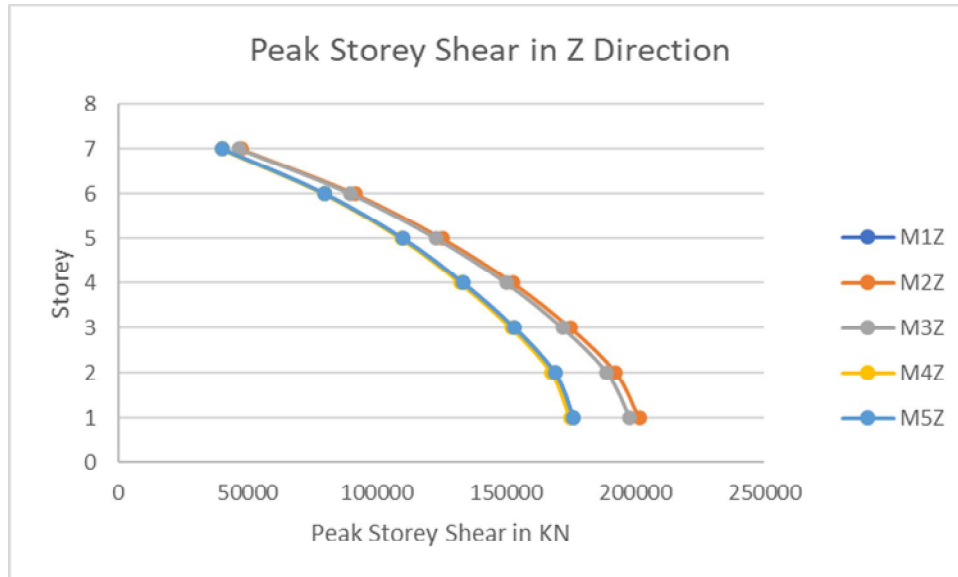
Graph No.2 Peak Storey Shear for all Model In Z Direction
