Seismic Analysis of Re-Entrant Corner Plan Irregular Buildings with Roof Openings Using STAAD Pro: A Case Study for Zone III Earthquake Intensity

Sanjay Mayda¹, Surajmal Patidar²

¹PG Scholar, Civil Engineering Department, VITM College, Indore, India

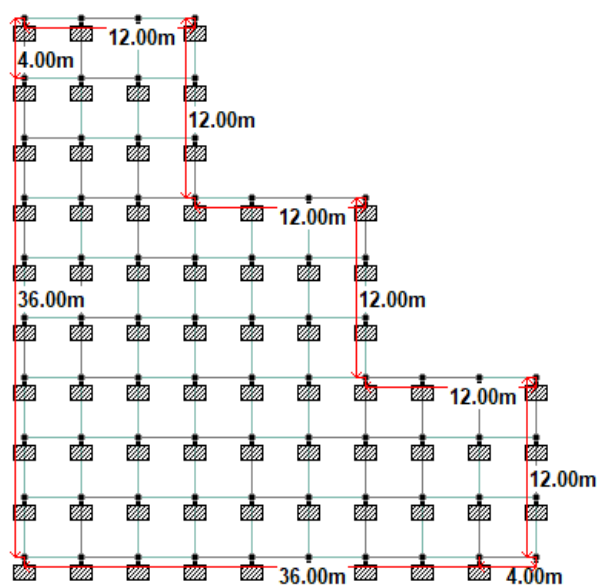
Fig. 1 Plan of G+6 structural model M1 with 0% Diaphragm Discontinuity

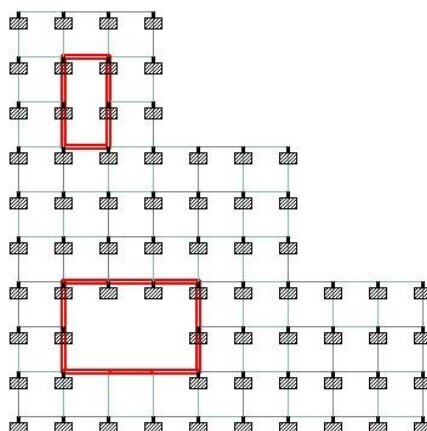
Fig. 2 Plan of G+6 Irregular Structural Model M2 with 15% Diaphragm Discontinuity in Centre and Side Corners

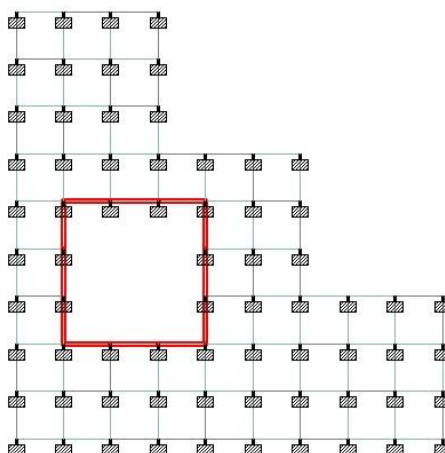
Fig. 3 Plan of G+6 Irregular Structural Model M3 with 17% Diaphragm Discontinuity in Centre

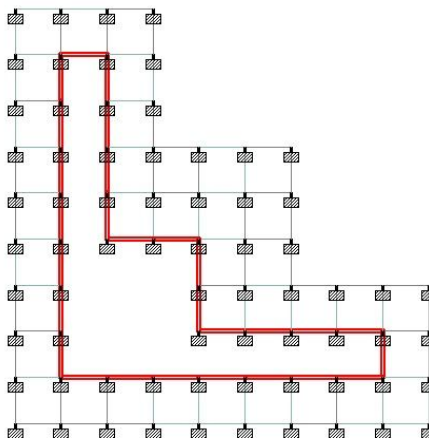
Fig.4 Plan of G+6 Irregular Structural Model M4 with 30% Diaphragm Discontinuity in L- Shape in Centre

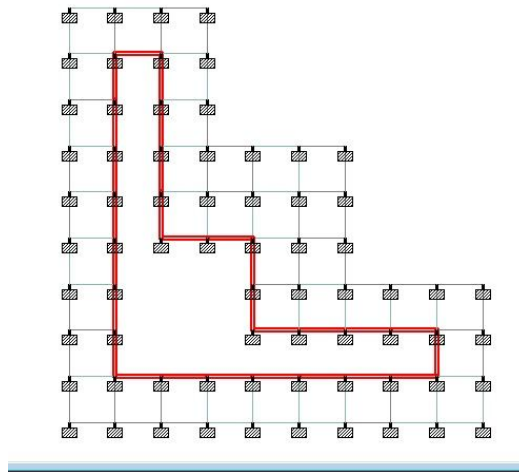
Fig.5 Re-entrant Plan Irregular Building with L Shape of Diaphragm Discontinuity

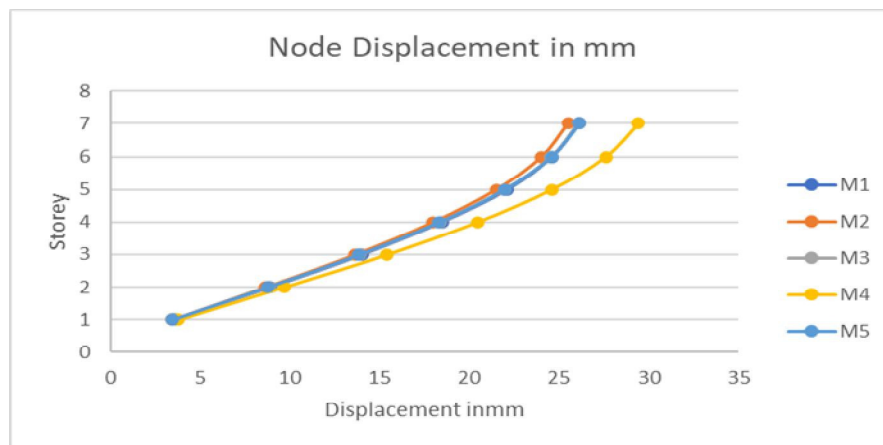
Graph No.1 Node Displacement For All Model

- 1) Models M2 and M4 generally exhibited higher node displacements across all storeys, suggesting decreased lateral stability as the percentage of diaphragm discontinuity increased.
- 2) Model M3 consistently showed lower node displacements, indicating better overall lateral stiffness and stability.

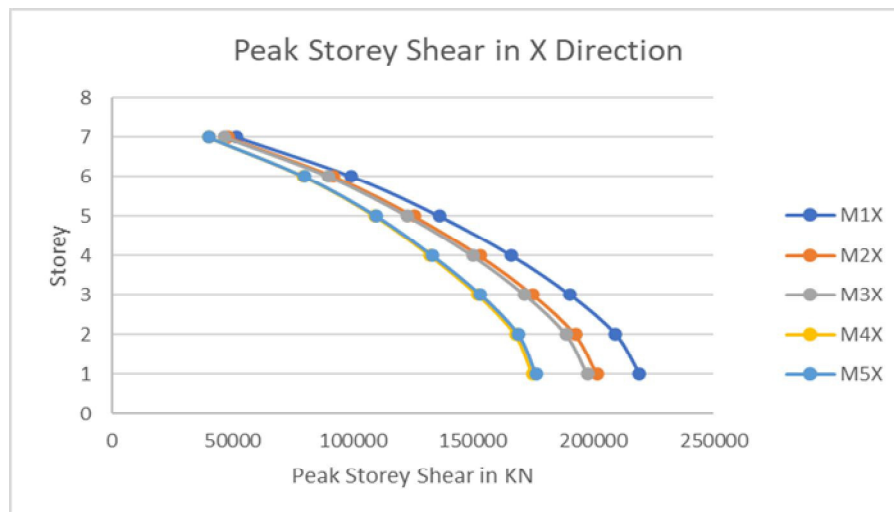
Graph No.2 Peak Storey Shear for all Model In X Direction

- 1) Model M2 consistently demonstrated the highest storey shear values, both in the X and Z directions, indicating that it experiences the highest lateral shear forces among the models.
- 2) Model M3 often followed M2 in terms of storey shear values, although the values were generally slightly lower.
- 3) Models M1, M4, and M5 exhibited lower storey shear values, with M1 frequently having the lowest shear values among them.

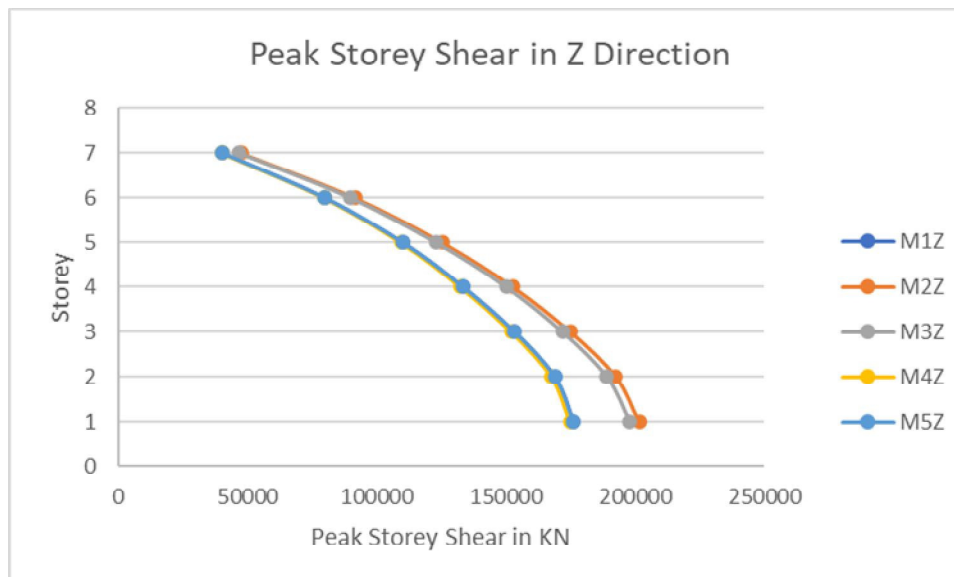
Graph No.2 Peak Storey Shear for all Model In Z Direction
