Seismic Analysis of Re-Entrant Corner Plan Irregular Buildings with Roof Openings Using STAAD Pro: A Case Study for Zone III Earthquake Intensity

Sanjay Mayda¹, Surajmal Patidar²

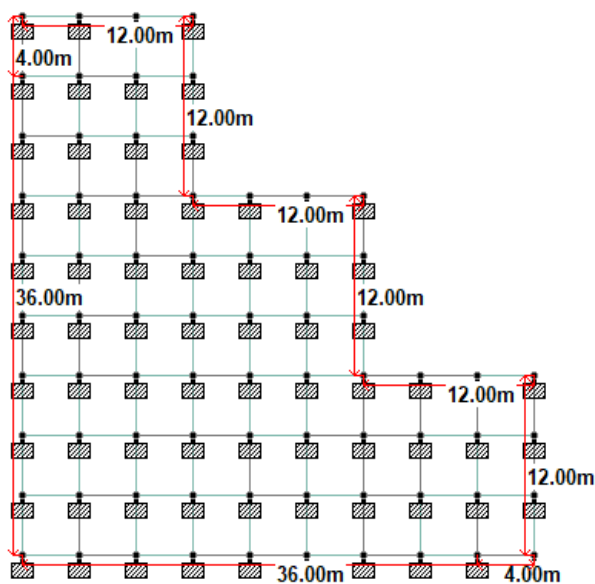
Fig. 1 Plan of G+6 structural model M1 with 0% Diaphragm Discontinuity

| S.no | Model ID | Model Description |
|---|---|---|
| 1 | M1 | Re-entrant Plan Irregular building with 0% Diaphragm Discontinuity |

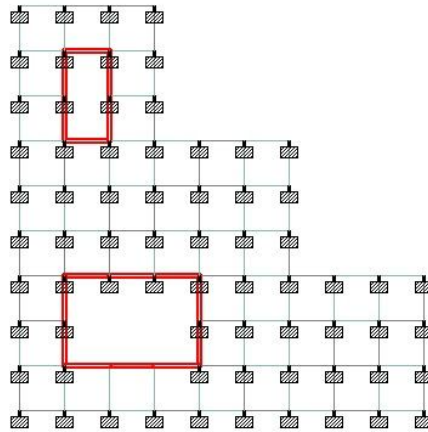
Fig. 2 Plan of G+6 Irregular Structural Model M2 with 15% Diaphragm Discontinuity in Centre and Side Corners

| S.no | Model ID | Model Description |
|---|---|---|
| 2 | M2 | Re-entrant Plan Irregular Building with 15% Diaphragm Discontinuity |

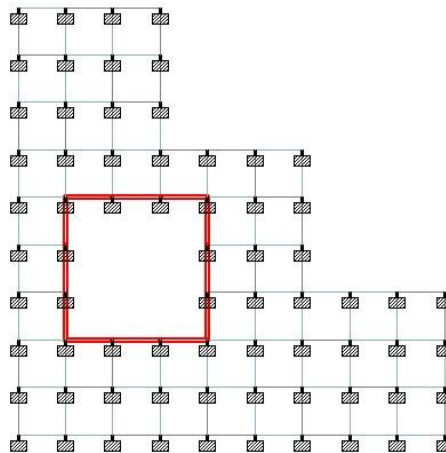
Fig. 3 Plan of G+6 Irregular Structural Model M3 with 17% Diaphragm Discontinuity in Centre

| S.no | Model ID | Model Description |
|---|---|---|
| 3 | M3 | Re-entrant Plan Irregular Building with 17% Diaphragm Discontinuity |

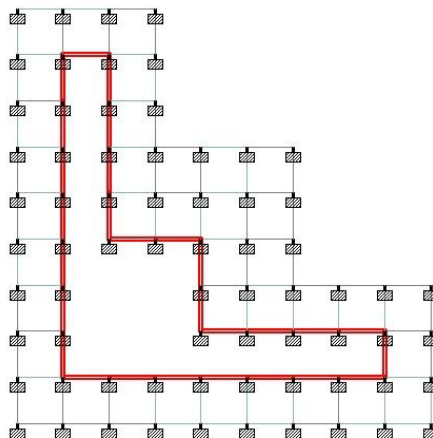
Fig.4 Plan of G+6 Irregular Structural Model M4 with 30% Diaphragm Discontinuity in L- Shape in Centre

| S.no | Model ID | Model Description |
|---|---|---|
| 4 | M4 | Re-entrant Plan Irregular Building with 30% Diaphragm Discontinuity |

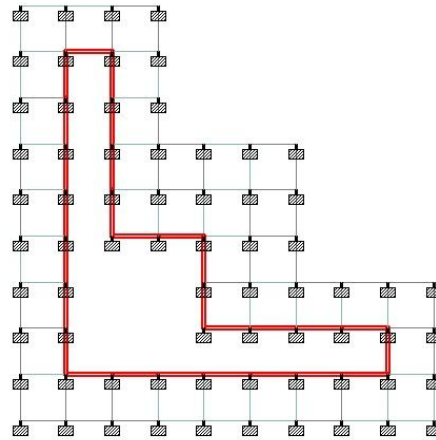
Fig.5 Re-entrant Plan Irregular Building with L Shape of Diaphragm Discontinuity

| S.no | Model ID | Model Description |
|---|---|---|
| 5 | M5 | Re-entrant Plan Irregular Building with 32% Diaphragm Discontinuity |

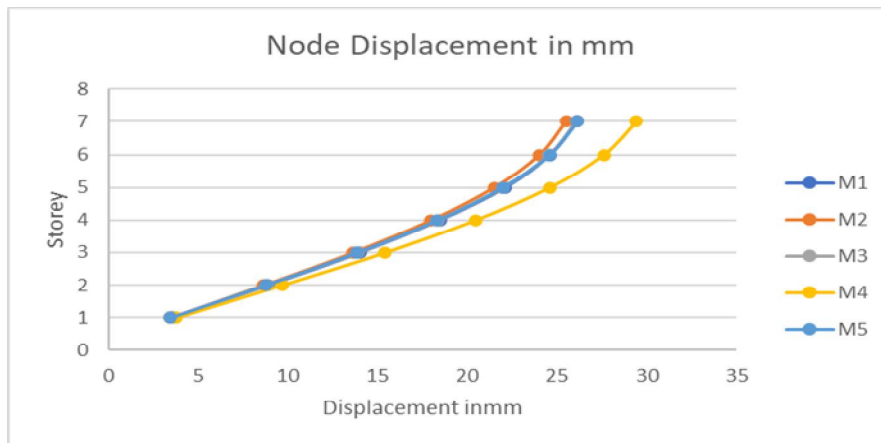
Graph No.1 Node Displacement For All Model

- 1) Models M2 and M4 generally exhibited higher node displacements across all storeys, suggesting decreased lateral stability as the percentage of diaphragm discontinuity increased.
- 2) Model M3 consistently showed lower node displacements, indicating better overall lateral stiffness and stability.

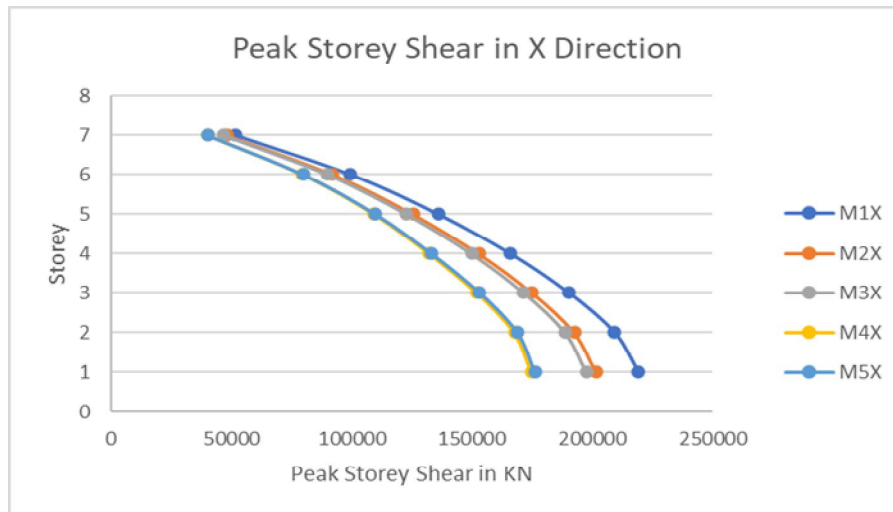
Graph No.2 Peak Storey Shear for all Model In X Direction

- 1) Model M2 consistently demonstrated the highest storey shear values, both in the X and Z directions, indicating that it experiences the highest lateral shear forces among the models.
- 2) Model M3 often followed M2 in terms of storey shear values, although the values were generally slightly lower.
- 3) Models M1, M4, and M5 exhibited lower storey shear values, with M1 frequently having the lowest shear values among them.

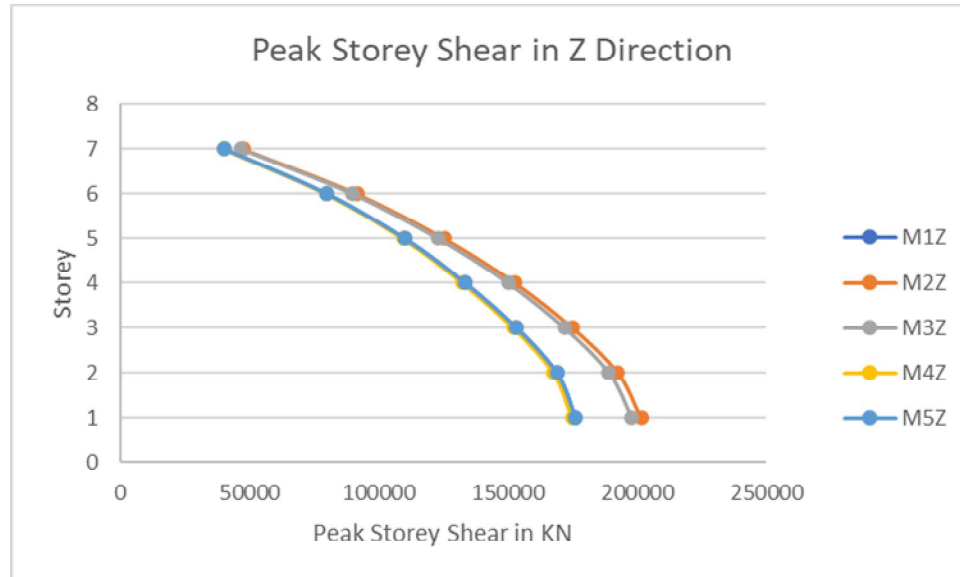
Graph No.2 Peak Storey Shear for all Model In Z Direction
