Seismic Analysis of Re-Entrant Corner Plan Irregular Buildings with Roof Openings Using STAAD Pro: A Case Study for Zone III Earthquake Intensity

Sanjay Mayda¹, Surajmal Patidar²

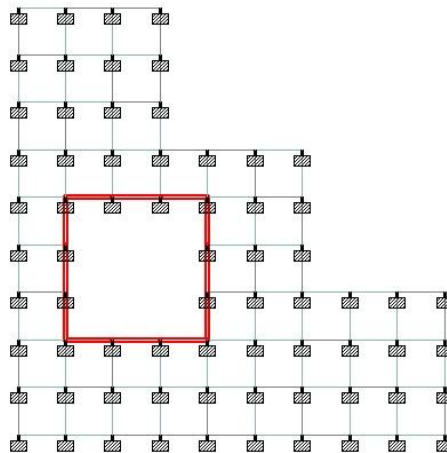
Fig. 3 Plan of G+6 Irregular Structural Model M3 with 17% Diaphragm Discontinuity in Centre

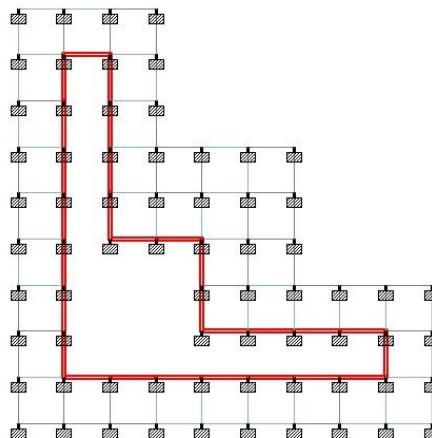
Fig.4 Plan of G+6 Irregular Structural Model M4 with 30% Diaphragm Discontinuity in L- Shape in Centre

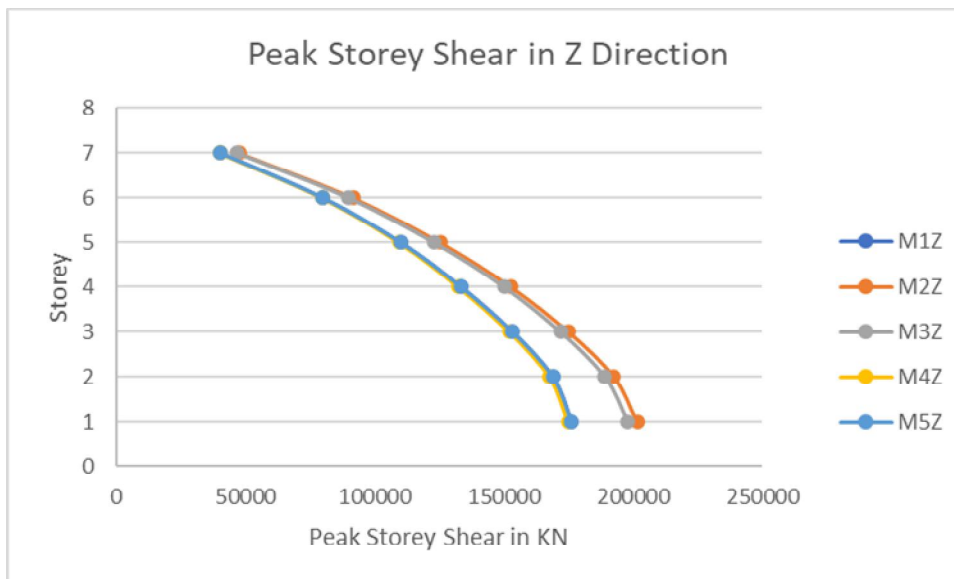
Graph No.2 Peak Storey Shear for all Model In Z Direction

- 1) Model M2 consistently demonstrated the highest storey shear values, both in the X and Z directions, indicating that it experiences the highest lateral shear forces among the models.
- 2) Model M3 often followed M2 in terms of storey shear values, although the values were generally slightly lower.
- 3) Models M1, M4, and M5 exhibited lower storey shear values, with M1 frequently having the lowest shear values among them.
