Seismic Analysis of Re-Entrant Corner Plan Irregular Buildings with Roof Openings Using STAAD Pro: A Case Study for Zone III Earthquake Intensity

Abstract: This research investigates the possibility of including roof openings in the re-entrant corner plan irregular buildings at different positions for the response to seismic loads. Five different models with different types and levels of diaphragm discontinuity were analyzed using the STAAD Pro software. Variables such as node displacement, storey shear X and Z directions, stress, and maximum bending moment were investigated to measure the efficiency of the structure. The findings reveal that models featuring heightened diaphragm discontinuity tend to exhibit amplified node displacements, storey shear, and stress levels. Particularly, Model M3, showcasing a 17% diaphragm discontinuity, consistently demonstrates superior performance by showcasing reduced displacements and stress values compared to its counterparts. However, it's imperative to note that the ultimate selection of the model should be contingent upon specific project requisites and design considerations. In essence, the study underscores the importance of considering t

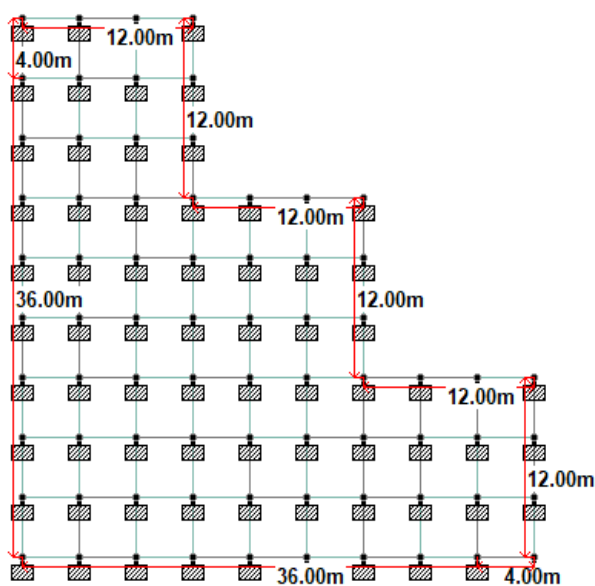
Fig. 1 Plan of G+6 structural model M1 with 0% Diaphragm Discontinuity

S.no	Model ID	Value
1	No. of Story	G + 6 Stories
2	Plan Area	36 Meters X 36 Meters
3	Story Height	3 Meters
4	Beam Size	500 millimeters X 500 millimeter
5	Column Size	600 millimeters X 600 millimeters
6	Column Spacing	4 Meters
7	Slab Thickness	150 millimeters
8	Grade of Concrete	M-25
9	Grade of Steel	Fe-550
10	Zone	Zone III
11	Shear Wall Thickness	150 millimeters

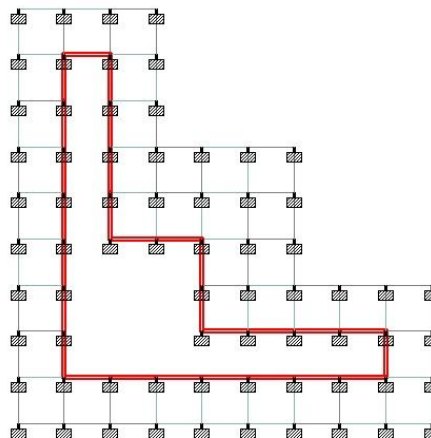
Fig.4 Plan of G+6 Irregular Structural Model M4 with 30% Diaphragm Discontinuity in L- Shape in Centre
