Seismic Retrofit or Rehabilitation of the Structures/Buildings - A Review

Jaineshwar Verma¹, Satish Parihar²

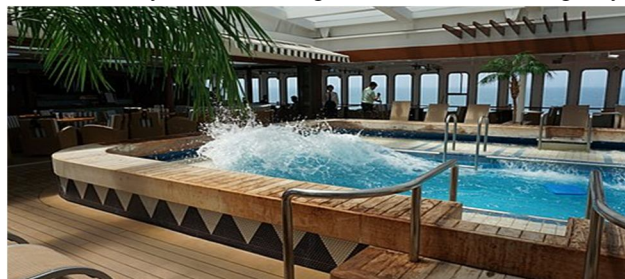
Fig. slosh tank

A slosh tank is a large container of low viscosity fluid (usually water) that may be placed at locations in a structure where lateral swaying motions are significant, such as the roof, and tuned to counter the local resonant dynamic motion. During a seismic (or wind) event the fluid in the tank will slosh back and forth with the fluid motion usually directed and controlled by internal baffles – partitions that prevent the tank itself becoming resonant with the structure. A slosh tank is a passive tuned mass damper. In order to be effective the mass of the liquid is usually on the order of 1% to 5% of the mass it is counteracting, and often this requires a significant volume of liquid. In some cases these systems are designed to double as emergency water cisterns for fire suppression.

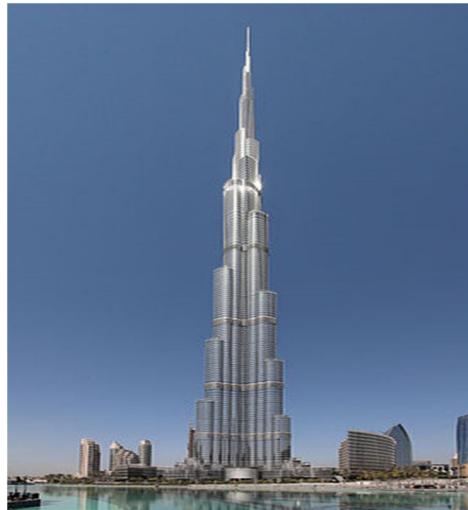
Fig. Skyscrapers

Very tall buildings ("skyscrapers"), when built using modern lightweight materials, might sway uncomfortably (but not dangerously) in certain wind conditions. A solution to this problem is to include at some upper story a large mass, constrained, but free to move within a limited range, and moving on some sort of bearing system such as an air cushion or hydraulic film. Hydraulic pistons, powered by electric pumps and accumulators, are actively driven to counter the wind forces and natural resonances. These may also, if properly designed, be effective in controlling excessive motion – with or without applied power – in an earthquake. In general, though, modern steel frame high rise buildings are not as subject to dangerous motion as are medium rise (eight to ten story) buildings, as the resonant period of a tall and massive building is longer than the approximately one second shocks applied by an earthquake.

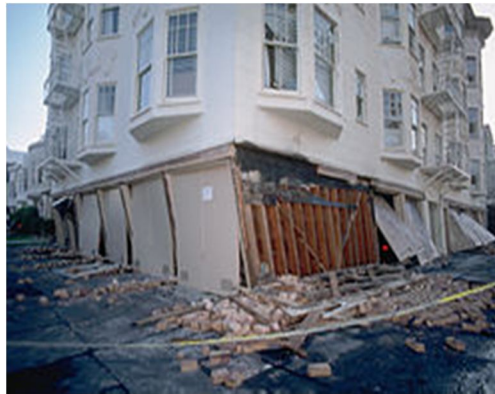
Fig. soft story collapse

This collapse mode is known as soft story collapse. In many buildings the ground level is designed for different uses than the upper levels. Low rise residential structures may be built over parking garages which have large doors on one side. Hotels may have a tall ground floor to allow for a grand entrance or ballrooms. Office buildings may have retail stores on the ground floor with continuous display windows.

Typically, where this type of problem is found, the weak story is reinforced to make it stronger than the floors above by adding shear walls or moment frames. Moment frames consisting of inverted U bents are useful in preserving lower story garage access, while a lower cost solution may be to use shear walls or trusses in several locations, which partially reduce the usefulness for automobile parking but still allow the space to be used for other storage.
