Seismic Retrofit or Rehabilitation of the Structures/Buildings - A Review

Jaineshwar Verma¹, Satish Parihar²

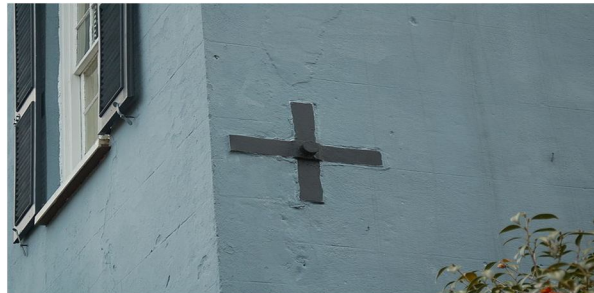
The uses of external post-tensioning for new structural systems have been developed in the past decade. A large-scale U.S./Japan joint research program, unbounded post-tensioning high strength steel tendons have been used to achieve a moment-resisting system that has self-centering capacity.

Pre-stressing can increase the capacity of structural elements such as beam, column and beam-column joints. External pre-stressing has been used for structural upgrade for gravity/live loading since the 1970s.

Fig. External post-tensioning

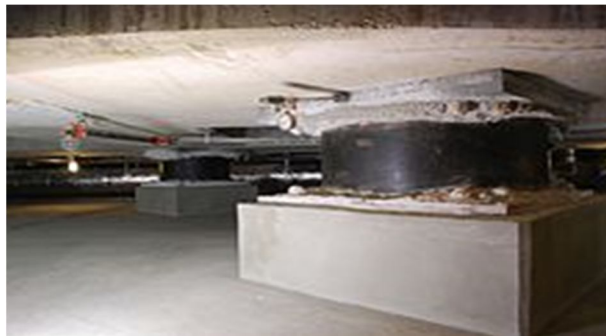
Base isolation is a collection of structural elements of a building that should substantially decouple the building's structure from the shaking ground thus protecting the building's integrity and enhancing its seismic performance. This earthquake engineering technology, which is a kind of seismic vibration control, can be applied both to a newly designed building and to seismic upgrading of existing structures. Normally, excavations are made around the building and the building is separated from the foundations. Steel or reinforced concrete beams replace the connections to the foundations, while under these, the isolating pads, or base isolators, replace the material removed. While the base isolation tends to restrict transmission of the ground motion to the building, it also keeps the building positioned properly over the foundation. Careful attention to detail is required where the building interfaces with the ground, especially at entrances, stairways and ramps, to ensure sufficient relative motion of those structural elements.

Fig. Base isolation

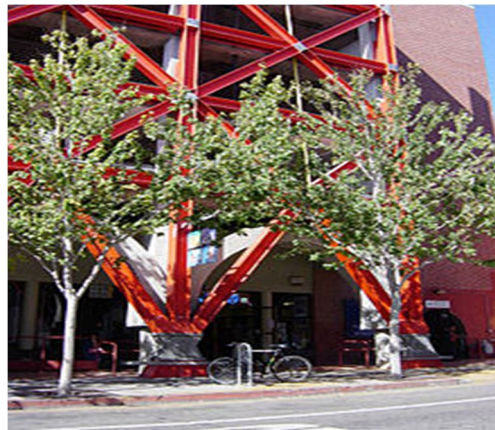
In other circumstances, far greater reinforcement is required. In the structure shown at right — a parking garage over shops — the placement, detailing, and painting of the reinforcement becomes itself an architectural embellishment.

Fig. Massive exterior structure

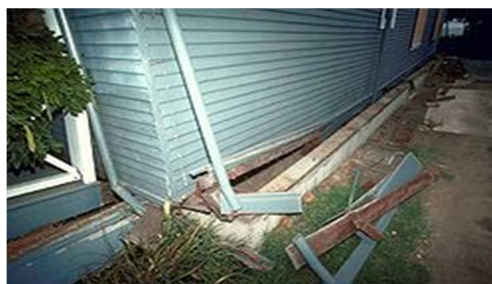
Single or two-story wood-frame domestic structures built on a perimeter or slab foundation are relatively safe in an earthquake, but in many structures built before 1950 the sill plate that sits between the concrete foundation and the floor diaphragm (perimeter foundation) or studwall (slab foundation) may not be sufficiently bolted in. Additionally, older attachments (without substantial corrosion-proofing) may have corroded to a point of weakness. A sideways shock can slide the building entirely off of the foundations or slab.

Fig. sliding off failure

This requires structural grade sheet plywood, often treated for rot resistance. This grade of plywood is made without interior unfilled knots and with more, thinner layers than common plywood. New buildings designed to resist earthquakes will typically use OSB (oriented strand board), sometimes with metal joints between panels, and with well attached stucco covering to enhance its performance. In many modern tract homes, especially those built upon expansive (clay) soil the building is constructed upon a single and relatively thick monolithic slab, kept in one piece by high tensile rods that are stressed after the slab has set. This post stressing places the concrete under compression – a condition under which it is extremely strong in bending and so will not crack under adverse soil conditions.
