# Seismic Retrofit or Rehabilitation of the Structures/Buildings - A Review

Jaineshwar Verma<sup>1</sup>, Satish Parihar<sup>2</sup>

**Abstract:** *This research programme provides solutions addressing the comparative absence of a national platform of knowledge and expertise associated with seismic retrofit or rehabilitation of the multi-storey buildings. This will be achieved through two research objectives that define retrofit solutions for building classes differentiated by:*

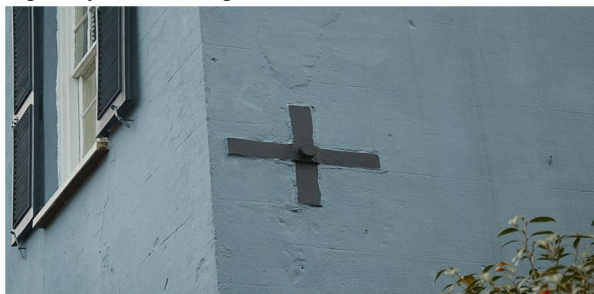
The uses of external post-tensioning for new structural systems have been developed in the past decade. A large-scale U.S./Japan joint research program, unbounded post-tensioning high strength steel tendons have been used to achieve a moment-resisting system that has self-centering capacity.

Pre-stressing can increase the capacity of structural elements such as beam, column and beam-column joints. External pre-stressing has been used for structural upgrade for gravity/live loading since the 1970s.

Fig. External post-tensioning

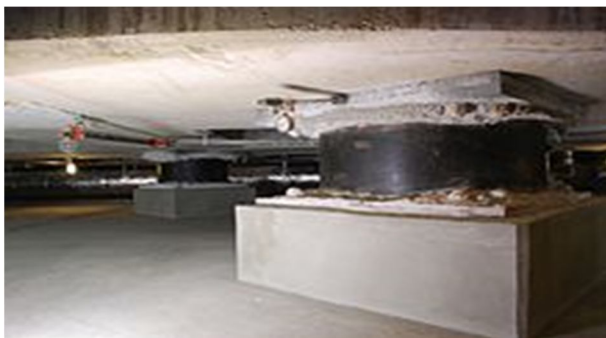
Base isolation is a collection of structural elements of a building that should substantially decouple the building's structure from the shaking ground thus protecting the building's integrity and enhancing its seismic performance. This earthquake engineering technology, which is a kind of seismic vibration control, can be applied both to a newly designed building and to seismic upgrading of existing structures. Normally, excavations are made around the building and the building is separated from the foundations. Steel or reinforced concrete beams replace the connections to the foundations, while under these, the isolating pads, or base isolators, replace the material removed. While the base isolation tends to restrict transmission of the ground motion to the building, it also keeps the building positioned properly over the foundation. Careful attention to detail is required where the building interfaces with the ground, especially at entrances, stairways and ramps, to ensure sufficient relative motion of those structural elements.

Fig. Base isolation

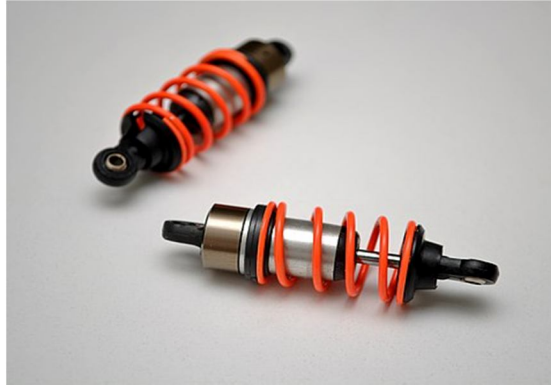
Supplementary dampers absorb the energy of motion and convert it to heat, thus damping resonant effects in structures that are rigidly attached to the ground. In addition to adding energy dissipation capacity to the structure, supplementary damping can reduce the displacement and acceleration demand within the structures. In some cases, the threat of damage does not come from the initial shock itself, but rather from the periodic resonant motion of the structure that repeated ground motion induces. In the practical sense, supplementary dampers act similarly to Shock absorbers used in automotive suspensions.

Fig. Supplementary dampers

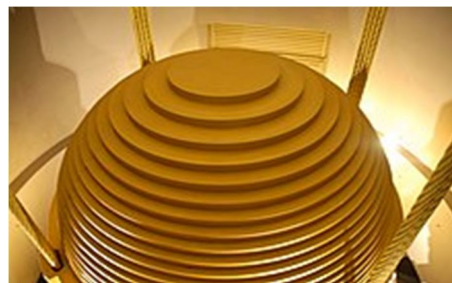
Tuned mass dampers (TMD) employ movable weights on some sort of springs. These are typically employed to reduce wind sway in very tall, light buildings. Similar designs may be employed to impart earthquake resistance in eight to ten story buildings that are prone to destructive earthquake induced resonances.

Fig. Tuned mass dampers

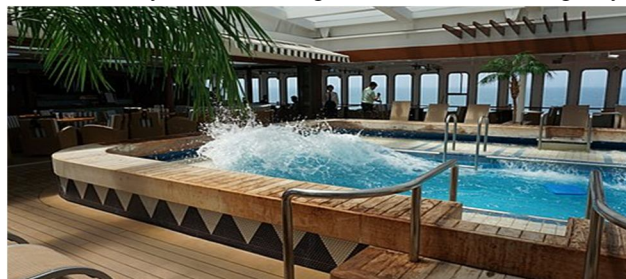
A slosh tank is a large container of low viscosity fluid (usually water) that may be placed at locations in a structure where lateral swaying motions are significant, such as the roof, and tuned to counter the local resonant dynamic motion. During a seismic (or wind) event the fluid in the tank will slosh back and forth with the fluid motion usually directed and controlled by internal baffles – partitions that prevent the tank itself becoming resonant with the structure. A slosh tank is a passive tuned mass damper. In order to be effective the mass of the liquid is usually on the order of 1% to 5% of the mass it is counteracting, and often this requires a significant volume of liquid. In some cases these systems are designed to double as emergency water cisterns for fire suppression.

Fig. slosh tank

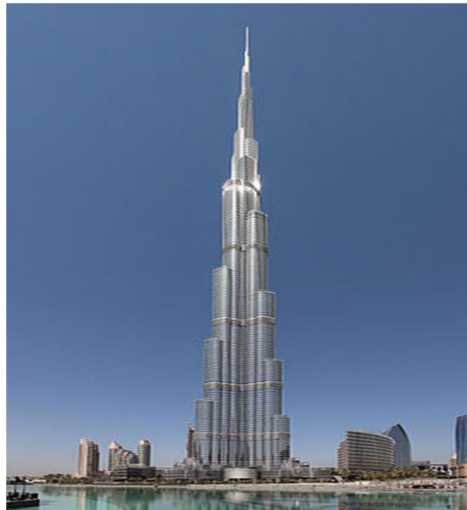
Very tall buildings ("skyscrapers"), when built using modern lightweight materials, might sway uncomfortably (but not dangerously) in certain wind conditions. A solution to this problem is to include at some upper story a large mass, constrained, but free to move within a limited range, and moving on some sort of bearing system such as an air cushion or hydraulic film. Hydraulic pistons, powered by electric pumps and accumulators, are actively driven to counter the wind forces and natural resonances. These may also, if properly designed, be effective in controlling excessive motion – with or without applied power – in an earthquake. In general, though, modern steel frame high rise buildings are not as subject to dangerous motion as are medium rise (eight to ten story) buildings, as the resonant period of a tall and massive building is longer than the approximately one second shocks applied by an earthquake.

Fig. Skyscrapers

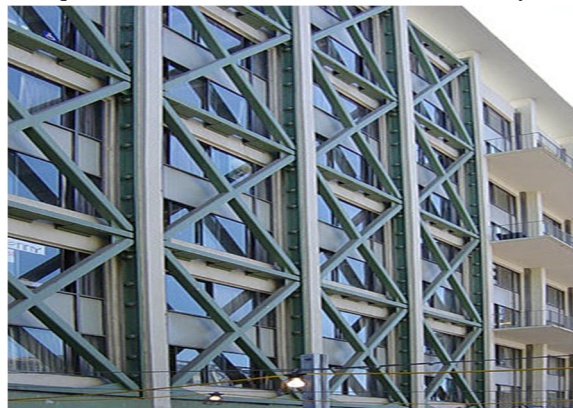
Shown here is an exterior shear reinforcement of a conventional reinforced concrete dormitory building. In this case, there was sufficient vertical strength in the building columns and sufficient shear strength in the lower stories that only limited shear reinforcement was required to make it earthquake resistant for this location near the Hayward fault.

Fig. Infill shear trusses

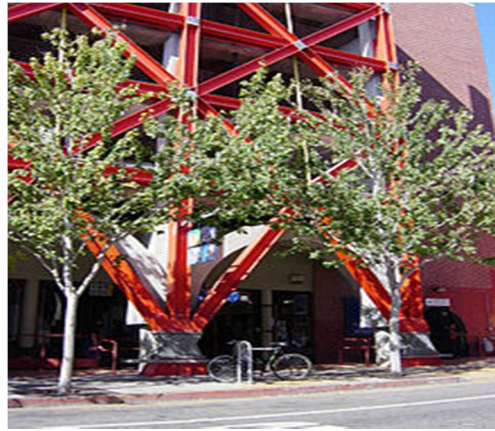
In other circumstances, far greater reinforcement is required. In the structure shown at right — a parking garage over shops — the placement, detailing, and painting of the reinforcement becomes itself an architectural embellishment.

Fig. Massive exterior structure

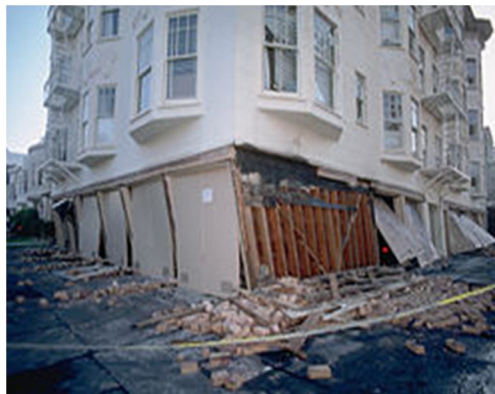
Fig. soft story collapse

This collapse mode is known as soft story collapse. In many buildings the ground level is designed for different uses than the upper levels. Low rise residential structures may be built over parking garages which have large doors on one side. Hotels may have a tall ground floor to allow for a grand entrance or ballrooms. Office buildings may have retail stores on the ground floor with continuous display windows.

Typically, where this type of problem is found, the weak story is reinforced to make it stronger than the floors above by adding shear walls or moment frames. Moment frames consisting of inverted U bents are useful in preserving lower story garage access, while a lower cost solution may be to use shear walls or trusses in several locations, which partially reduce the usefulness for automobile parking but still allow the space to be used for other storage.

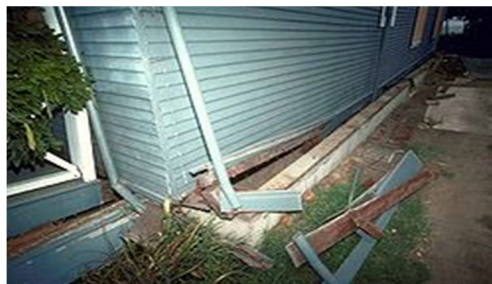
Single or two-story wood-frame domestic structures built on a perimeter or slab foundation are relatively safe in an earthquake, but in many structures built before 1950 the sill plate that sits between the concrete foundation and the floor diaphragm (perimeter foundation) or studwall (slab foundation) may not be sufficiently bolted in. Additionally, older attachments (without substantial corrosion-proofing) may have corroded to a point of weakness. A sideways shock can slide the building entirely off of the foundations or slab.

Fig. sliding off failure

This requires structural grade sheet plywood, often treated for rot resistance. This grade of plywood is made without interior unfilled knots and with more, thinner layers than common plywood. New buildings designed to resist earthquakes will typically use OSB (oriented strand board), sometimes with metal joints between panels, and with well attached stucco covering to enhance its performance. In many modern tract homes, especially those built upon expansive (clay) soil the building is constructed upon a single and relatively thick monolithic slab, kept in one piece by high tensile rods that are stressed after the slab has set. This post stressing places the concrete under compression – a condition under which it is extremely strong in bending and so will not crack under adverse soil conditions.
