Speed and Crash Analysis: A Case Study of Bangalore-Mysore Expressway

The proposed route is the NH 275 expressway from Bangalore to Mysore (toll from Bangalore to Nidaghatta– State of Karnataka) which is 50.5 km long. This study deals with the inventory of roads, the inventory ofsignaling, the inventory of traffic volumes, the study of point speed, the study of speed and delays, and other investigations. Accident data has been collected for the 2017-2022 stretch period and analysis is beingconducted. The goal of the study is to evaluate the road safety audit of a section of the Six-Lane National Highway (NH)-275 and the speed analysis and focus on assessing the benefits of proposed actions as a result of deficiencies identified through the audit process. Missing and medium marks must be made and speed readings should match the speed. Speed restriction and control of speed in curves and straight portionsare also deficient, requiring immediate action.

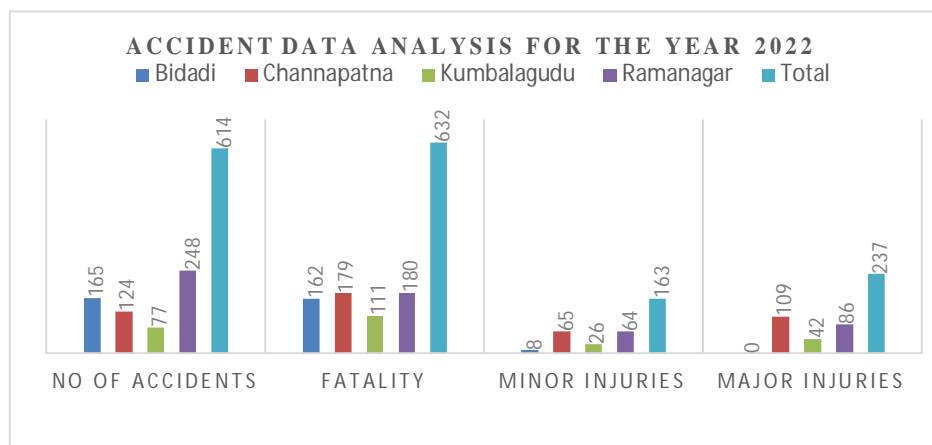
Table 1: Road Accident Statistics of Selected Stretch

Police Station	No of accidents	Fatality	Minor injuries	Major injuries
Bidadi	165	162	8	0
Channapatna	124	179	65	109
Kumbalagudu	77	111	26	42
Ramanagar	248	180	64	86
Total	614	632	163	237

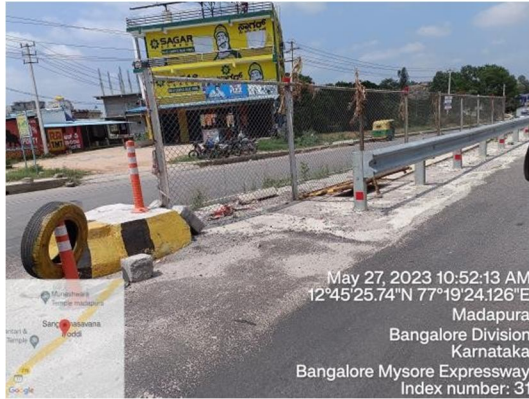
No End Treatment

- 13) Install W-Beam Crash Barriers on the raised median and across deep drainage ditches (with a rough surface).
- 14) The modern solution is to provide the crash cushion or impact attenuators at the end of the W-beam guard rail, which must be flared away.

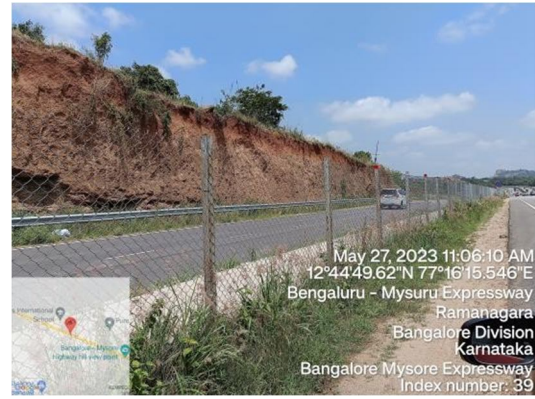
No Slope Protection

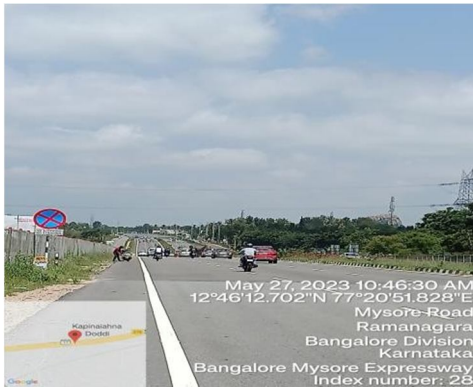
No Dip Sign Board/No Advance Warning

- 3) Guardrails were missing and medians were not adequately maintained; as a result, IRC-119 must be notified that guardrails are present.
- 4) Proper signage that should be posted in accordance with IRC-67 is missing.

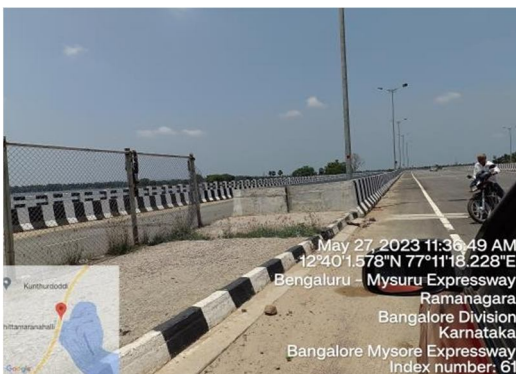
Illegal Approach From Service Road To Nh

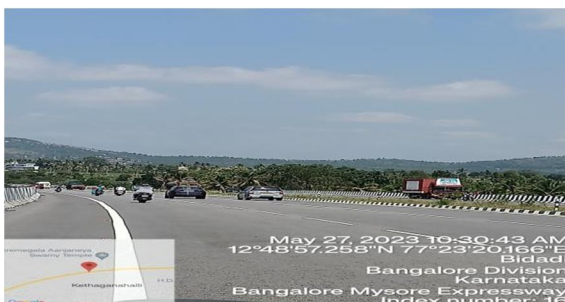
No Advance Warning About Curve/Cheron Marker/Delinator

- 12) Provide a convergent and divergent Chevron marking sign in accordance with the appendix IRC Table A.3 for 2015 8. For the full longitudinal Stretch, provide Edge Line Marking LM24/25 and LaneMarking LM18/19.

- 1) The influence of a warning sign before a sharp bend on approaching and navigating cars will vary depending on where it is placed.
- 2) The location of warning signs affects how drivers lane-position their cars before sharp turns. In comparison to warning signs placed at 0 m or 50 m, drivers would drive more closely to the centerline in tangents if they were placed at 100 m, 200 m, or 400 m before acute curves.

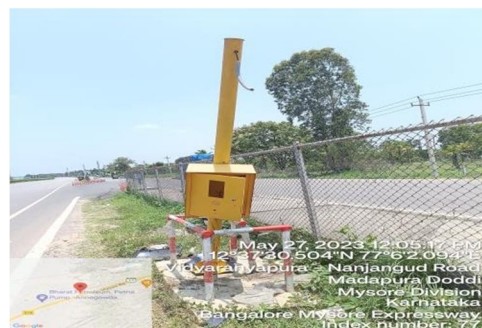
Sos Not Working
