Speed and Crash Analysis: A Case Study of Bangalore-Mysore Expressway

Sanketh Gowda B S¹, Akshatha², Kushal Kumar R³

The proposed route is the NH 275 expressway from Bangalore to Mysore (toll from Bangalore to Nidaghatta– State of Karnataka) which is 50.5 km long. This study deals with the inventory of roads, the inventory ofsignaling, the inventory of traffic volumes, the study of point speed, the study of speed and delays, and other investigations. Accident data has been collected for the 2017-2022 stretch period and analysis is beingconducted. The goal of the study is to evaluate the road safety audit of a section of the Six-Lane National Highway (NH)-275 and the speed analysis and focus on assessing the benefits of proposed actions as a result of deficiencies identified through the audit process. Missing and medium marks must be made and speed readings should match the speed. Speed restriction and control of speed in curves and straight portionsare also deficient, requiring immediate action.

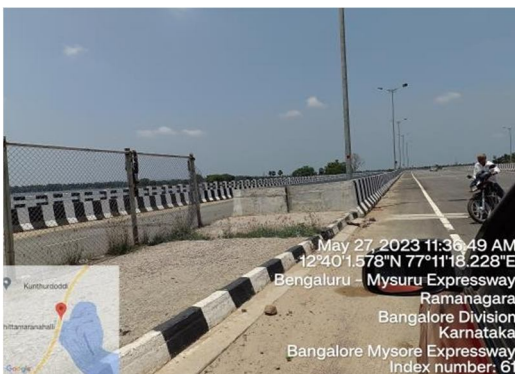
Illegal Approach From Service Road To Nh

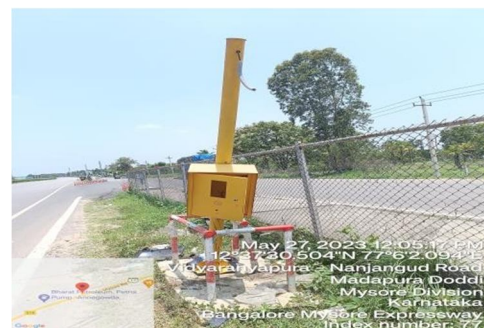
Sos Not Working
