Analysis of Transformer Bushing Failure Based on Frequency Response Analysis (FRA)

A.Srikanth¹, Dr. K. Shashidhar Reddy², Sangeetha C.N³, Dr. M. Surya Kalavathi⁴

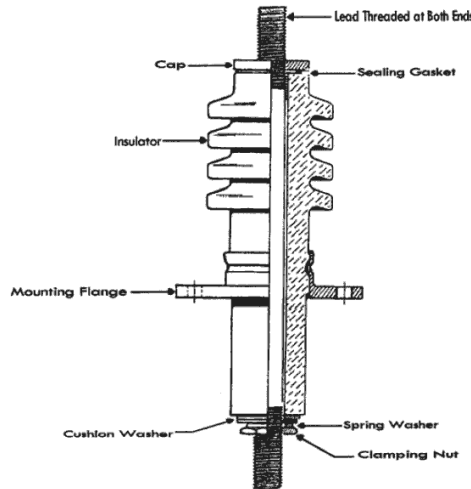
Fig.1. The general constructional diagram of bushing

The power transformer bushing is a sort of porcelain or ebonite post encasing put on the best or side of the transformer tank through which associations are made to the outer circuit. The general constructional points of interest are appeared in Fig.1. The dynamic piece of the bushing comprises of oil Impregnated Paper (OIP) center made from unrivaled review Kraft protecting paper with condenser evaluated layers for field control twisted under strain on focal tube/conductor. The deepest condenser layer is electrically associated with the settling rib through a test tap . The center is dried under warmth and vacuum and afterward impregnated with prevalent review of protecting oil. Porcelain covers on the upper and lower sides of the bushing, oil insulation brilliant elastic gaskets and 'O' rings are held together with the focal tube by methods for an arrangement of intense springs. The settling rib is given a test tap for the estimation of Capacitance and Tan delta, air discharging screw to discharge the air caught in the transformer amid fixing up of oil or can be associated with Buchholz transfer, name plate giving the item points of interest, handle/eyebolt for lifting and space for ring sort CT's on the oil end of the bushing. At the oil end, an epoxy covered anxiety shield or base plate is given to control the high worries in oil inside the transformer. A separable base circular segment shield is accommodated bushing evaluated 245 KV or more. The interceding space between the center of the transformer and the porcelain covers is loaded with uncommonly treated mineral oil under vacuum. A kaleidoscopic (upto 300KV) or attractive (upto 400 KV) oil locate glass is given on the

development bowl . A best terminal is given to interface with the over head line. Arcing horns are given on ask for in the middle of best shield and base plate.

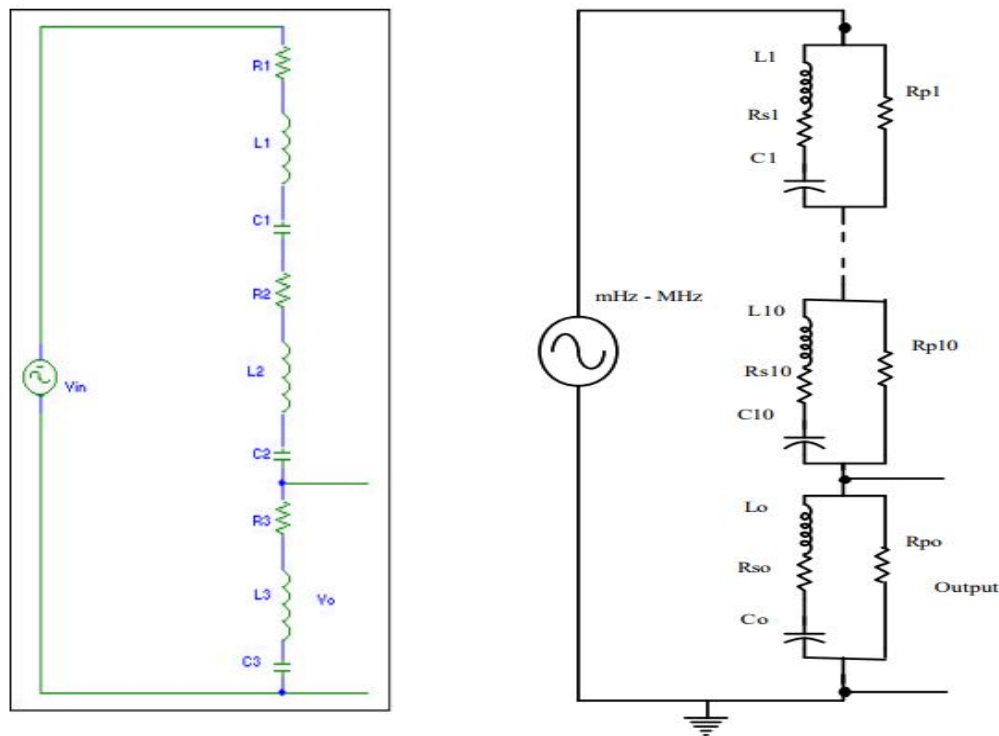
Fig.2. Equivalent Circuit model of bushing

To set up the attainability of utilizing TFA/FRA for fault location in bushings a bushing proportional circuit display is considered. Despite the fact that when all is said in done bushings are considered as non-inductive capacitor and resistive component organize, in the present examination the leftover (self) inductance is additionally considered to think about the impact of this inductance on the affectability of the method. The aggregate misfortunes in the bushing can be either spoken to as a proportional arrangement or parallel insulation. In the models considered both arrangement and parallel portrayals are considered alongside some conceivable

mixes of both arrangement and parallel resistors (eight combinational circuits were dissected). This has been done to build up the affectability of the method to equal circuit portrayal and comprehend the physical wonders.

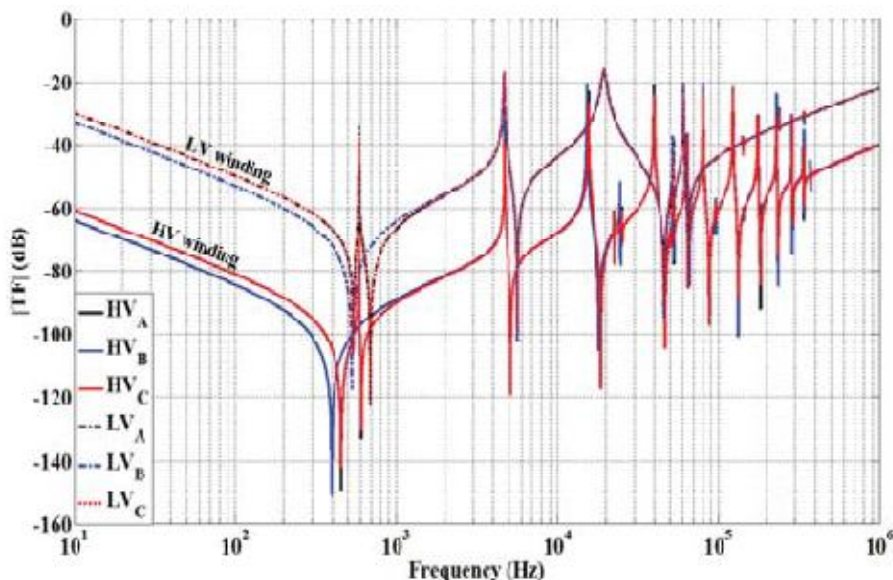
Fig.3. HV and LV windings FRA analysis.

The FRA technique is directed on the 40MVA transformer to get a solid FRA magnitude signature by infusing a variable frequency low amplitude AC voltage (v_{in}) at one terminal of the HV winding, and measuring the reaction signal over another terminal of HV winding (v_{out}). The FRA mark of the 40MVA transformer HV winding is plotted as a transfer function work for the three phases (A, B and C) shown in Figure

As can be found in Fig.3, the marks are characterized by resonances and anti-resonances frequencies over the whole frequency. As the frequency expands, more space harmonics are developed in the winding. At a low frequency range, resonances and anti-resonances frequencies are influenced by the inductive segments while the impact of capacitive segments is appeared in the high frequency run. Further, the FRA marks of the three phases are practically indistinguishable aside from the center (phase B). This variety can be ascribed to the slight contrast of the attractive motion amid phase B (contrasted with phases A and C).

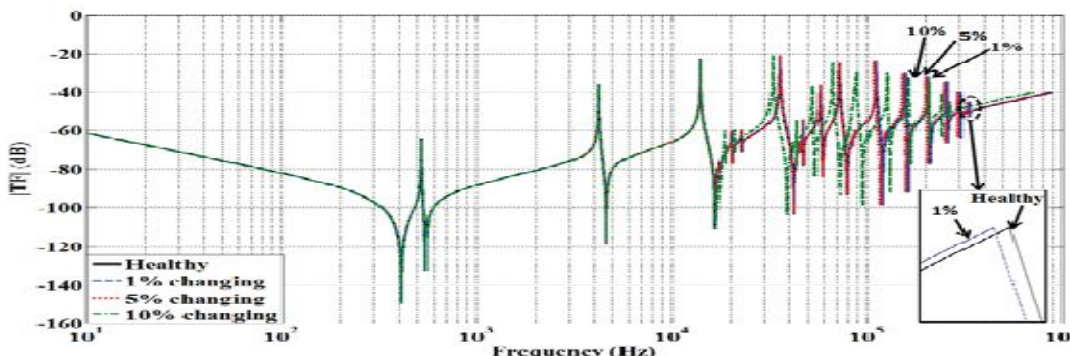
Fig.5. The failure levels of transformer bushing of 40MVA transformer HV winding on FRA signature.

As appeared in Figure 5, the effect of a 1% transformer bushing failure (changing the dielectric elements of transformer bushing by 1%) on the 40MVA transformer HV winding stage A FRA mark is gotten and contrasted with a sound mark. As uncovered Figure5, the sound and broken marks are practically indistinguishable, and it is hard to recognize any variety. A slight variety however can be outwardly recognized in the high recurrence go (50 kHz) when the transformer bushing failure increments to 5% (as appeared in Figure 5) that movements resonances and hostile to resonances frequencies in the high recurrence range to one side. The effect of the transformer bushing failure on the FRA signature turns out to be more articulated when the bushing failure level is expanded by 10% as appeared in Figure 5.
