Frost Effects on Solar Farms in Canada and their Rehabilitation

Kibriya T. ¹

¹ PhD, Black & Veatch Canada Ex Professor/ Head of Civil Engineering, NUST

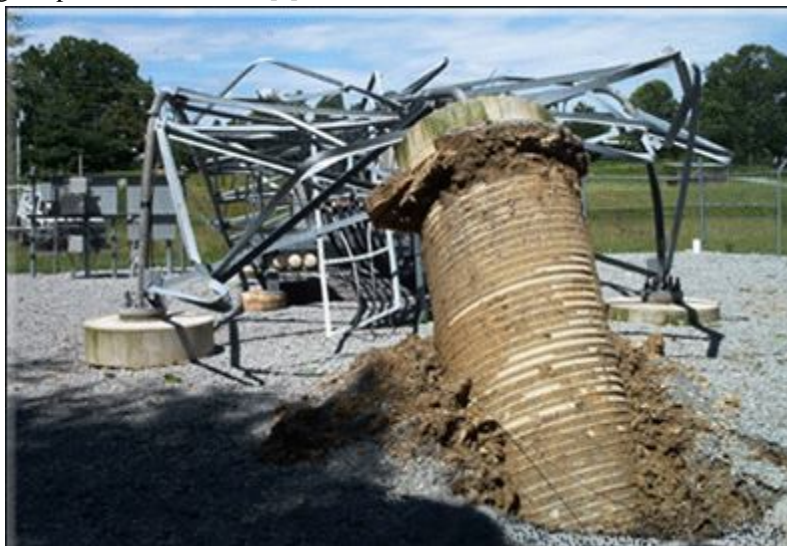
Fig 1:- Tower foundation failing under effects of uplift and frost.

Effects of frost heaving can be devastating. Frost heaving has displaced wood piling upward as much as 14 inches in a single winter season on an Alaska railroad bridge near Fairbanks, Alaska. About 24 inches of frost heaving of piles has been recorded in a single year in Russia. About 8" of uplift has been recorded for a bridge piles at Norman Wells, Northwest Territory, Canada. The maximum recorded cumulative heaving of a pile in a Russian bridge is about 6½ feet. Piling of a bridge, 8 miles southeast of Big Delta, Alaska, has frost heaved by 11 feet. Frost heaving combined with wind uplift can overturn communication towers as shown in Figure 1 below.

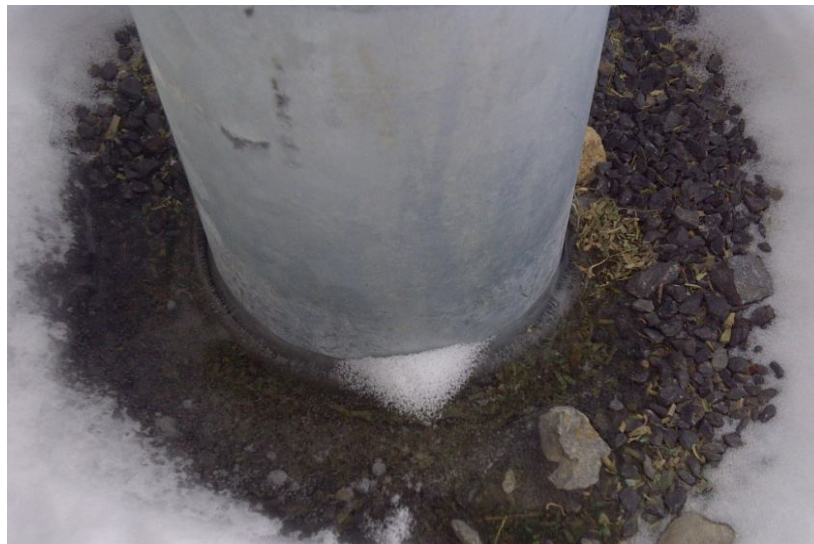
Figure 2. A pile moving out due to frost. The movement can be observed at the base of the pile.

In case some piles are visually observed to have heaved, a complete survey of the area is usually carried out to establish the extent of damage and the precise amount of heave which has occurred. Figure 2 below indicates a pile which has been affected by frost. It is quite rare that complete rows of piles experience uniform heave, though such heave will not create much of issues for the facility. Usually a number of piles in each row will experience pile heave while others will not be affected. The piles experiencing heave are usually observed to experience different values of uplift which are rarely uniform as can be seen in Figure 3. The generally acceptable limits of pile heaving are 36mm of differential heaving based on IEC 61646 (Thin-film terrestrial photovoltaic (PV)

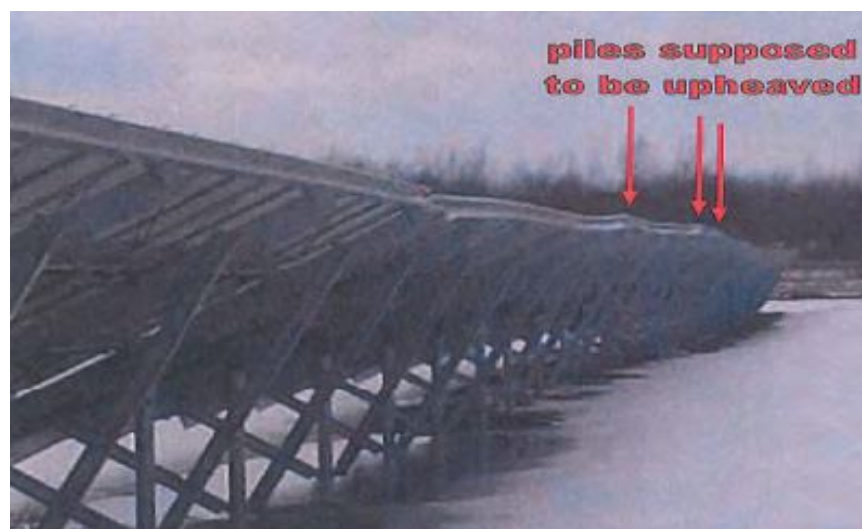
Figure 3. Piles affected by frost showing deformation of the racking.

A close visual inspection of the foundation piles is usually required to establish whether frost heave of the piles has occurred. Such inspections of solar PV facilities are usual when some of the circuits/ arrays in renewable generating solar PV facilities stop producing current or following an extreme event and at the end of every winter season. During such inspections, piles, combiner boxes and their wiring, solar panel racking and the joints where wires connect are closely inspected. Moving out of piles can be felt at the pile-grade interface, damage of combiner boxes at pile-box connections and wires at sockets getting into tension/ breaking, wire connections getting taut/ broken at the junction of racking/ panel connection, bending of racking beams along the longitudinal axis due to differential uplift of the piles.

Modules – “Design qualification and type approval”) since beyond these limits, excess torsional stresses are induced in the solar panels along with additional flexural stresses induced in the racking beams possibly causing structural damage in addition to the connecting wires and connections getting into failure/breakage due to induced tension.
