# Assessment of Groundwater Quality Using ArcGIS for Mangadu

Vishnuvardan Narayanamurthi<sup>1</sup>

<sup>1</sup>Department OD Civil Engineering, Sri Muthukumaran Institute of Technology

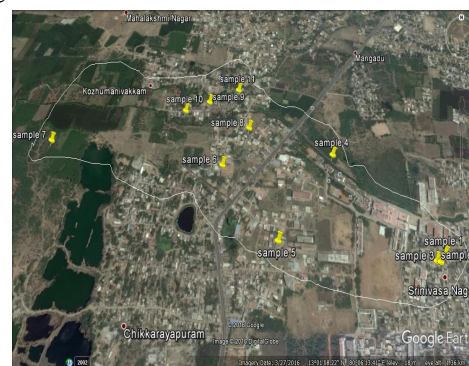
Fig. 2 Study area and Well locations

Kozhumanivakkam & Chikkarayapuram, a suburban of Chennai, In India it is situated in between Kumananchavadi to Kundrathur at a distance of 3 kilometres. Mangadu forms a part of Kanchipuram district.. The drinking water for Mangadu comes from various source points. There are many water reservoirs are situated in and out of Mangadu town, in which city depends upon only specific reservoirs mentioned in Fig 1. As of 2011 India census, In Mangadu, Kozhumanivakkam had a population of 38,188. Males constitute 50% of the population and females 50%. In Mangadu, 11% of the population is under 6 years of age. There are hundreds of houses, institutions are situation in Chikkarayapuram, and water is an important need in these areas. On day one we inspected the Chikkarayapuram area and it surroundings, we found in many residential apartments there where using sump water supply system, only in houses open well and ground water are used. We started our project in Kozumanivakkam and Chikkarayapuram, thus in result we found 11 well backside of our college campus in which we specifically selected bore well. From 11 open well now are in usable condition. These eleven open well are situated in different latitude and longitudinal distance as shown in Table 1. Totally eleven samples in an surrounding of Kozhumanivaakam and Chikkarayapuram around are collected, these sample where collected using plastic containers of two liters. These plastic containers will maintain the temperature of the water and it original characteristics. The samples taken backside of the college campus where taken on the same day, and samples from front side the campus where collected on the same day. The well location points are shown in Fig 2.

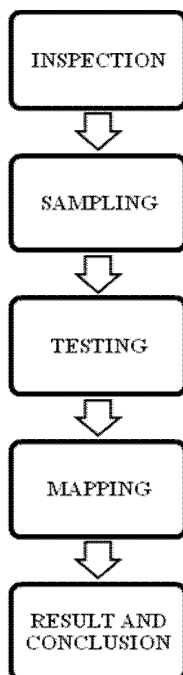
Fig. 3 Methodology flow chart

In general we know the characteristics of groundwater, thus we particularly selected only necessary parameter condition for testing purpose. Usually there is a minimum percentage chances for the presence of BOD (bio-chemical oxygen demand), and COD (chemical oxygen demand), so we neglected these parameter will testing. Thus the selected parameters are Chloride, pH, Turbidity, Calcium, Total Hardness, potassium, sodium, iron and fluoride. Every 10<sup>th</sup> of January, February and March of 2017 the groundwater levels are measured and samples are collected in 2 litre can which are tightly closed thus volatile materials cannot escape. The can are is choose for sampling as they are capable to maintain the temperature. These samples are immediately taken to laboratory and the tests for all parameters are conducted. The tests are conducted according to corresponding Indian Standard codes in laboratory. The results are then mapped in GIS software to find the spatial water quality index map. Fig 3 shows the flow chart of process. The mapping is done with ArcGIS 10.1 software which is widely used around worldwide. The results of samples are tabulated with latitude and longitude and feed to the software and it is made to draw contour maps of each parameter for month of January, February and March of 2017.

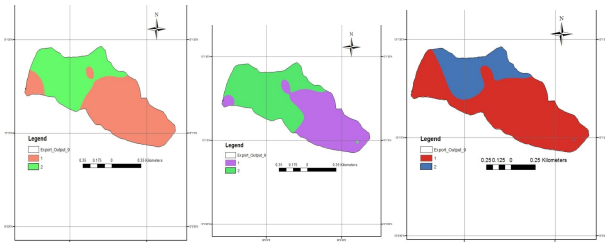
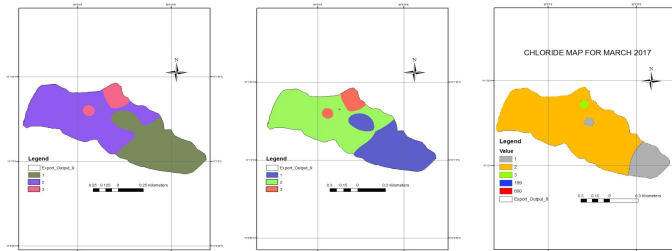
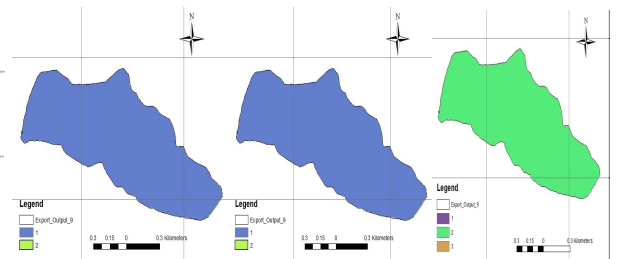
Fig.3. Mapping results with all parameters

From the testing results of water samples from all 11 wells water quality index is the important parameter. The water quality index is good in entire area, but north western zone have little pollution effect but within the desirable limits. The pH parameter is also in desirable limit with slight basic in nature. Chloride parameter is excellent with below 250 ppm in majority area and is little higher in the northern zone in a minor area. No turbidity in month of January and February, but turbidity increased in March due to reduction of water table and frequent pumping. Similar as chlorine calcium and hardness is slightly more in the northern zone compared to other zones. Potassium important mineral in agriculture fertilizer is also in desirable range over most area but slight more in the central area where agriculture is been done. Sodium is of within desirable limits and imparts no pollution. Iron which causes decolouring in white cloths are under desirable limits over all but have a slight higher value in the agricultural area where fertilizers are used. The mapping of each parameter for January, February and March is shown in Fig. 3.

This study produced a groundwater recharge potential map of the Mangadu in Chennai. The result indicates that the most effective groundwater recharge potential zone is located in downstream. In this region the gravelly stratum and agriculture land have high infiltration ability. Additionally, the concentration of drainage also indicates the ability of stream flow to recharge the groundwater system. The groundwater recharge potential zones are demonstrated using the GIS MAPPING, which can be partially modified to study groundwater recharge potential factors (such as changes in terrain and river courses caused by an changes in land utilization) in a small area in the future. The map shows that water quality index at eastern region is little lowered compared to the western region. This is due to the water stagnation and inhabited area in western low areas by which water been started to contamination. Specifically individual parameter analysis shows that chlorine and hardness is slightly more in the northern region due to the nearest factory. In the central agricultural area due to fertilizers and other mineral implementation potassium and iron is slightly more compared to other area Overall the parameters are within limits and can be used for domestic purposes.
