# Improvement in Millipore and Implementation of Pneumatic System for Burr Removal

Akshay Kshatriya<sup>1</sup>, Dhanraj Mane<sup>2</sup>, Rohit Patil<sup>3</sup>

<sup>1,2</sup> UG Students, Department of Mechanical Engineering, Suman Ramesh Tulsiani Tehnical Campus Faculty of Engineering Pune, Maharashtra, India

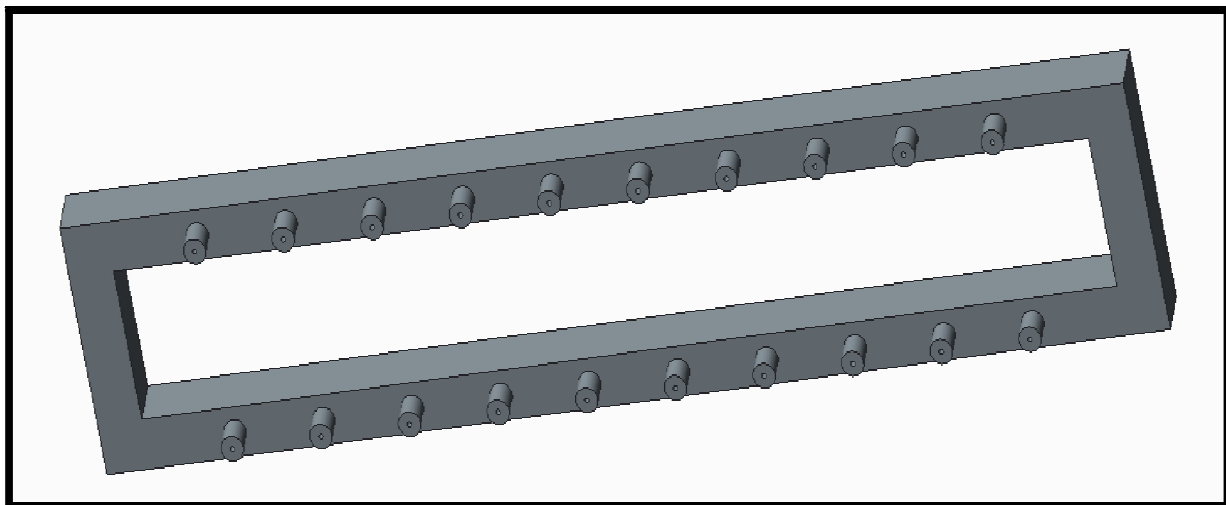
Fig. 3: Design of nozzle plate

It was found that, out of the total contaminants present on the surface of the MB caps about 50-70% contaminants were in the inner surface of the bore of the MB caps. Designing of this nozzle plate helps in proper cleaning of the MB caps, which decreases overall contamination in the cylinder block.

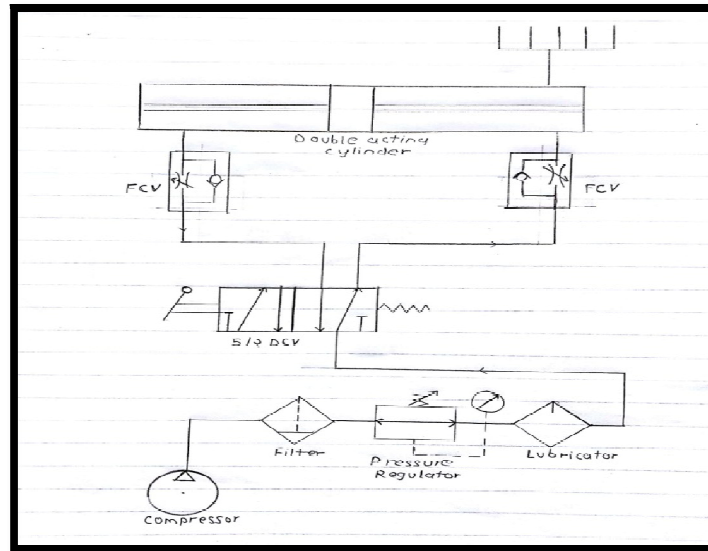
Fig. 4: Pneumatic Circuit

The presence of burr in the cylinder block leads to scratching of the inner surfaces of the cylinder bore also due to the friction which arises between the outer surface of piston and the inner surface of the bore damages the piston. Introducing this pneumatic system, removed the burr present in the cylinder block, hence solved the problem.
