Design Optimisation and Manufacturing Analysis of Transmission Fork of Heavy Motor Vehicles

Harikant Sahu¹, Dheeraj Lal Soni², Shailesh Singh Thakur³

^{1, 2, 3}Mechanical Department, Kalinga University, Raipur

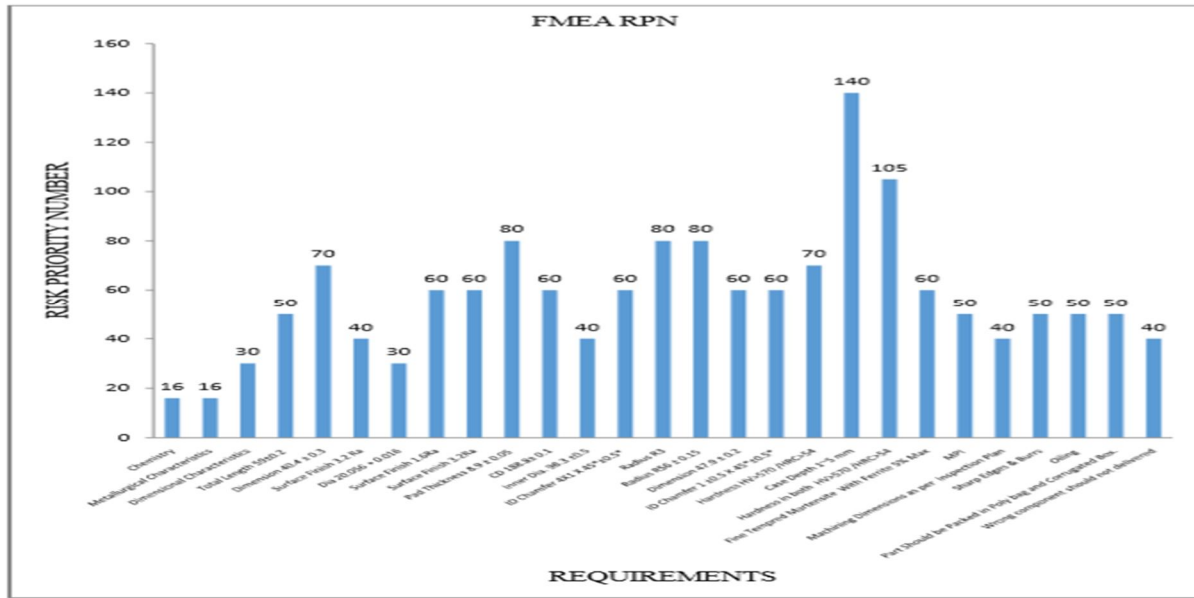
Fig. 3 Process Flow Diagram of 671 Fork

The analysis of the effective modes of process error is based on different parameters to determine the number of risk priorities obtained by the severity of the specifications, the appearance of errors and the detection of dimensions in different operations as shown in the Figure 3.

Risk priority number = severity x occurrence x detection

As should be obvious in the chart between the necessities and the quantity of hazard needs, the most extreme hazard in the fork is to keep up the profundity of the crate of 125 mm and accomplish the hardness in the acceptance procedure.

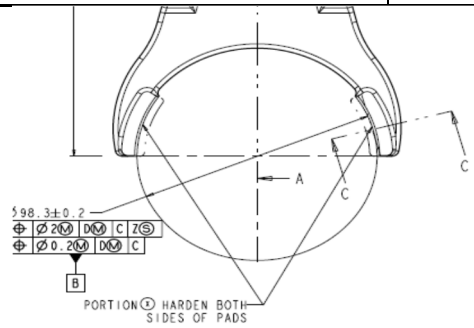
Fig. 5: Material test report of 671 Fork

METALMAN AUTO PVT. LTD. Material Test Report	Form No.	MAPL/F/PROD/51
Report No.	18030018	Date	15/04/2018
Part Name.	FORK, DIFF LOCK SHIFTER	Raw Material	SAE 1541
Part No./ Rev. No.	R140671(218384RE/B)20010302	Raw Material Used	SAE 1541
Material TC	Received Ok	Heat No.	B239(5567)
Heat Treatment Process	Induction Hard. & Temp. (HT30T)	Quantity	10 Nos.
Induction Hardening Batch, done & date	K22C18	Chemical Composition Report No. & Date	
	14/04/2018		
Component Sketch

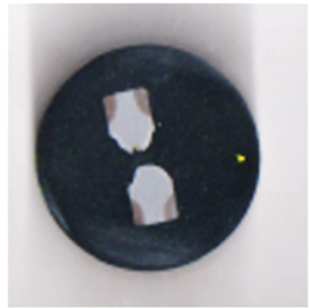
Fig. 7 Case depth testing report

In the induction hardening model we performed the operation in position x as shown in the report, with an energy consumption of 18% after 2 seconds and a lifting speed of 150 mm with a cooling speed of 8 seconds. The depth of the box on a road is 2.4 mm. and b is 2.3 mm based on the required requirements. The microstructure is a well-designed martensite, a microstructure of ferrite core and a perlite with a grain size of 7 mm and a rigidity between 56 and 57 hc as shown in Figure 6 and Figure 7.

Case Depth @ Pad 1 Loc.

Dist. In mm	A	0.1	1.0	2.0	2.4		
Hard. In HV1		630	630	584	395		
Dist. In mm	B	0.1	1.0	2.0	2.3		
Hard. In HV1		623	627	500	260

Case Depth @ Pad 2 Loc.

Dist. In mm	A	0.1	1.0	2.0	2.5		
Hard. In HV1		613	652	605	304		
Dist. In mm	B	0.1	1.0	2.0	2.2		
Hard. In HV1		664	675	522	271

Pattern Photo

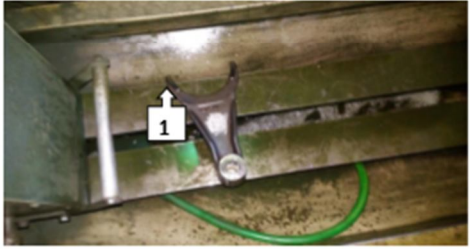
Fig. 8 M.P.I testing report

MPI testing is a kind of non-destructive test to detect cracks with a coil of approximately 1250 to 1400 amps with an oil concentration of 3.15- and 0.3-ml. Check the cracks that generate a magnetic field in the fork, apply the oil flow and then detect in the presence of UV rays. On the one hand, the magnetic field is generated and, on the other hand, the stress control generated by the ultraviolet rays to create cracks in the part during the process. 100% of the parts must be checked in MPI to eliminate the cause of the field failure in the vehicle function. In this process, the following parameters should be maintained as shown in fig 8.

METALMAN		M.P.I. Check Sheet				Format No.:- MAPL/F/QC/110	
						Rev No. 00	
Process Parameter details:-	1. Machine No. 01	3. Demagnetize :- Working	4. Defective Sample:-Checked	7. Circular coil:-Working

2. Oil flow:- Yes	4. Bulb Intensity:- ok	2. Pie Testing:-Checked	8. L Coil :- Working			
	9. Oil level:-Yes	10. Calibration Status:- Yes	11.No. of Strokes :- 1	12.Type of Magnitized:- Combined

13. Coil knob setting:- 2+2High	14. L. Knob Setting:- 3	15.Copper bush availability:- N.A	OK			
Part details	Part Length:- 212 mm		Operator Name:				
	Part Name: Fork		Part Grade :- SAE-1541				
	Part Max. Dia :- 42 mm		Part Condition:- Forged, Bright bar:- Forged				
	Induction Batch No.- K28C18		Heat No.- THE FORGING				
Date:- 16.04.18		Lot Qty.- 10 NOS					
Setup	Required Current:-	Circular Coil:- 1250 ± 100	L. Coil :- 3.00 Kat Min.	Oil Concentrate :- 0.2~0.4 ml/ltr			
	Actual :-	1400 AMP	3.15 KAT	0.3 ml			
	Sl No.	Time	Quantity			Demagnetize	Loading pattern photograph
			Checked	OK	NOT OK		
	1	8:00 PM	5	5	0	Yes

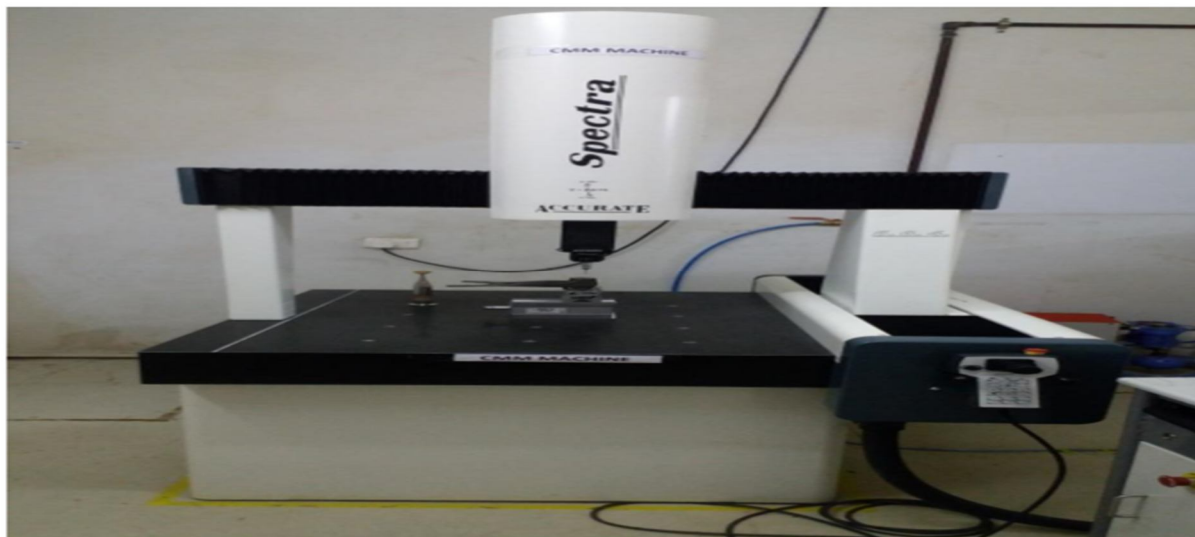
Figure 9: CMM testing machine

In the test section of the test machine of the test bench to control the adjacent dimensions, which is the required position of the indirect hole and the CD tent, which is the main dimension of the set. In CMM, the test was perpendicular and the parallelism and angle of the hole crossed within tolerance and strict specifications as can be seen in Figure 9.
