# Impact of Artesian Pressure on Foundation: A Case Study

**Abstract:** The case study covered in this paper is a unique attempt to investigate the cases of bottom plug failure. The safe and most elegant method of construction has been proposed in artesian conditions. The bridge across Chambal River on the Ater-Jaitpur Highway has been studied. The site has multiple layers with artesian ground water flow at different depths. The foundation design must be based on two salient features, bed boiling (quick condition) should not occur even in the case of maximum scour, a minimum soil cushion thickness should be compulsorily available at the time of construction. This cushion must be between foundation level and strata having artesian flow. In case of Low pressure Construction of false Steining to neutralize the effect of Artesian Pressure. Deep foundations embedded in artesian aquifers can be the cause of serious problems during, and more importantly, after their installation, due to a disproportionately high risk of washout during construction. In the case of well foundation, the failure in the bottom plug, error in sinking the well, faults in false Steining can trigger the sinking o

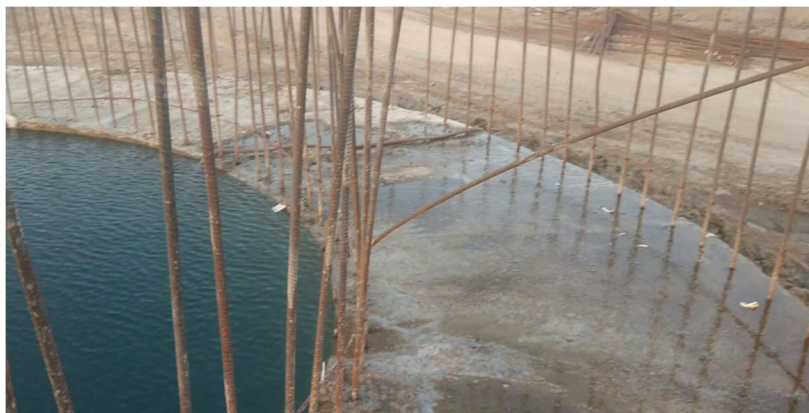
Fig 1:- Artesian Water Pressure

The water embedded in the underground gravel, sand and rock. The water has the pressure and it flows. This layer of the soil is called as aquifer. The positive pressure in water is responsible for the filling of water inside a well excavated for the foundation and this becomes constant when the hydrostatic balance is obtained. In case of intrusion of the aquifer open to atmospheric pressure like well, shaft or borehole initiates the up thrust and it leads to soil erosion finally instability in the civil structures. The deep foundation like well foundation having the artesian layers can result into the failure of the foundation after the construction. The soil erosion is triggered by sudden artesian pressure and the movement is naturally upwards. The global practice has been the use of water circulation drilling or polymer bentonite slurry to flush the well. The platforms above the ground level are constructed in the soil having embedded artesian layers. This method has been popular over several decades. But, this method is not foolproof and the evidence is the failure of few deep foundations like one discussed in this paper. Deep foundations under the artesian conditions can create hazards and lead to big problems during, and post installation. This is due to the high risk of soil erosion resulting from the foundation elements sometimes work like pathways or pits responsible for the upward movement of soil particles carried by groundwater following the newly introduced pressure relief openings to surface. This has been the most popular because it can manage the risks associated with breaching of the confining layer of an artesian aquifer.

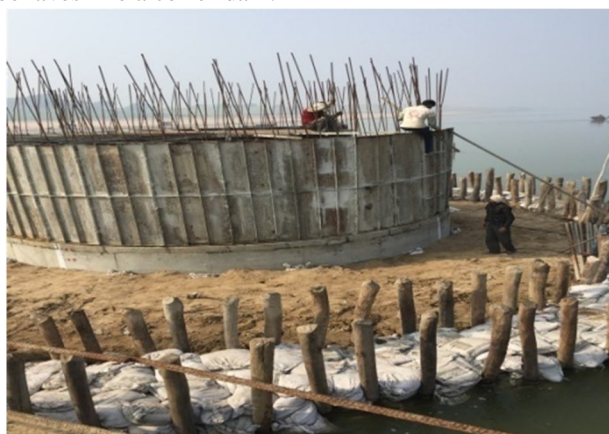
Fig 3 False Steining

1) *The Construction of False Steining:* The deep foundations where low water pressure exists, the false Steining is constructed to counteract the artesian pressure. This is the solution which protects the bridge structures over entire service period. The local artesian head is relieved by the construction of false Steining and this requires expert technical workforce. The wooden piles are provided below at 300 mm/cc spacing. This results into water tight surroundings and thus responsible for the stability of the soil. . The platform is constructed with double the diameter of the well and piles are driven along the boundary and sand bags are placed between the piles. This behaves like a coffer dam.

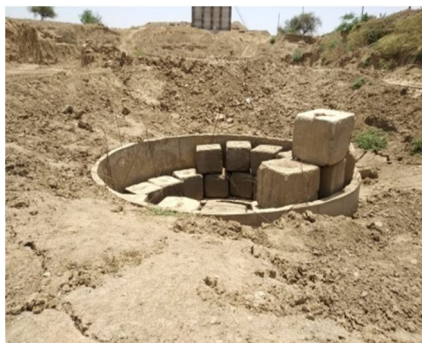
Fig 4 False Steining

Although, to neutralize the effect of both false Steining is considered as a effective solution by building false Steining up to the height of artesian head above ground level will neutralize the negative artesian pressure.

The afflux effect can be neutralized by providing, false Steining with thickness of 300 mm and 4 m height which can be dismantled at the designed top level of the well cap.
