Magnetic Particle Inspection of Transmission Shaft using Machine Vision

Prof. Narendra Patil¹, Ameya Amar Karode², Sanket Gautam Gosavi³, Pranav Jayant Mahajan⁴

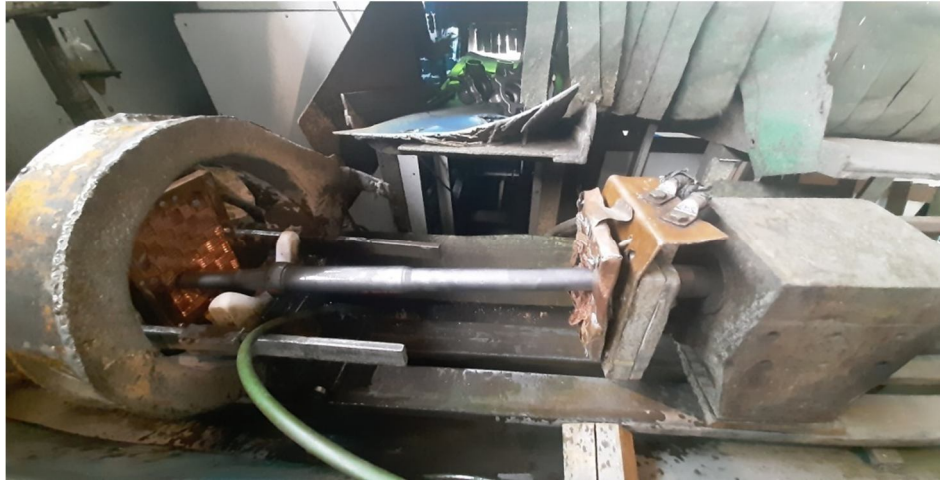
Fig I.1 Conventional System

In conventional system the shaft is mounted between two magnetic copper coils as shown in the figure and the worker sprays the ferromagnetic solution on it with the help of a pipe. This magnetizes the shaft after which it is sent to the UV light room for inspection. The worker in the UV light room then inspects the job for cracks under UV light. The time required for it is approximately 50 seconds. Now if the worker is working in second or third shift in the industry, the chances of him making manual errors due to fatigue are high and the time of inspection due to fatigue also increases. Hence, to eliminate the manual errors a new automated system has been proposed. In this system, the shaft will be mounted on two roller supports and a stepper motor coupled to it at one end to rotate the shaft. A rack and pinion mechanism will allow the camera to move along the length of the shaft. A DC motor will be coupled to the pinion and the UV will be mounted adjacent to the camera as shown in the figure.

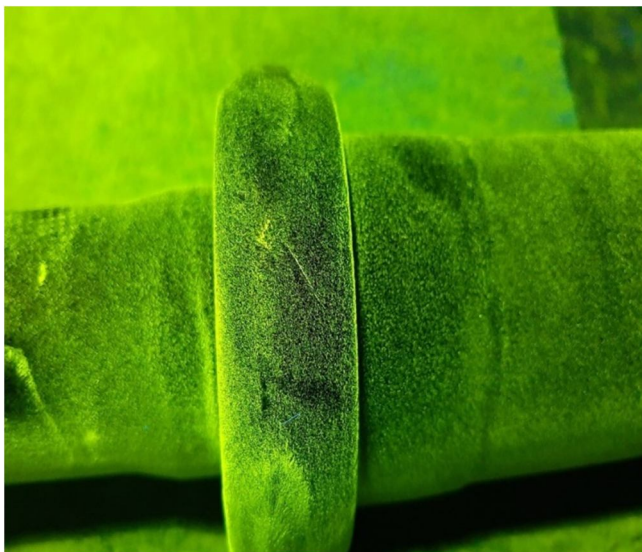
Fig II. 5 Crack detected under UV Light
