# Corrosion - Fatigue Characteristics of 4043 Aluminium Alloy

Mr. L. R Harsha<sup>1</sup>, Mr. V Chandan<sup>2</sup>, Dr. G. B Krishnappa<sup>3</sup>

**Abstract:** *The paper provides the information of corrosion - fatigue characteristics of aluminium alloy 4043 (AA4043). Casted aluminium alloy 4043 was used for tensile and fatigue test with and without corrosion. The ultimate tensile strength obtained from tensile test and was used to conduct fatigue test on rotating bending fatigue testing machine as per RR Moore rotating bending fatigue test for un-corroded specimens for different stress values and compared the results with that of corroded specimens. The S-N curves were plotted. It is found that the corroded specimen became weak due to formation of oxides on its surface which resulted in early failure.*

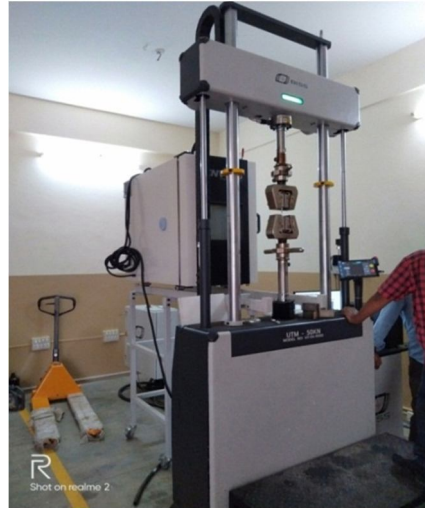
Fig 1: Universal Testing Machine

The tensile test was conducted on Universal Testing Machine as shown in Fig.1 as per ASTM E8/E8M-13a standards. Test is conducted on three specimens and average of the three is considered for further calculations. The average ultimate tensile stress obtained is 345.42 MPa.

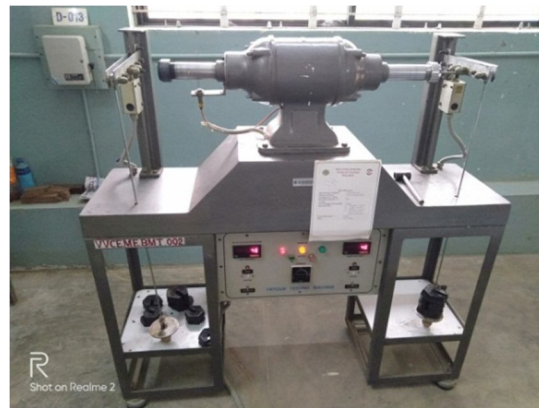
Fig 2: Rotating Bending fatigue testing machine

The salt solution is prepared as per ASTM D1141-98. The test specimens were dipped in the salt solution and allowed them to corrode for 17 days and the amount of corrosion on each specimen is found out by weight loss method. To perform a fatigue test, the test sample is placed in rotating bending fatigue testing machine and loaded under the pre-calculated bending stress and tested till failure.

Two set of specimens (corroded and un –corroded) are tested in rotating bending fatigue testing machine for different loads. The test results are tabulated and are shown in Table III and graph 1.

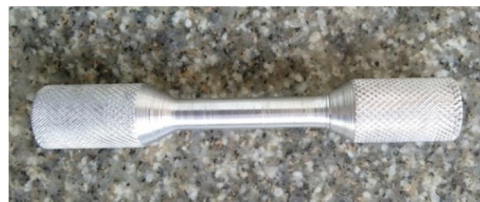
Fig 3: Tensile test specimen

AA4043 is obtained in the form of a cylindrical rod of 16mm diameter through casting process and it is subjected to machining process to the required shape as per tensile and fatigue test confirming to ASTM standards (ASTM D1141-98 to prepare salt solution, ASTM E8/E8M-13a for tensile test, RR Moore rotating bending fatigue test for fatigue test). Firstly, tensile test is conducted on three un-corroded specimens to find out its ultimate tensile strength and using this ultimate strength, fatigue test is conducted on un-corroded and corroded specimens.

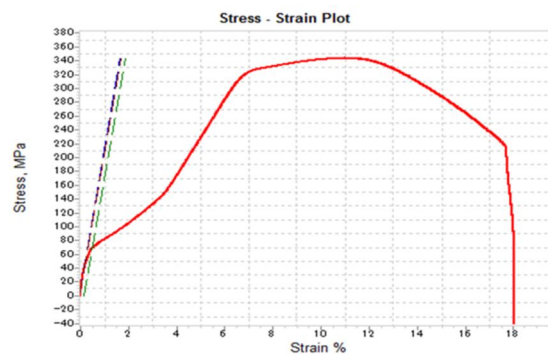
Fig 4: Stress v/s Strain plot

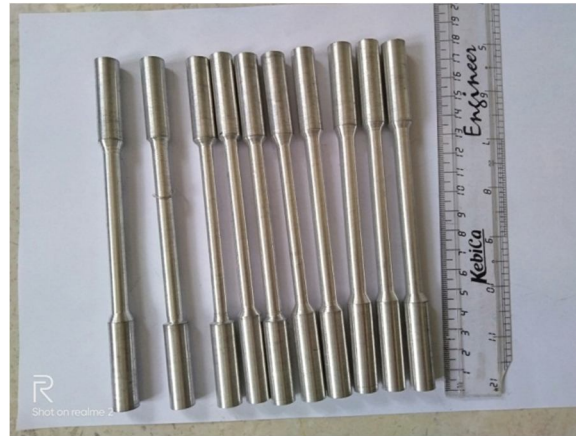
Fig 5: Fatigue test specimens

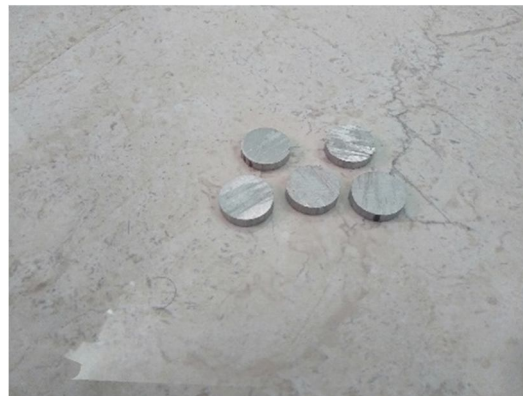
Fig 6: Sample corrosion specimens

A sample corrosion test is carried out to find the corrosiveness of the salt water. Five small specimens of 16 mm diameter and thickness 5mm (Fig.6) are kept in salt solution for 17 days and allowed to corrode and the mass of the specimens is noted before and after corrosion. Test results are shown in Table II. Actual test specimens are also dipped in salt water for 17 days to corrode the same (Fig.7)

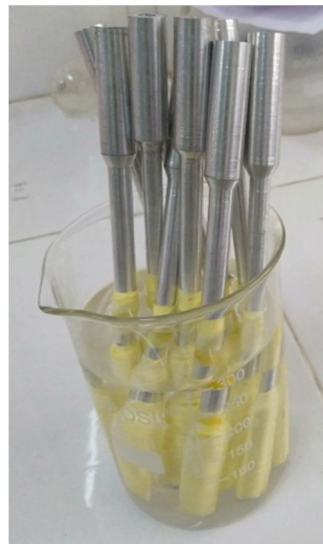
Fig 7: Specimens dipped in salt solution

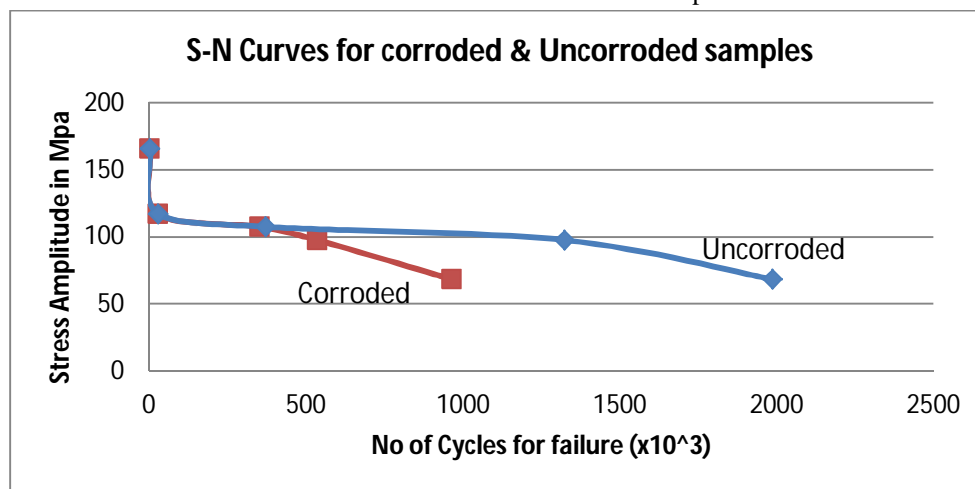
GRAPH I  
S-N Curves For Corroded & Un-Corroded Specimens

Trial no	Stress Amplitude (MPa)	Percentage of Ultimate tensile stress	No. of Cycles required for Un-corroded Specimen to fail ( $\times 10^3$ )	No of Cycles required for Corroded Specimen to fail ( $\times 10^3$ )
1	165.9	48	27	05
2	117.13	34	39	16
3	107.4	31	372	352
4	97.6	28	1323	536
5	68.3	20	1886	965

Fatigue test was conducted for both corroded and un-corroded specimens. It was found that the corroded specimens lost their fatigue strength and hence failed at minimum number of cycles compared to un-corroded specimens.
