Road Safety Audit of SH-26 Section from Khandwa to Chhegaon Makhan - A Case Study (M.P.) India

Siddhant Karahe¹, Dr. Sunil Sugandhi²

¹P.G.scholar, Transportation Engineering, ²Professor and Dean Academic, Civil Engineering Department of Jawaharlal Institute Of Technology Borawan, Khargone (M.P) India

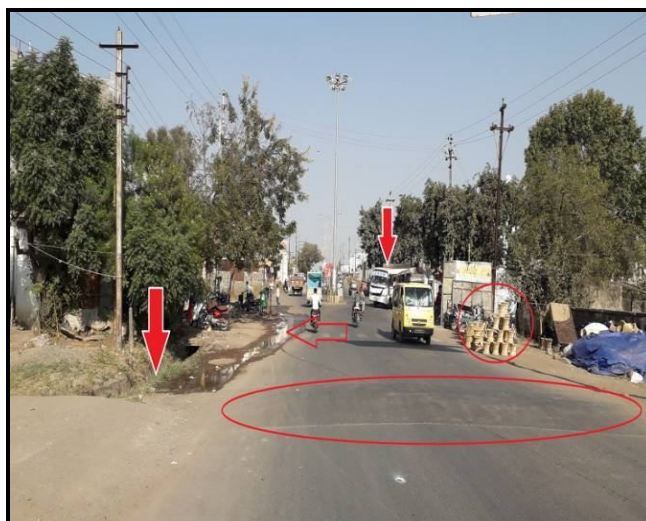
Figure 2:- Passenger boarding and alighting, Drainage problem, road side activity, non-engineered speed breaker at intersection.at bhairaw mandir square

Figure 2 showed that in this intersection Road markings missing, lack of pedestrian facilities and Passenger boarding and alighting at this junction. Road markings should be there to guide the traffic and lane division. Zebra crossings should be there for the safety of pedestrians. Bus stops causes' traffic jams on the highway and even accidents. It was not covered properly and the drainage water flooded at this junction which directly turned in to a major accidental creating situation among pedestrians. At bhairaw mandir square speed-breaker are not marked or poorly marked and contributing to accidents of different natures.

- A. At Bhairaw mandir square bus stops should be 60 meters away from the junction and Passenger boarding and alighting at junction should be avoided and Various roadside activities like temporary shops, tea-stalls, shops, advertising boards and private construction materials should be removed from the shoulder at junction, Retro-reflective materials or paintings to be used at all speed reducing devices, necessary regulatory and warning signs with clear visibility and retro-reflective markings on pavement, Properly marking on speed breaker with sign board.

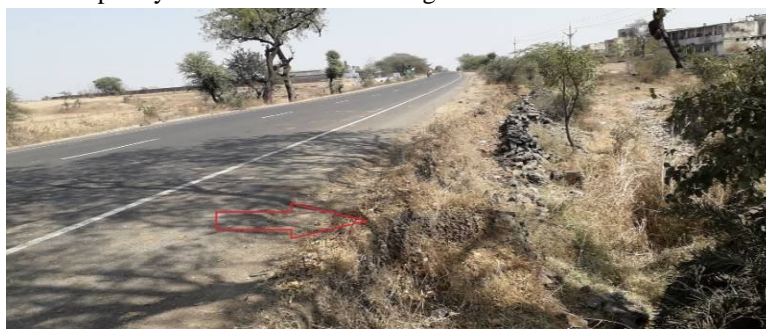
Figure 3:- steep embankments at near dondwada village.

Figure 3 showed that highway as constructed on high (10 to 15 feet) and steep embankments, batter slopes are quite dangerous for run off vehicles. According to Transport Research Laboratory (as cited in Handbook of Highway Safety Design and Operating Practices (1978), Federal Highway Administration, Department of Transportation, USA), standard/ safe batter slope should be between 1:4- 1:6 which is almost absent to the highway. According to locals, many accidents on this highway involve vehicles leaving the road and being in collision with hazardous obstacles such as trees or simply rolling down the high embankment.

- B. At near dondwada village the highway being constructed on high embankments, provision of safe batter slopes is costly. The risk of accidents can be significantly reduced by the use of guard rails or barriers. The purpose of the barrier is to absorb the impact with as little overall severity as possible.

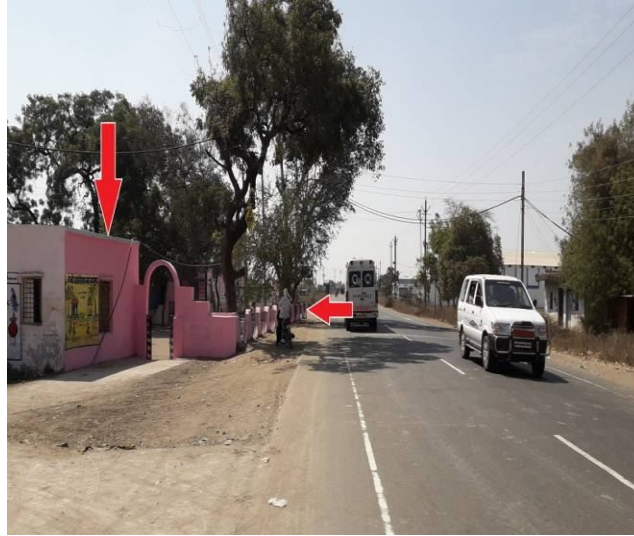
Figure 4:- School is very close to highway at Dondwada village (SH-26)

Figure 4 showed that there is a school on the left side of the highway at Dondwada village. It is approximately nearby village, and it appears most of the young children attending the school walk along the edge of the highway from the village. With an unpaved shoulder, children sometimes walk on the road pavement. This exposes them to a risk of a collision with fast-moving traffic and at Dondwada Village School is very close to highway (SH-26) this place is hazardous and contributing to accident. And the Boundary wall of school is on the shoulder this place is hazardous and contributing to accident. Posing surprise situations to drivers at night.

- C. At dondwada village appropriate signs should be erected to warn through traffics about school zones. In school zone area, raised sidewalks/ separated sidewalks should be provided. It is not possible to remove boundary of school but if we provide Retro-reflective materials or paintings to be used at boundary wall and Sign board for warning also provided.

- E. Pedestrian crossing markings, speed breaker on both side (enter& exist of school zone) with markings should be provided and speed limit sign board to control the speed of the vehicle. Appropriate speed reducing devices prior to the locations are to be provided. Crosswalks with appropriate marking and delineations should be placed. Appropriate signs should be erected to warn through traffics about school zones.

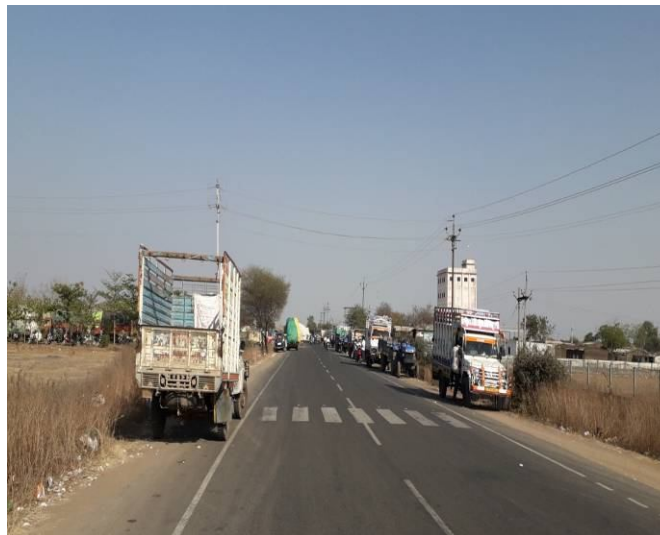
Figure 5:- No independent parking space was provided on road side at In Front of and approx near to Shree Dadaji Institute of technology & science (SH26)

Figure 5 showed The industries has been in working condition where in the peak hours the people working in Industries gets off their duties at that time this path becomes sensitive. The workers of the industries mainly used the two wheelers to reach to homes from industries. On the left side the turn of village it helps to that village. Along this highway the provisions for or restrictions on parking is not satisfactory in relation to traffic safety. There exist no signs or markings allowing or prohibiting parking. Parking manoeuvre is not well-suited with the safety of the highway. Parking on the carriageway/ shoulder creates congestion and compels through vehicles to use opposite lane on the highway. Illegal parking/ stoppage makes movement of through vehicles unsafe. Pedestrians are compelled to use shoulder and carriageway for walking and have to wait for vehicles at shoulder. Pedestrian crossing of the road becomes unsafe and pedestrians are unable to use walkway.

No independent parking space was provided on road side therefore, the vehicles parked randomly on road side and covered a very wide area of the road way. The trucks are waiting for their turn to load the material. Unlit Parked vehicles were observed which were posing surprise situations for running vehicles.

- D. In Front of and approx near to Shree Dadaji Institute of technology & science (SH26) Parking of vehicles at on the highway should be banned. In unavoidable circumstances (vehicle under repair), appropriate lighting should be arranged to make these vehicles visible

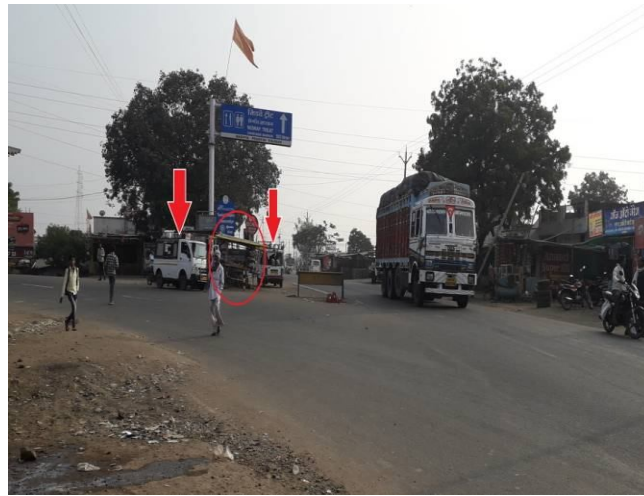
Figure 6:- Required junction improvement and Parking/ stoppage of vehicle on the intersection at SH 26 connects to SH 27 (T-intersection)

Figure 6 showed along this highway the provisions for or restrictions on parking are not satisfactory in relation to traffic safety. The sight distance at intersections and along the route is affected by parked vehicles. Parking/stoppage/ passenger boarding and alighting on the T-intersection congestion and compels through vehicles to use opposite lane on the highway. Illegal parking/ stoppage at junctions makes turning movements to/from highway unsafe. Illegal parking/ stoppage makes movement of through vehicles unsafe. Temporary shop on the carriageway at T-junction posing surprise situations for drivers Signboards, billboards, banners, posters etc on T-junction restricting sight distance.
