# Study on Process and Time Optimization using Flow Process Chart, Time Study and Critical Path

**Abstract:** *The main aim of the study is to learn and analyze the processes involved in engine repairing and reconditioning section at MSRTC, Central Workshop, Nagpur and to suggest possible Movements to optimize the process to increase efficiency and the output of the plant.*

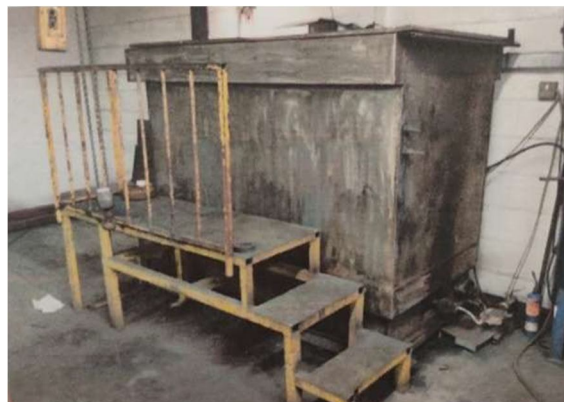
Fig. 3 Degreasing Chamber

In degreasing plant, separated parts and dump in degreasing tank, Trichloroethylene ( $C_2HCL_3$ ) is poured in the tank and tank is then heated at constant temperature. Fumes generated in the tank helps in cleaning of parts.

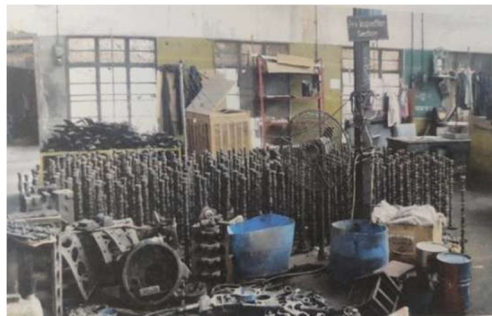
Fig.4 Pre inspection section

Dismantled parts are inspected in this section and the rejected parts are scrapped. The usable parts are then distributed to different sections. In this section the parts are also cleaned and inspected for any damage.

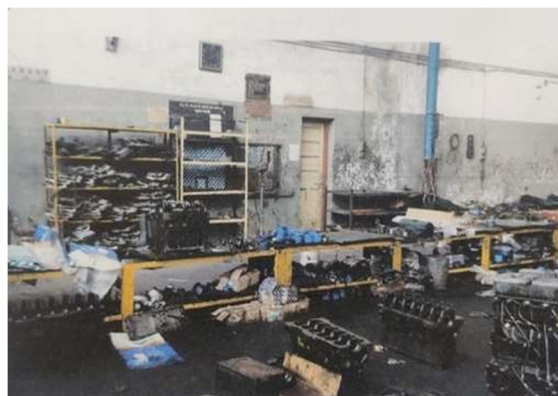
Fig. 5 Assembly area

Parts from different sections are brought and assembled in the assembly section.

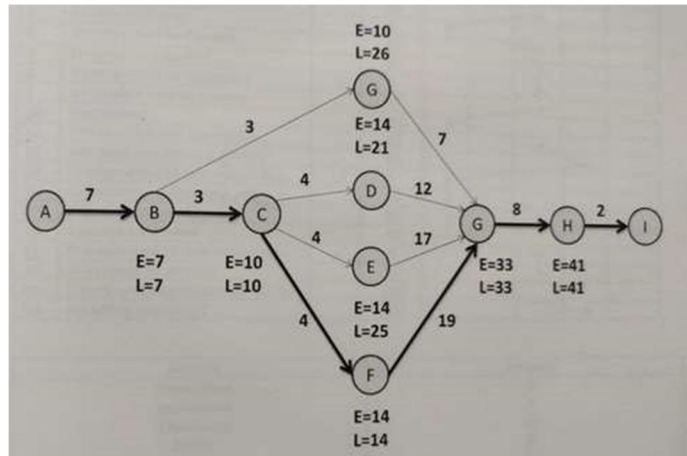
C. Critical Path

Activity	Precedence	Description	Duration (Hrs)
A	---	Stripping	7
B	A	Degreasing	3
C	B	Pre-inspection	4
D	C	Auto machine shop	12
E	C	Sub Assembly shop	17
F	C	General machine shop	19
G	B	F.I. pump section	7
H	D,E,F,G	Assembly line	8
I	H	Testing Section	2
J	I	ODS section	---
