Comparative Study of High-Rise Residential Building for Progressive Collapse as per Indian & American Code

Anurag Jamankar¹, Prof. Atul B. Pujari²

^{1,2}ME Structure, KJCOMER, Pune, Savitribai Phule Pune University.

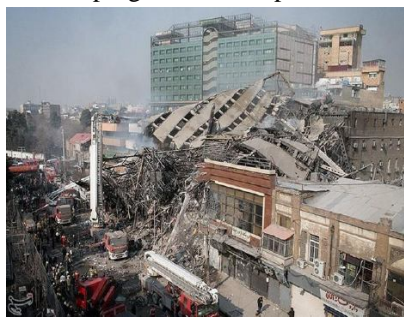
Fig 1 collapse of a part of the Ronan Point apartment

Progressive collapse was appeared not so a long time ago. For the first time engineers faced with this phenomenon in 1968 when the Ronan Point apartment building was destroyed. A gas explosion in a corner on the 18th floor blew out the exterior wall panel and failure of the corner bay of the building spread upward to the roof structure and down till the ground level, but the entire building did not suffer. progressive collapse has been used to describe the propagate of an initial local failure in a manner like a chain reaction that causes to partial or total collapse of the structure. The basic characteristic of the progressive collapse that the end state of the destructions is disproportionately greater than the failure that made the collapse. Catastrophic failures of structures, due to progressive failure, have occurred, therefore highlighting the need to design against such events. Extensive research has been conducted into steel structures; however, the response of existing RCC frame structure located in to accidental or malicious events is not fully understood while its design. Residential building are prone to have any accidental event like bursting of gas cylinder, removal of key structural element for internal renovation, therefore many structures may be at risk of progressive collapse. These structural forms have alternative load paths which can protect such structures after the loss of a key element, but the capacity of these can be difficult to assess due to the nonlinear material and geometric factors. Additionally, the sudden removal of a structural element is a dynamic event, and so such factors must be included to obtain accurate indication into the response. Study of structural response leads to decide the preventive measures for the progressive collapse.
