# Decision Making for Retrofitting in Existing RCC Structures

The Existing structure is a Group Housing Society situated in Sector 6, Dwarka, New Delhi 110075.

Condition health assessment of Group Housing Society situated in Sector 6, Dwarka, New Delhi by using Visual Inspection & Non-destructive testing. This report pertains to the stated safety appraisal & health assessments.

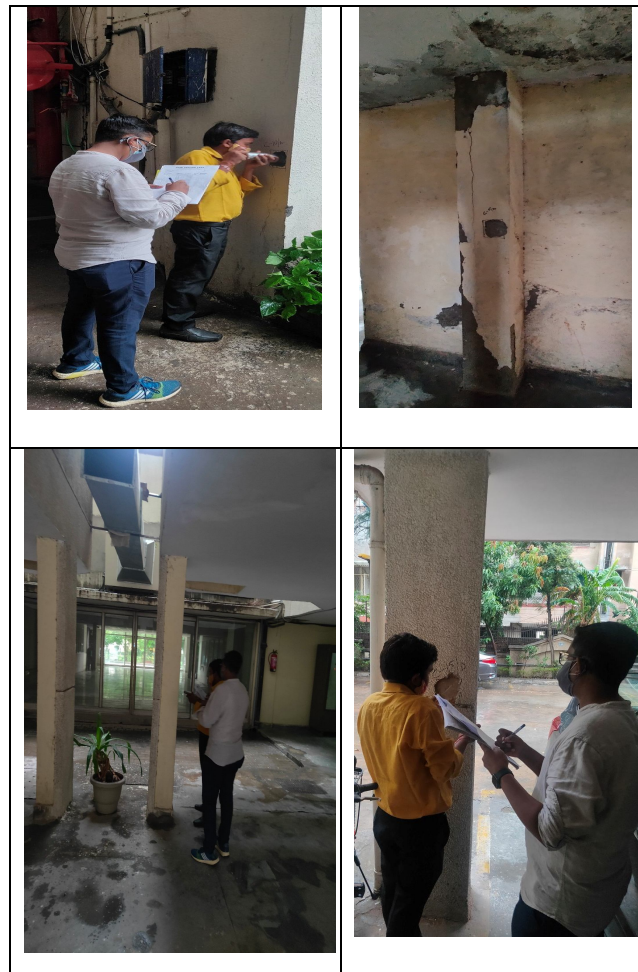
Visual Survey and Testing

Visual survey of the structural members and documenting the damage if any with the help of photographs

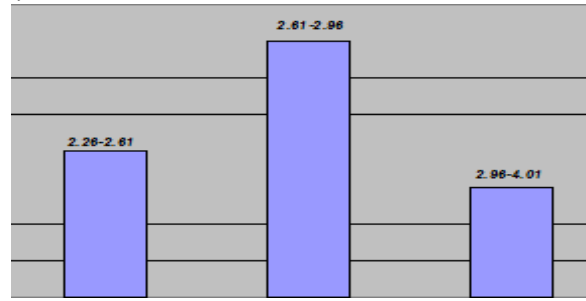
4) Results of Ultrasonic Pulse Velocity Test

Total No. of Test Location/ Results/samples	Min.	Max.	Mean	Mode	Median	Standard Deviation S/P
14	2.26	4.01	2.86	#N/A	2.72	0.54

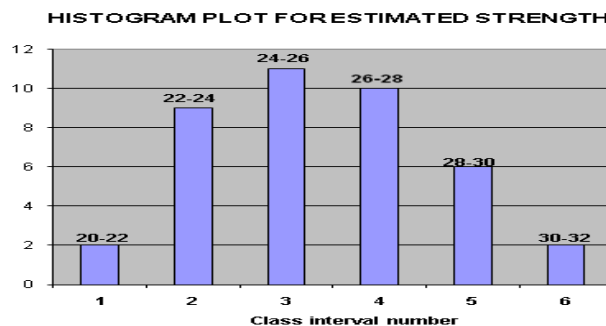
4) Results of Rebound Hammer Test

Total No. of Test Location/ Results/samples	Min.	Max.	Mean	Mode	Median	Standard Deviation S/P
40	20	32	26	25	26	2.94

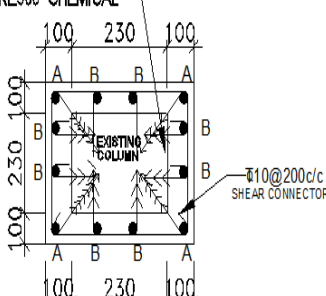
**COLUMN STRENGTHENING SCHEDULE FOR INTERIOR COLUMN**

LEVEL	COLUMN SIZE (230mmx230mm)	TIES
COLUMN MARK	M25(PPC,A20+10,WATER PROOFING)	Fe550
C1	<p>REBAR BY HILTI-RE500 CHEMICAL</p>

<p>FOUNDATION LVL. TO TERRACE LVL.</p> <p>RINGS-8@150mmC/C</p> <p>SHEAR CONNECTOR-10@200mmC/C</p>

- Removal of loose concrete from the member so as to prevent from the deterioration or de-bonding issues that entire loose particle from the concrete should remove around 25-50mm from all the sides of columns. After removal of loose concrete entire surface should be wetted by spraying water. Propped the slab during chipping by hydraulic jacks at 1 @ 1sqm each.

- Based on the design aspect additional reinforcement is added to concrete with maintaining of proper alignment and cover with a lap length of  $50 \times \text{dia of bar} = 1 \text{ meters}$ .

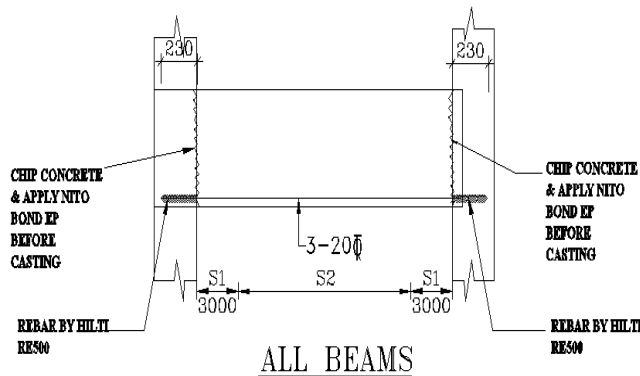
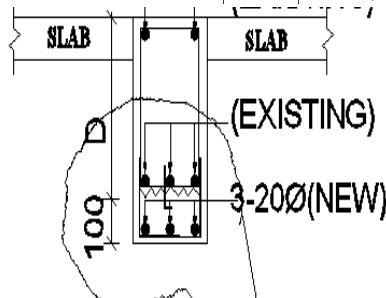
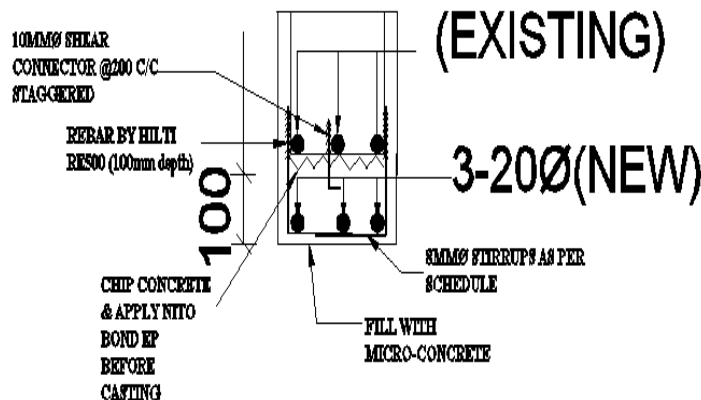
(STIRRUPS SCHEDULE)

MARK	DESCRIPTION
S1	8 $\Phi$ -(2L)@4" c/c
S2	8 $\Phi$ -(2L)@6" c/c

- c) Based on the design aspect additional reinforcement is added to beam with maintaining of proper alignment and cover with a lap length of 50Xdia of bar= 1 meters.

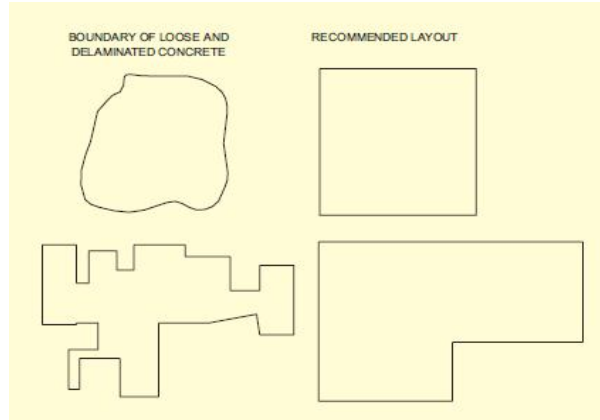
The general procedure for marking area to prepare the surface of spalled area for carrying out repairs

Fig Recommended Layout of Surface Repairs.

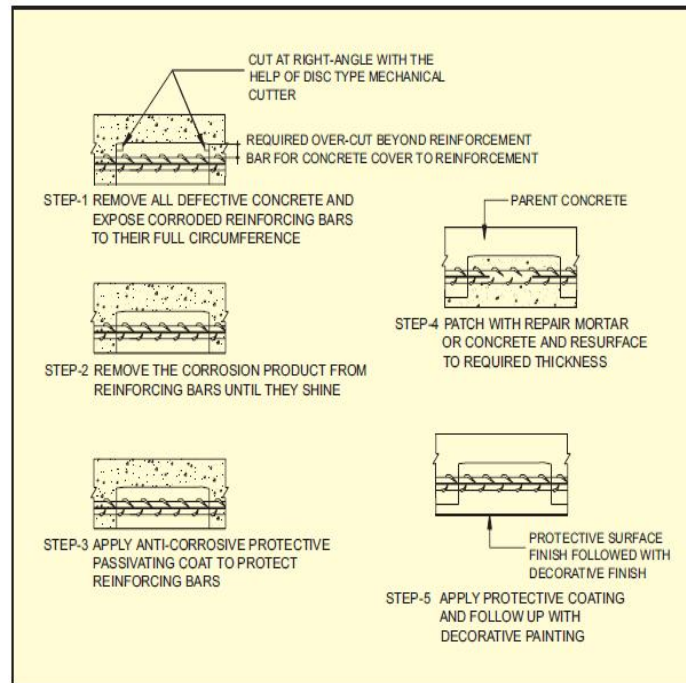
Prior to preparation of concrete surfaces, exposed reinforcement should be inspected for access clearance, cross-sectional area and location. Reinforcing bars must be further exposed if the remaining concrete is de-bonded from the reinforcing steel. Removal must be continued to completely expose the bar if more than half of a reinforcing bar perimeter has been exposed. For completely exposed reinforcing bars, a minimum average clearance of 25 mm or nominal maximum size of aggregate plus 5mm, whichever is greater, must be provided between the reinforcing bar and surrounding concrete.

The process of Surface preparation is illustrated stepwise (Step 1 to 3) in Fig. The general procedure in preparing concrete and reinforcement surfaces for optimum bonding is to sandblast the surfaces and then remove dust and debris by air blasting, low-pressure water blasting, or brooming. If the damage is due to corrosion, a suitable coating may be considered after removal of total rust from its surface to protect the exposed reinforcing steel. Final inspection of the prepared area including remedying any deficiencies should be completed just prior to batching the repair material.
